Wisconsin Incidents 1986-Present

Wisconsin Pipeline Safety Seminar

February 9th, 2024

Public Service Commission of Wisconsin

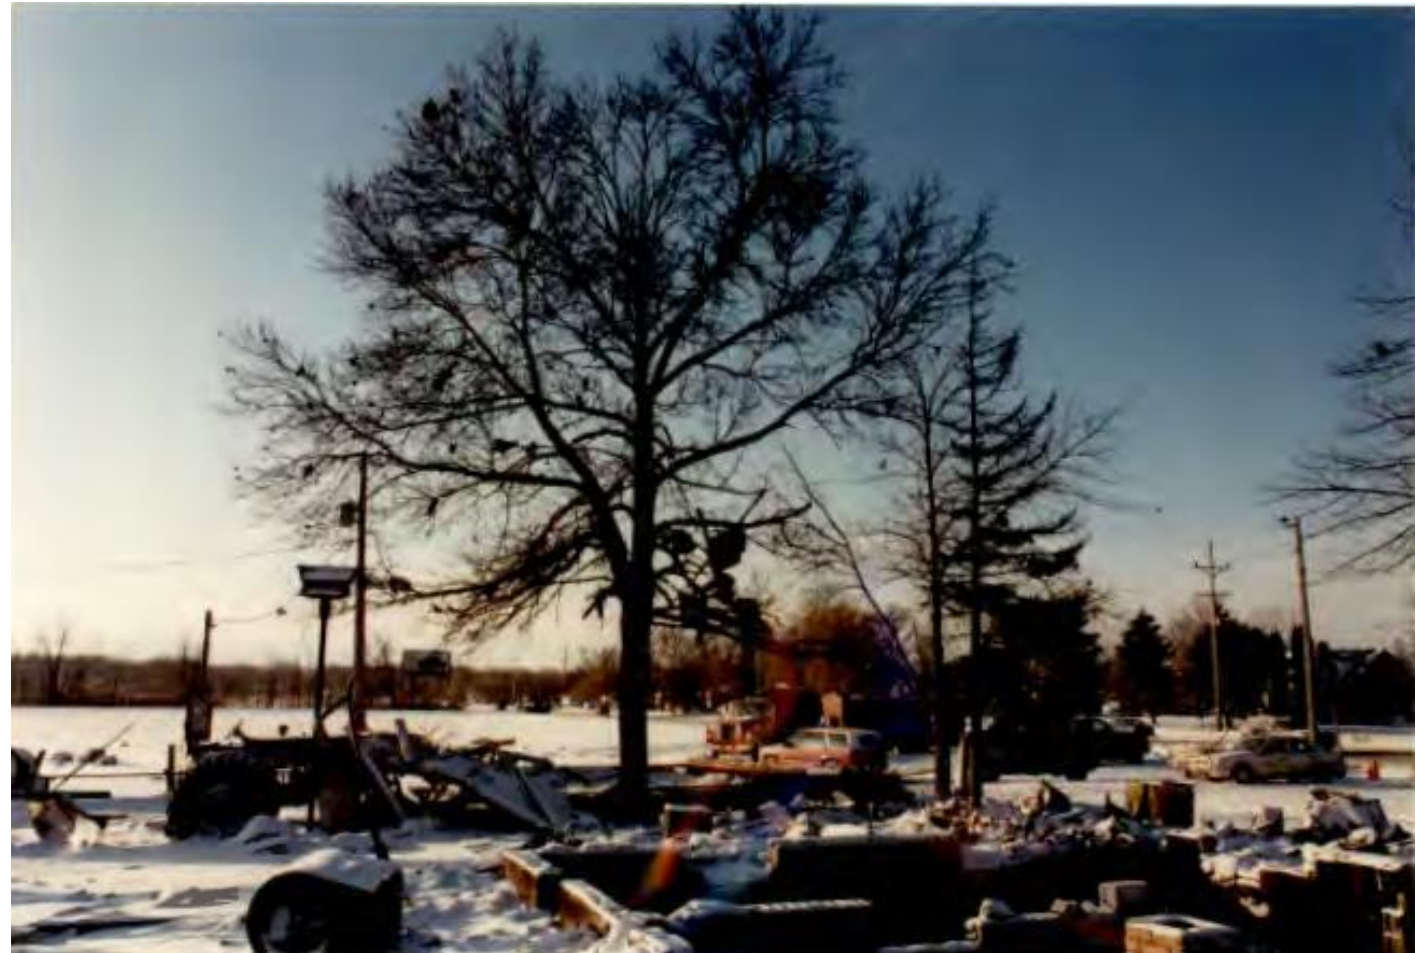
- Telecommunications company contractor
- Boring alongside 2" PE (50psi) main
- Crew called utility after smelling gas
- Utility crew arrived and explosion occurred shortly after

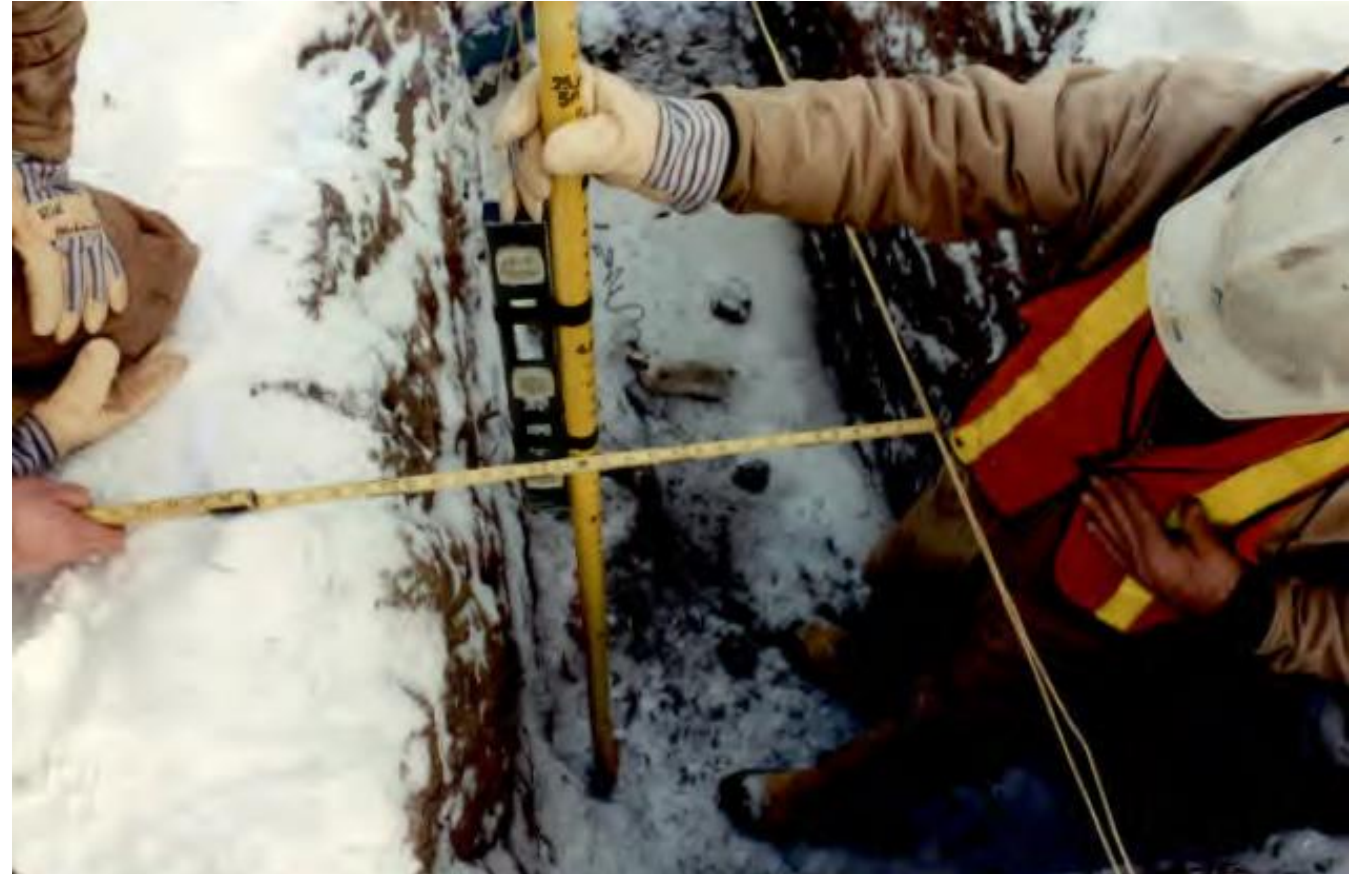
- No Fatalities
- Damage exceeded \$150,000
- Boring head accidentally veered into pipe, ripping through a 5 ft length
- 30" frost cap made the service to the home the path of least resistance
- Main was properly remarked the morning of the incident

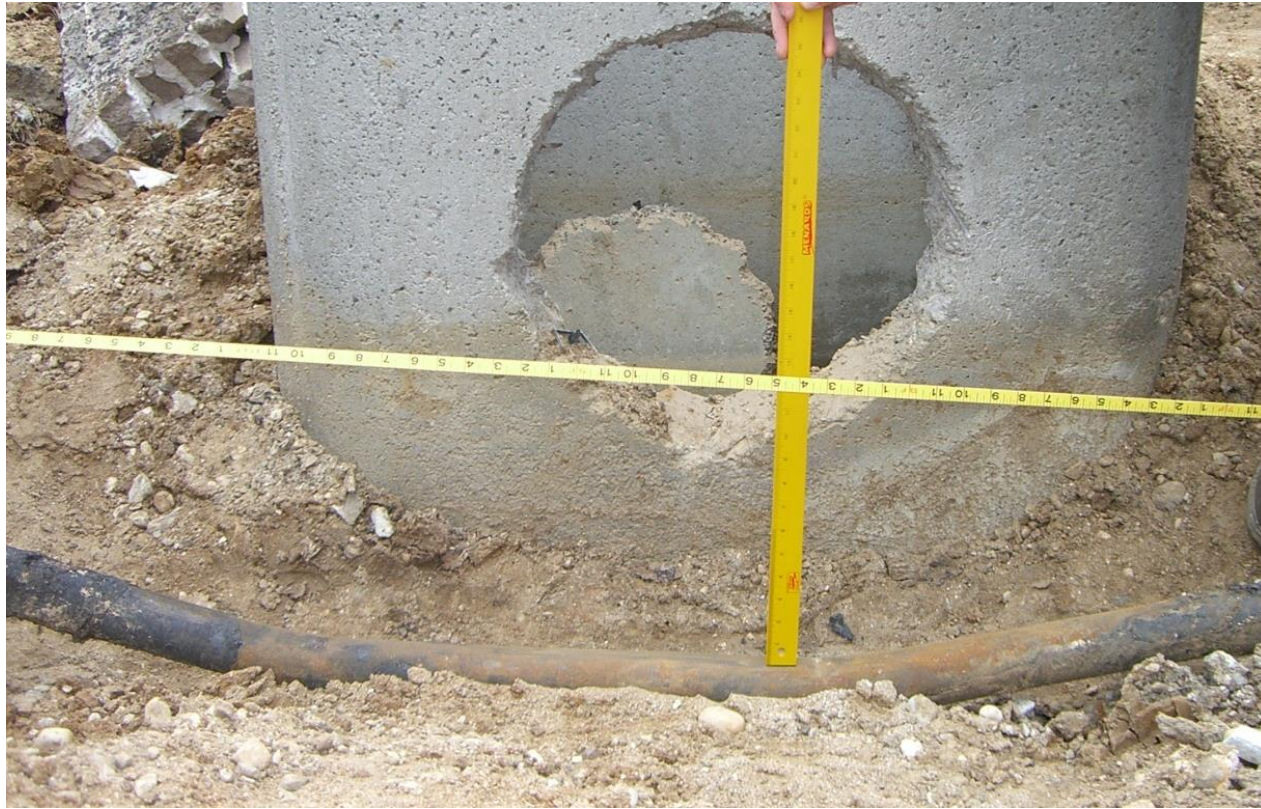
Displaced steel main (not located)

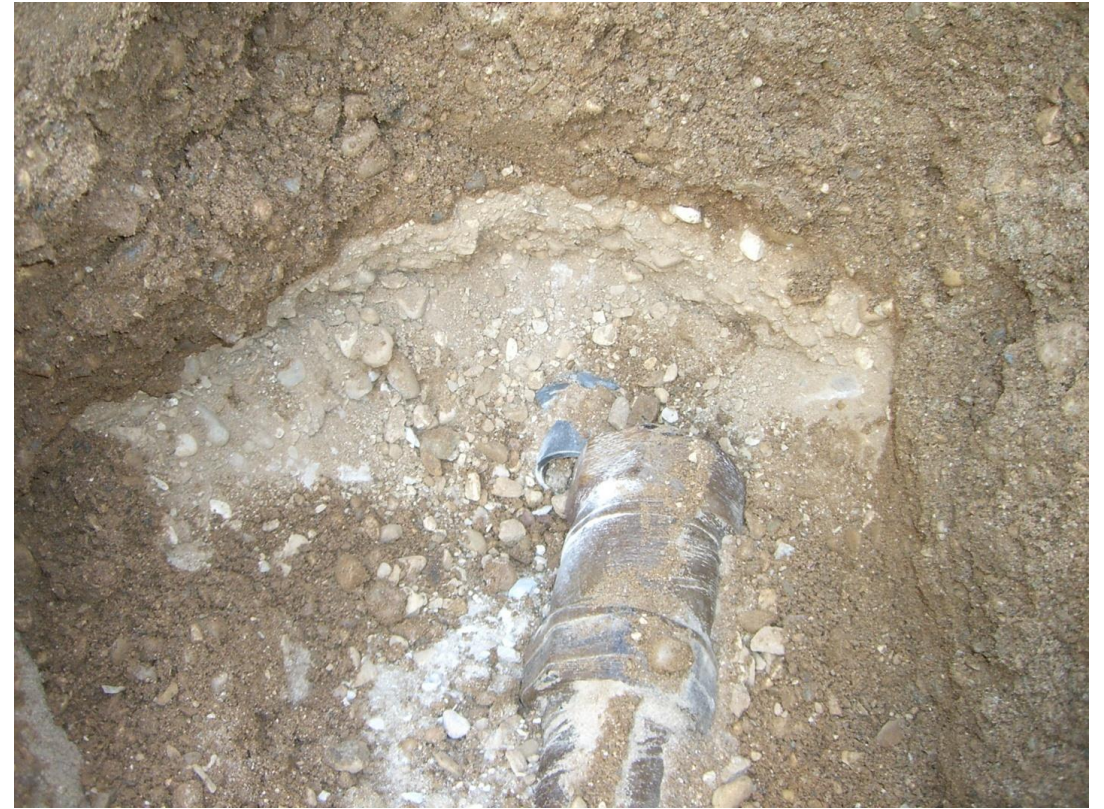
Compression coupling about 12' away from catch basin

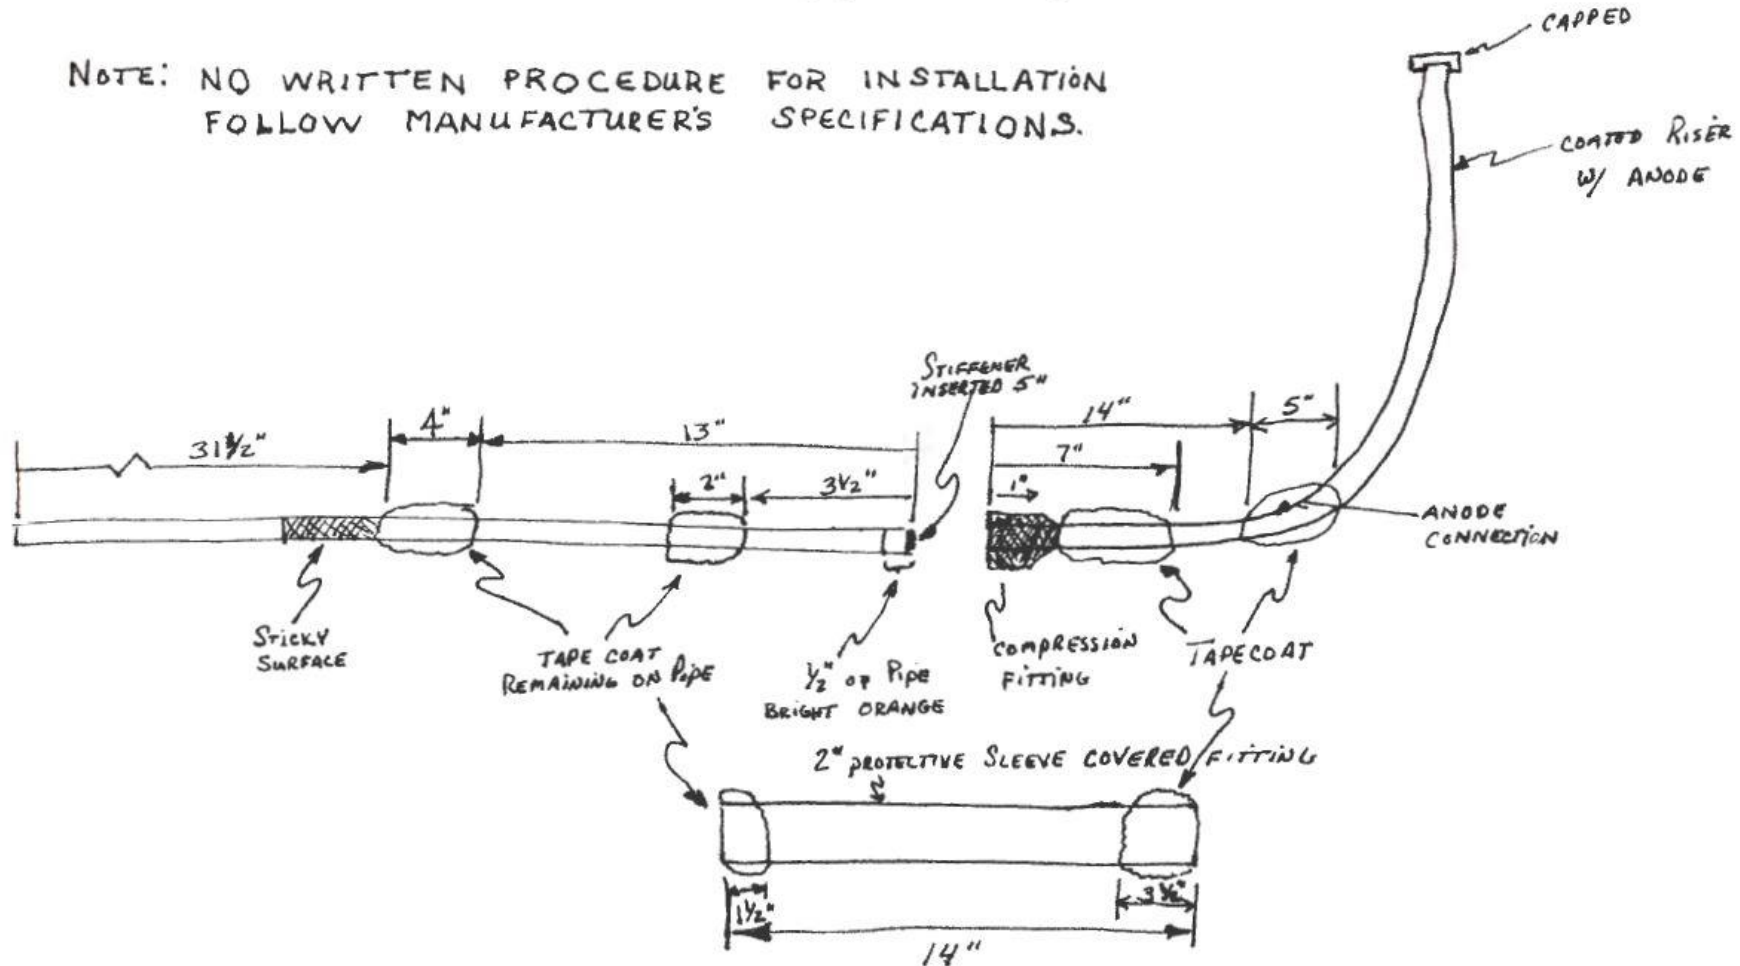
SKETCH OF RISER AND FITTING

- Leak occurred when the service partially pulled out of the compression fitting
- Utility had no record of the failed fitting and said, “Like nothing we have ordered before.”
- Only 0.5in of service was left in the fitting, typical depth was 3in

VIEWED 10-29-86 (NOT TO SCALE)

NOTE: NO WRITTEN PROCEDURE FOR INSTALLATION
FOLLOW MANUFACTURER'S SPECIFICATIONS.

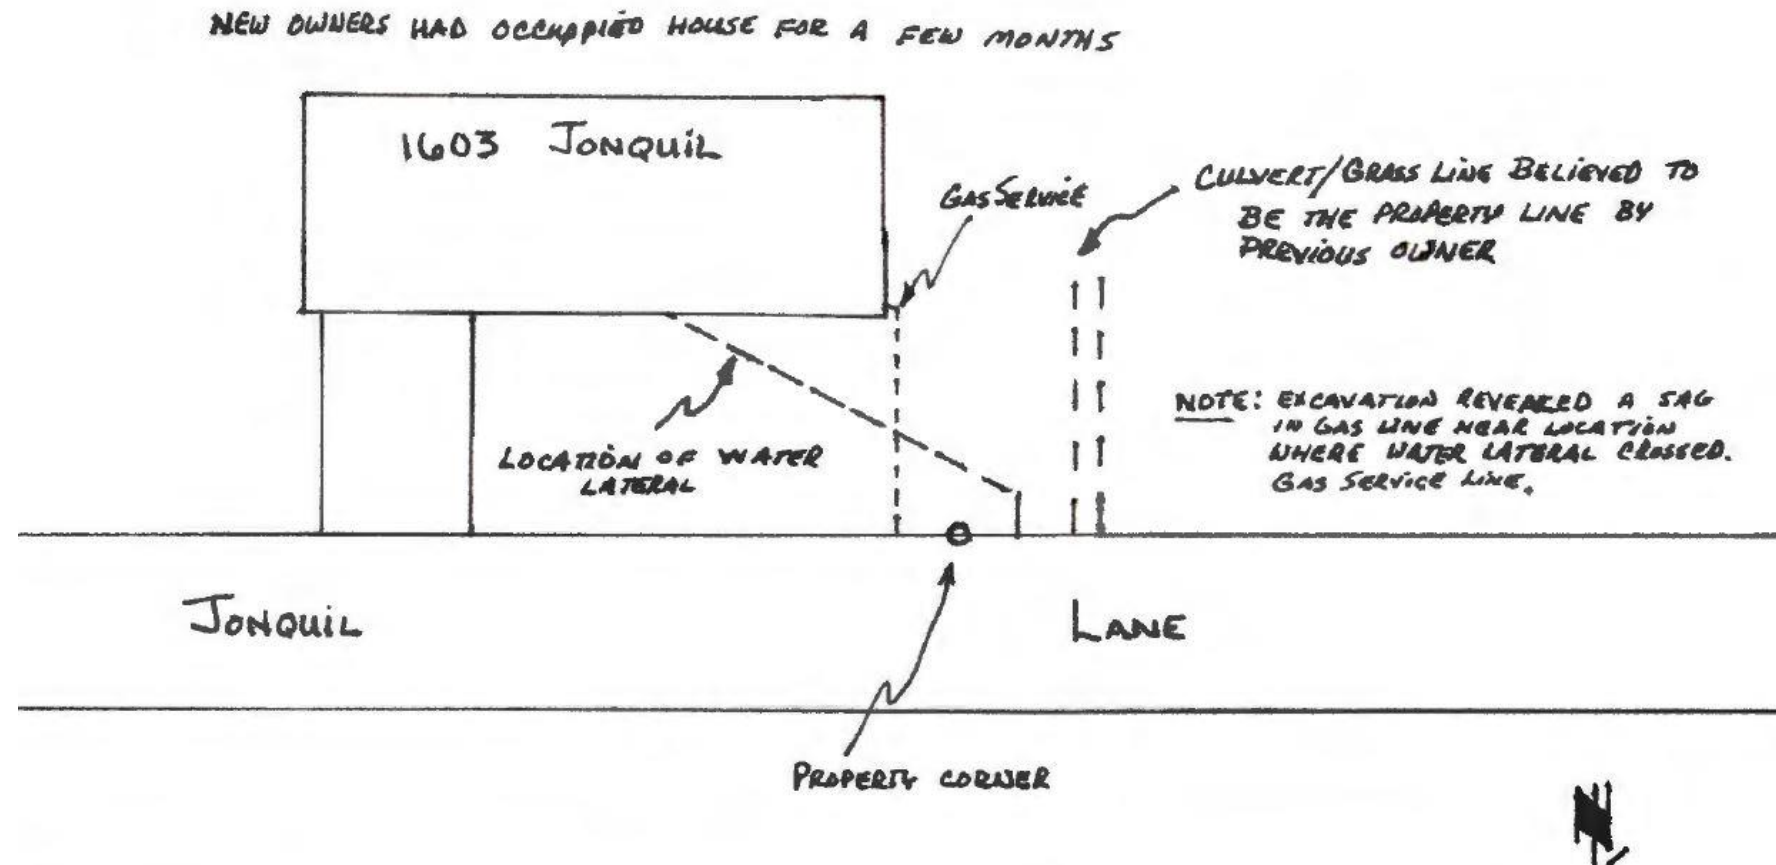
- Hand excavation of the service line led to the discovery of a severe sag in the line near where it crossed the water lateral
- During construction of new sewer and water lines the previous year it is believed the service was altered

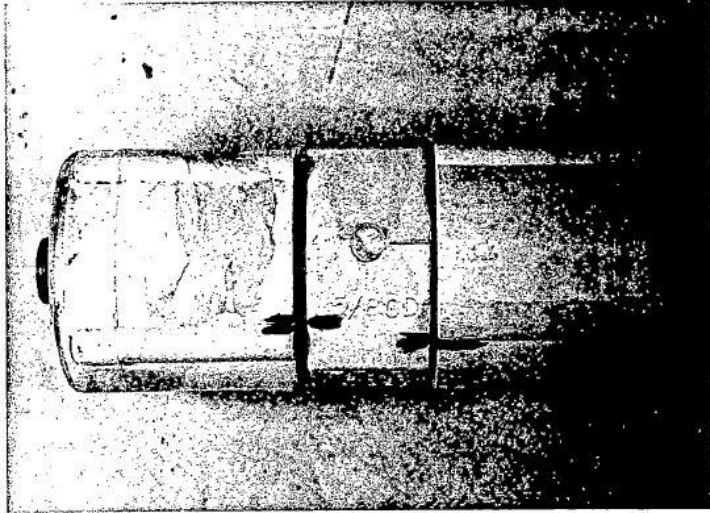
Figure 3. Markings on coupling showing initial position of nut.

- Portion of service pipe attached via coupling was removed
- Nuts on coupling not fully engaged
- Removed piping/coupling sent to laboratory for further analysis.

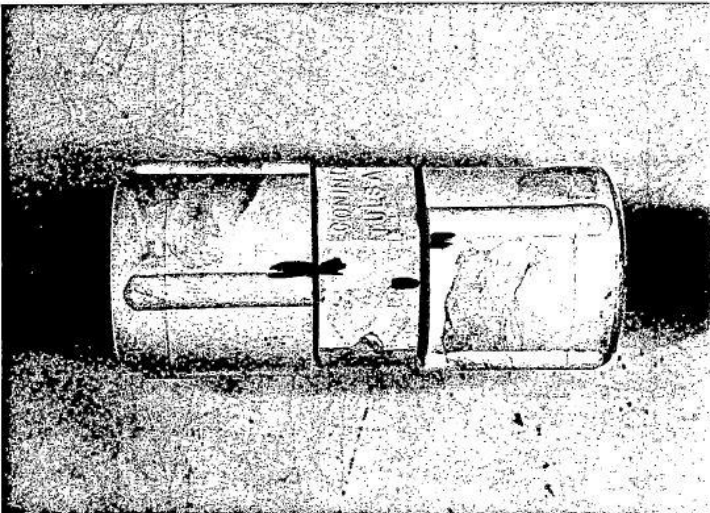
Figure 4. Position of marks after further tightening of nut.

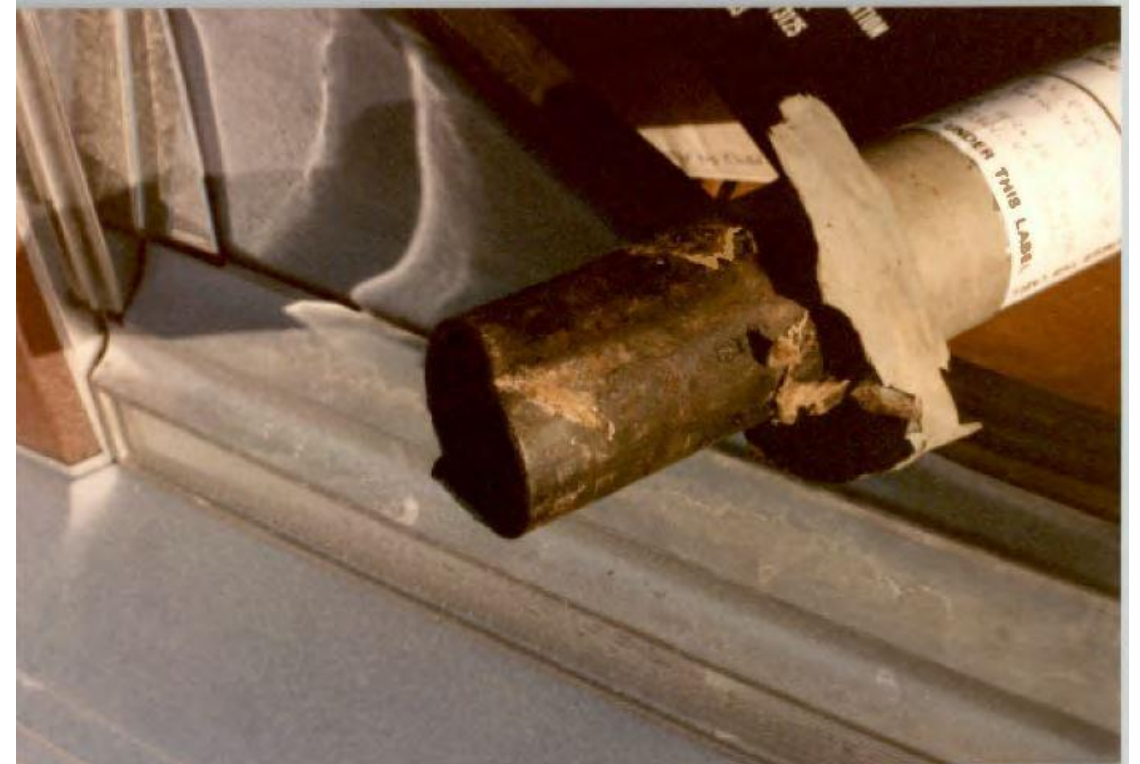
- Bar-holes found high concentrations of gas in soil
- 2in main in street had a circumferential crack
