# **Integrity Management Near Misses – Findings & Remediation**

Kyle Frayn – 2/5/2026 PSCW Safety Conference

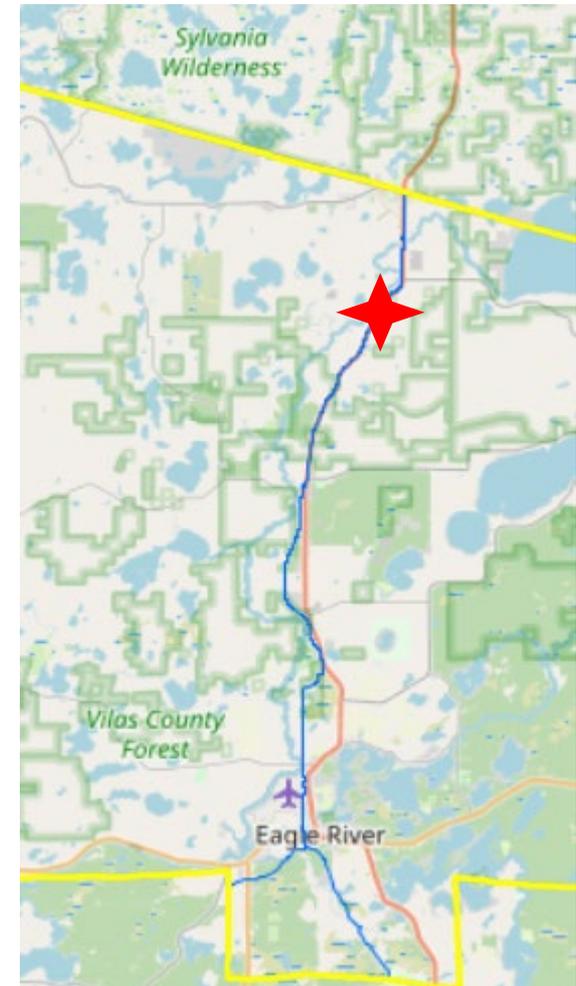
## **ECDA 50% Wall Loss**

- 8in pipe, 960 psig MAOP, built in 1998
- In 2010 a 50% wall loss feature was found at a DCVG indication
- Pipeline assessment method changed to ILI
- ILI runs in the last 15 years have allowed WEC to identify, address, and monitor corrosion.

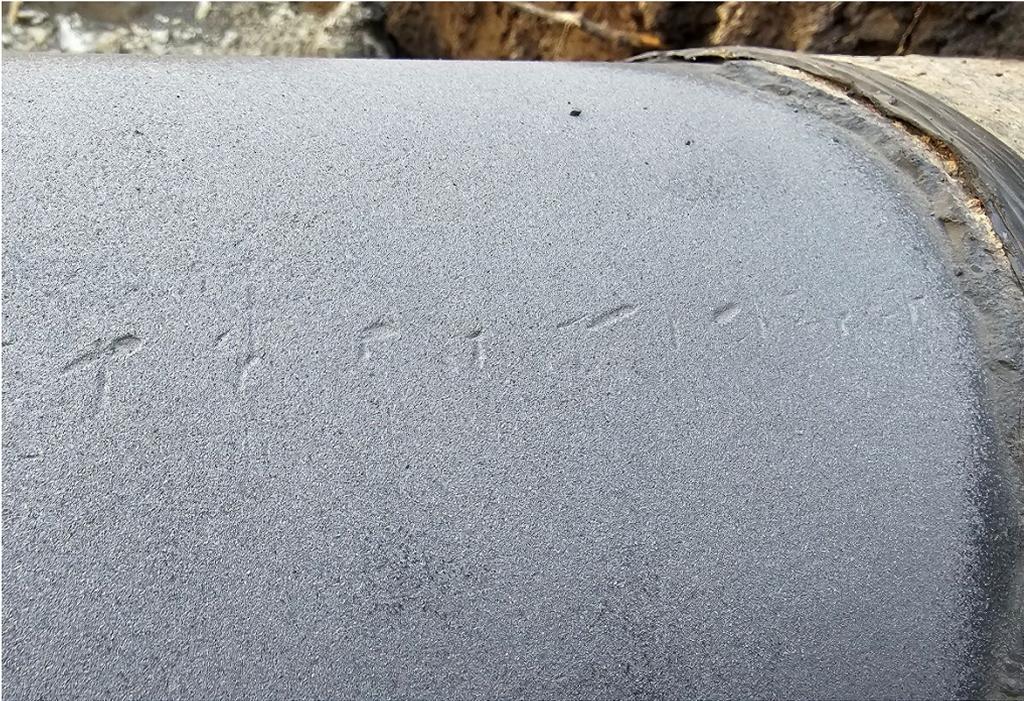
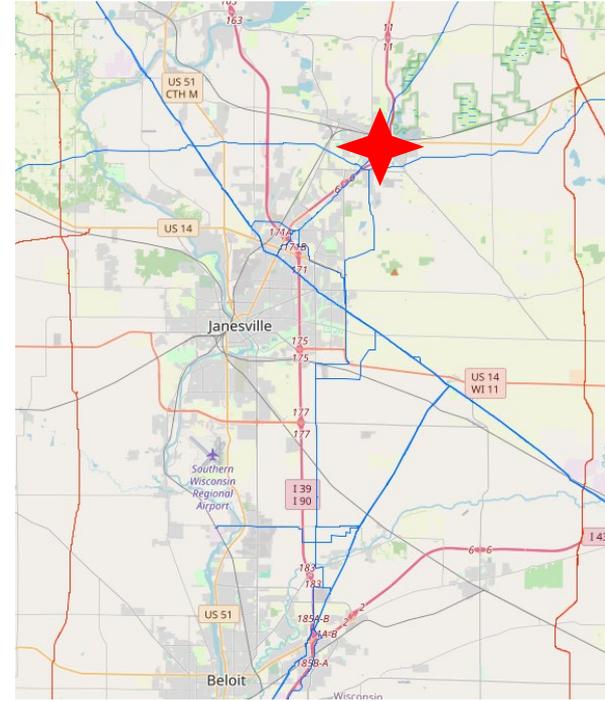
## **ECDA Manufacturing defect**

- 8in pipe, 500 psig MAOP, built in 1952
- Manufacturing defects found at ECDA indication

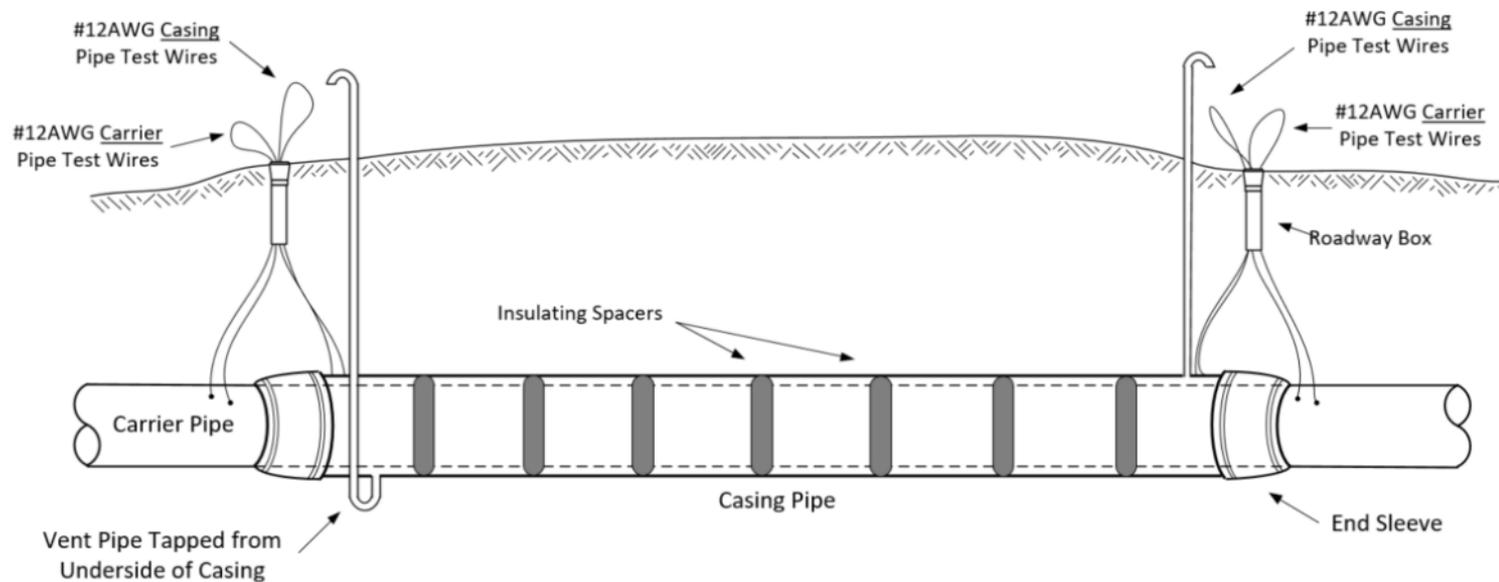
## **ECDA Casing Limitations**

- 8in pipe, 500 psig MAOP, built in 1952
- Development created a new HCA that included a cased railroad crossing
- Cased segment was identified and will be replaced to allow CIS/DCVG assessment

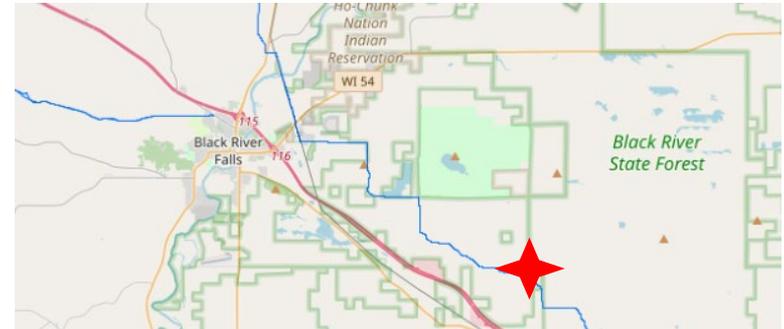
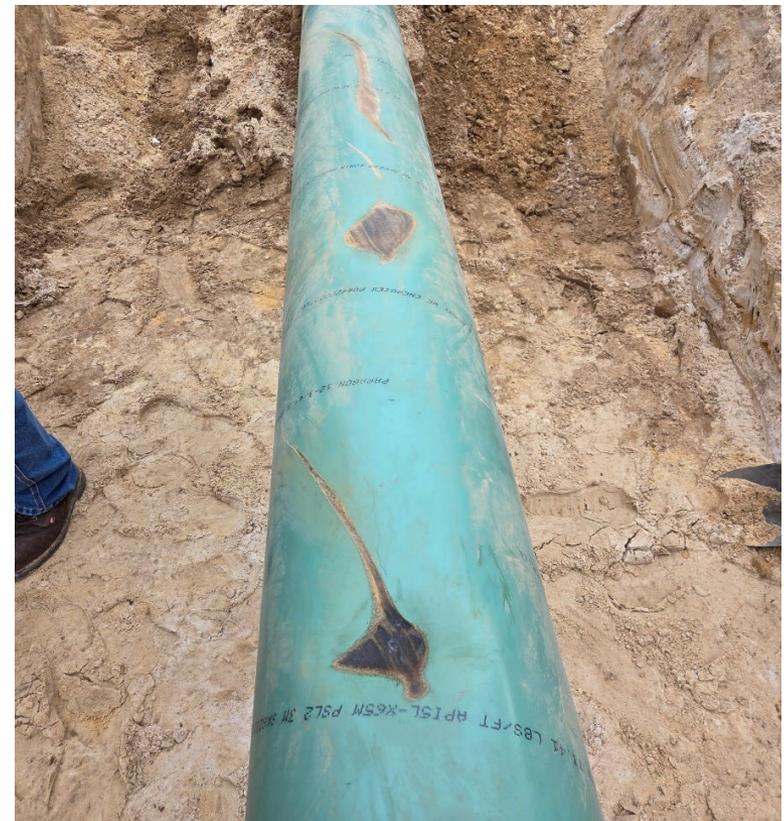
### ILI 3<sup>rd</sup> Party Damage

- 12in pipe, 475 psig MAOP, built in 2015
- Post construction ILI found no dents over 2%
- 2025 ILI indicated a 5% dent with metal loss in a non-HCA area
- Company responded to the indication as an immediate condition and confirmed apparent 3<sup>rd</sup> party damage

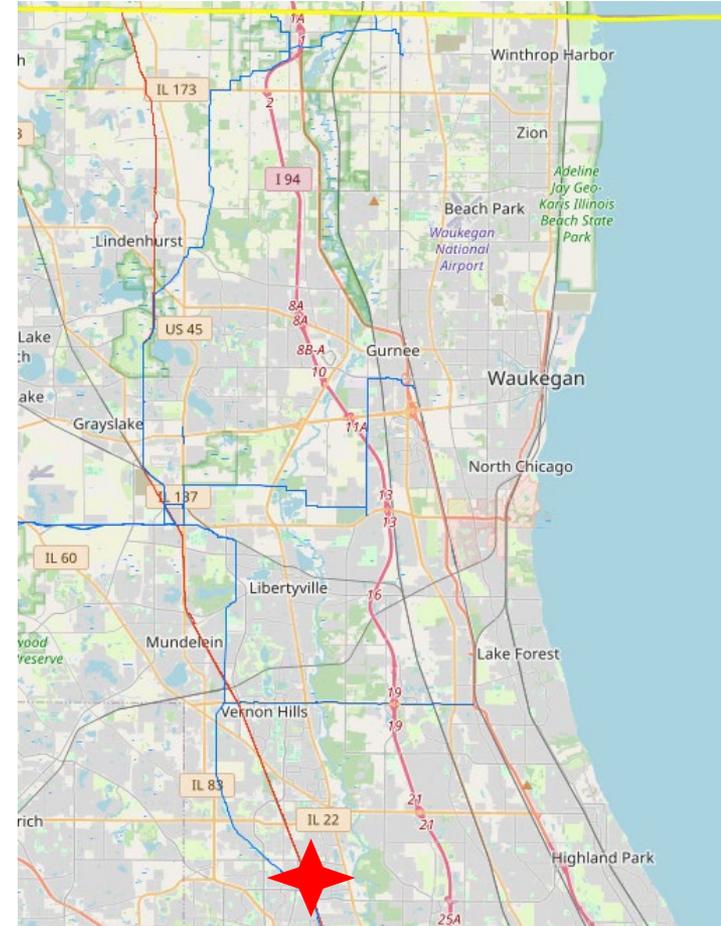
## ILI 3<sup>rd</sup> Party Damage on Retrofitted Pipeline

- 30in pipe, 218 psig MAOP, built between 1987 and 1991
- 13 miles of pipe was retrofitted to be ILI able in 2020
- Pipeline was pigged in 2021
- 71% wall loss feature was found by the ILI tool

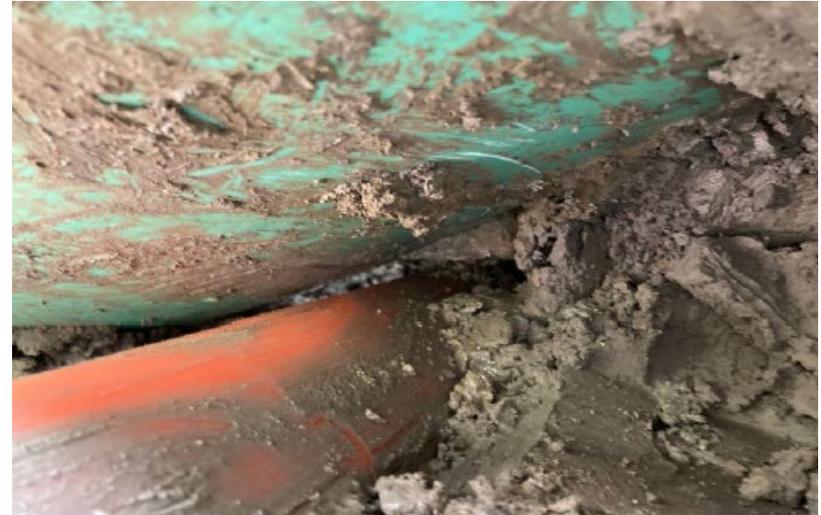
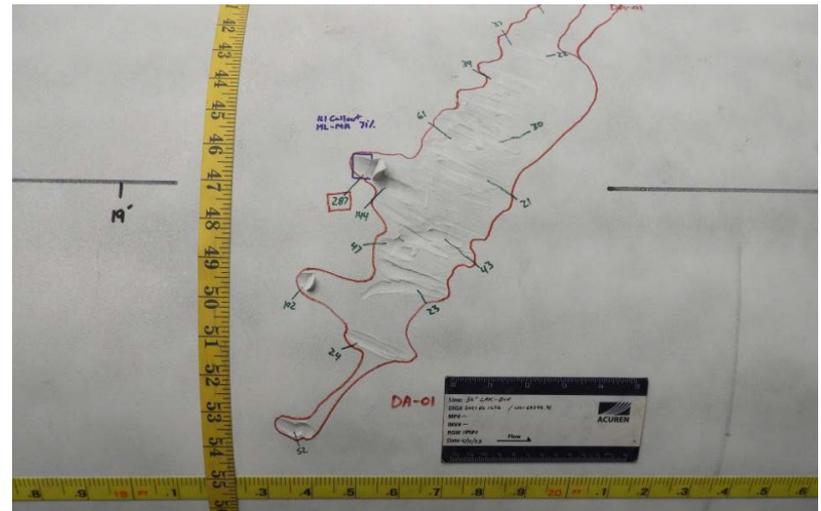
## ILI 3<sup>rd</sup> Party Damage on Retrofitted Pipeline

- The direct examination found a telecommunications cable in direct contact with the pipeline
- The cable had been directionally bored into the 30in gas line in late 1990s
- The damaged pipe was cut out and replaced
