# **NTSB Findings & Recommendations West Reading, PA candy factory explosion**

2026 Wisconsin Pipeline Safety Seminar  
Joe Murphy, PSC of Wisconsin

## UGI Corporation Natural Gas-Fueled Explosion and Fire

West Reading, Pennsylvania  
March 24, 2023

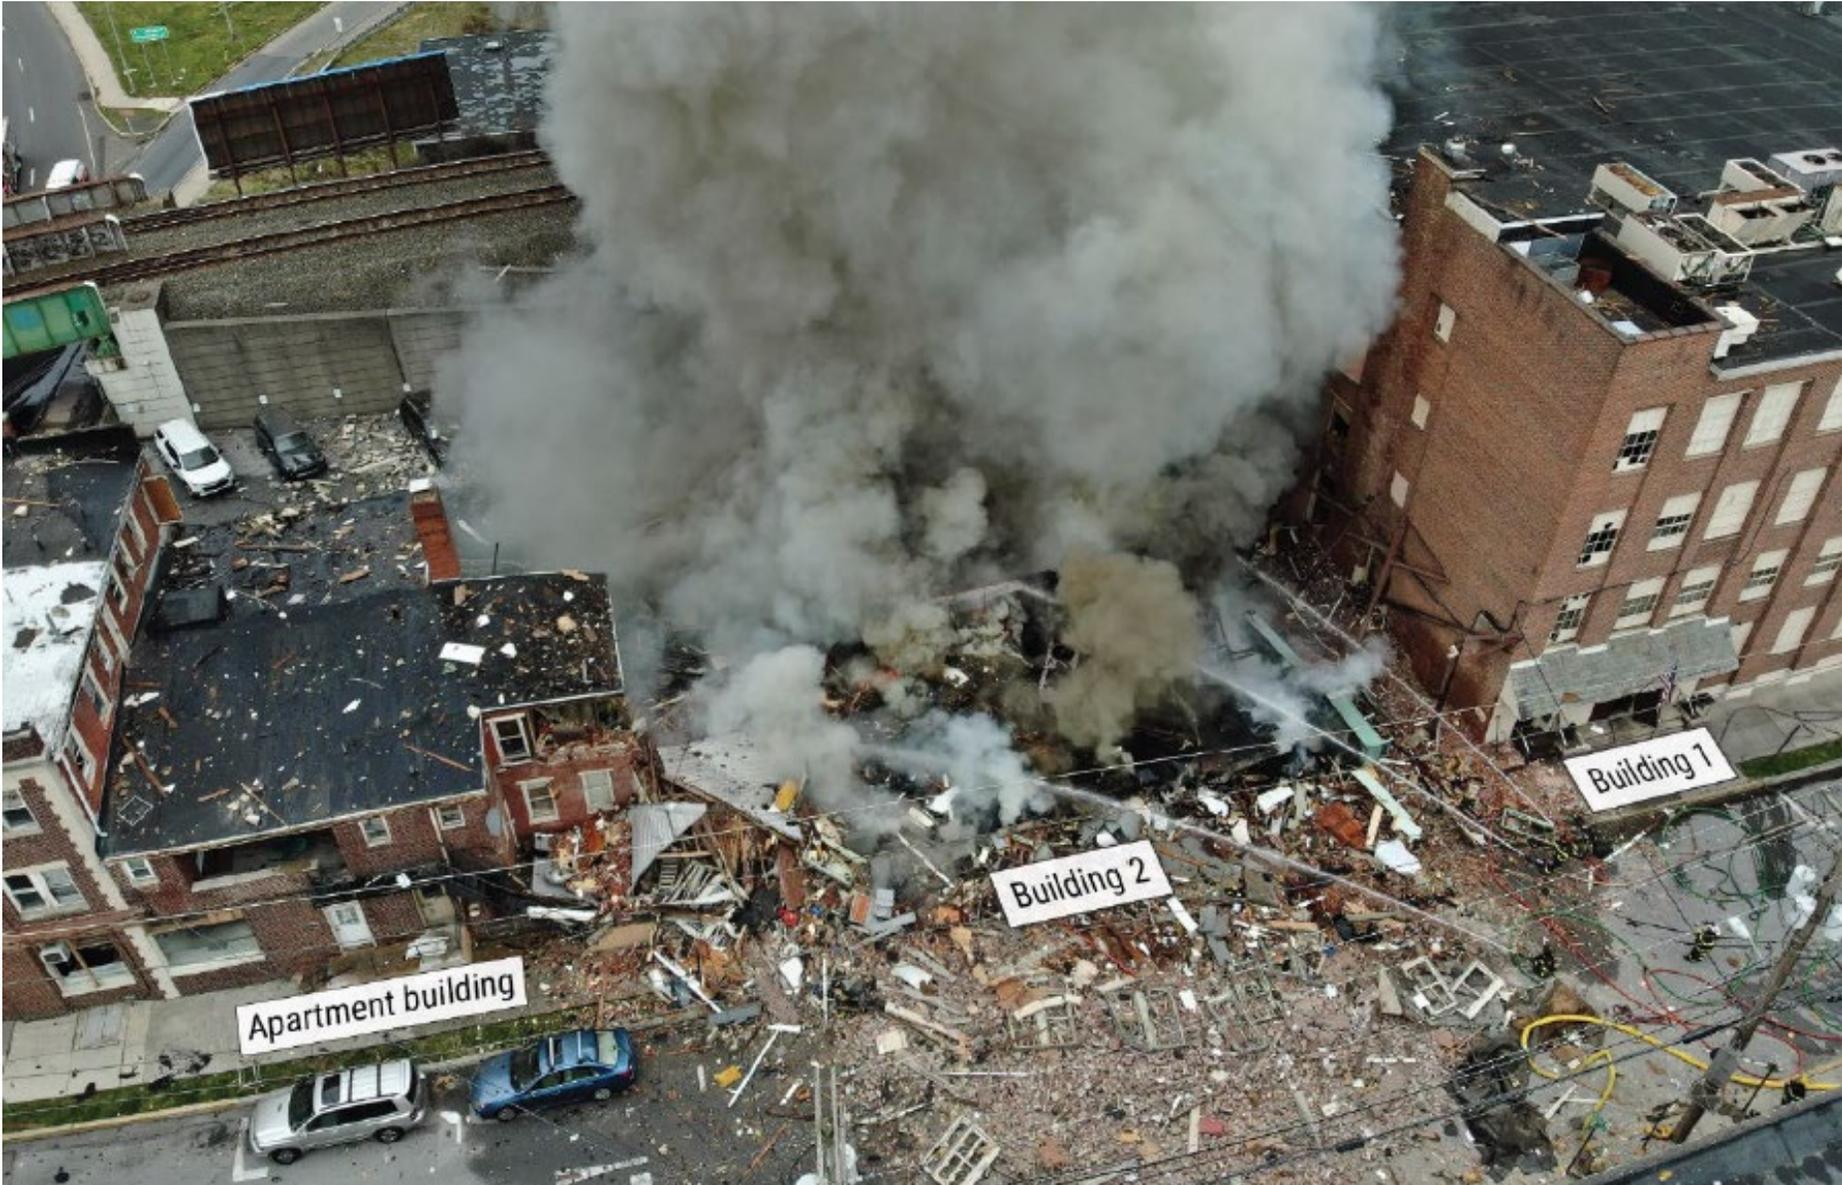
- 7 people were killed in the explosion. All were employees of the Palmer Company
- 10 injured (4 of these serious)
- 3 families displaced

- Palmer Building 2 destroyed
- Apartment building next-door sustained significant structural damage as did Palmer Building 1
- Estimated \$42 million in property damage

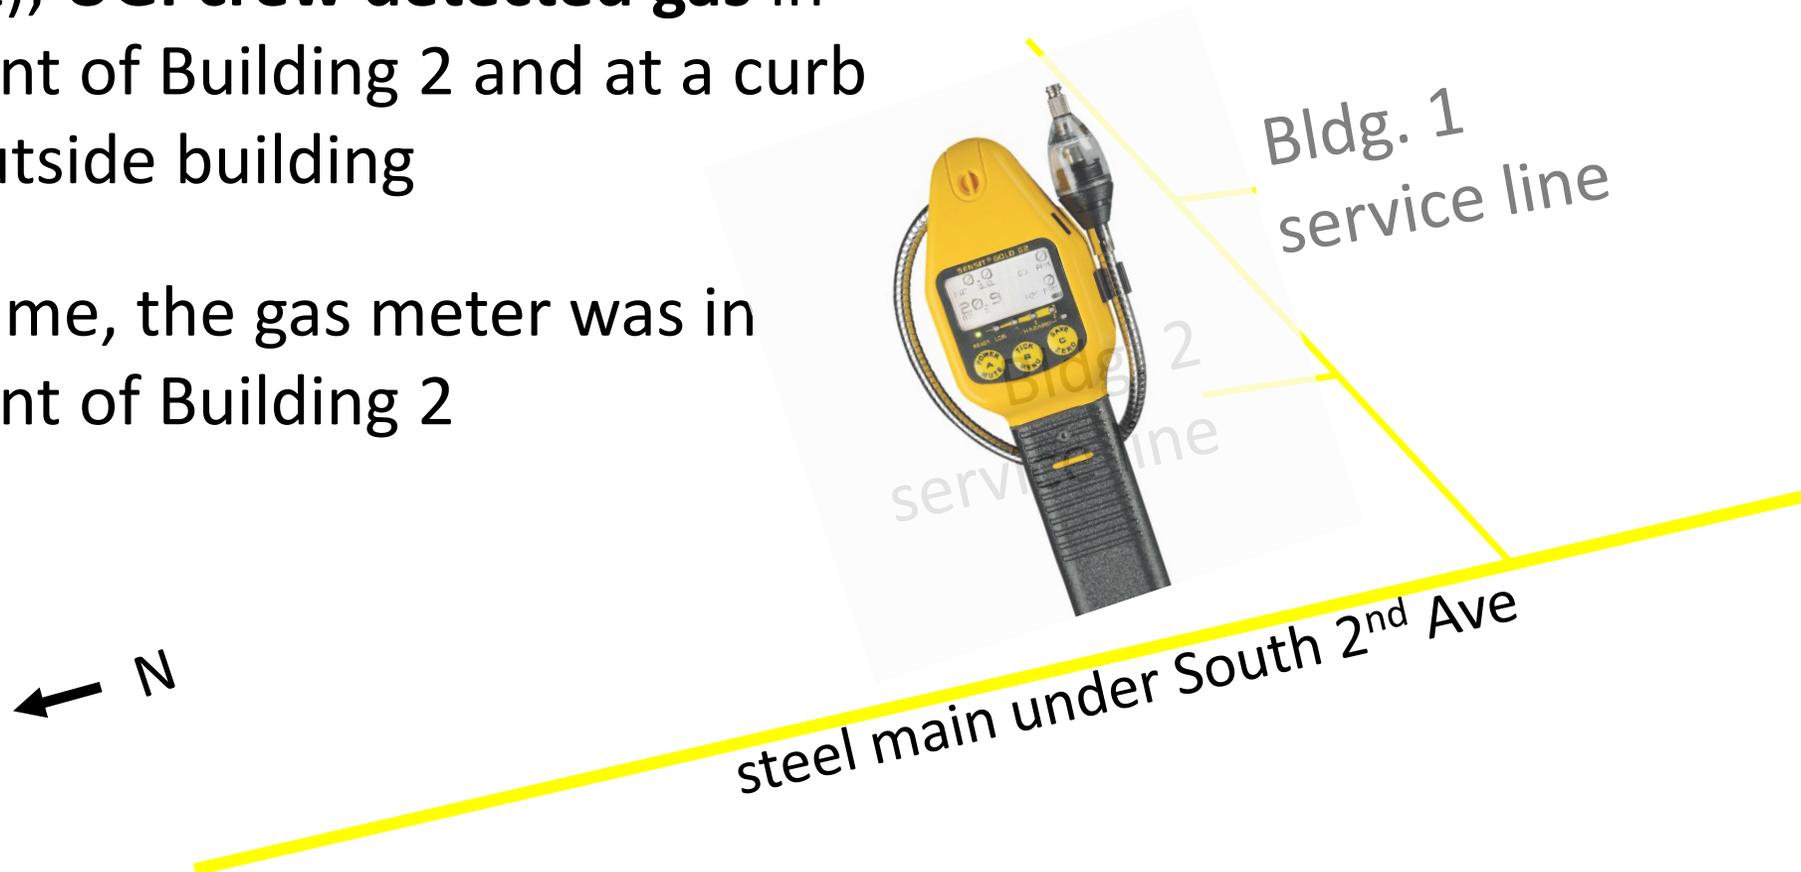
- During a meter inspection in February of 2021 (two years before the incident), **UGI crew detected gas** in basement of Building 2 and at a curb valve outside building
- At the time, the gas meter was in basement of Building 2

- As required by UGI procedures this grade of leak called for immediate attention, so UGI replaced the service line, service tee, and moved the meter from basement of Building 2
- As part of this process, the old Aldyl A service line and tee from 1982 was cut and capped and the stub left in place

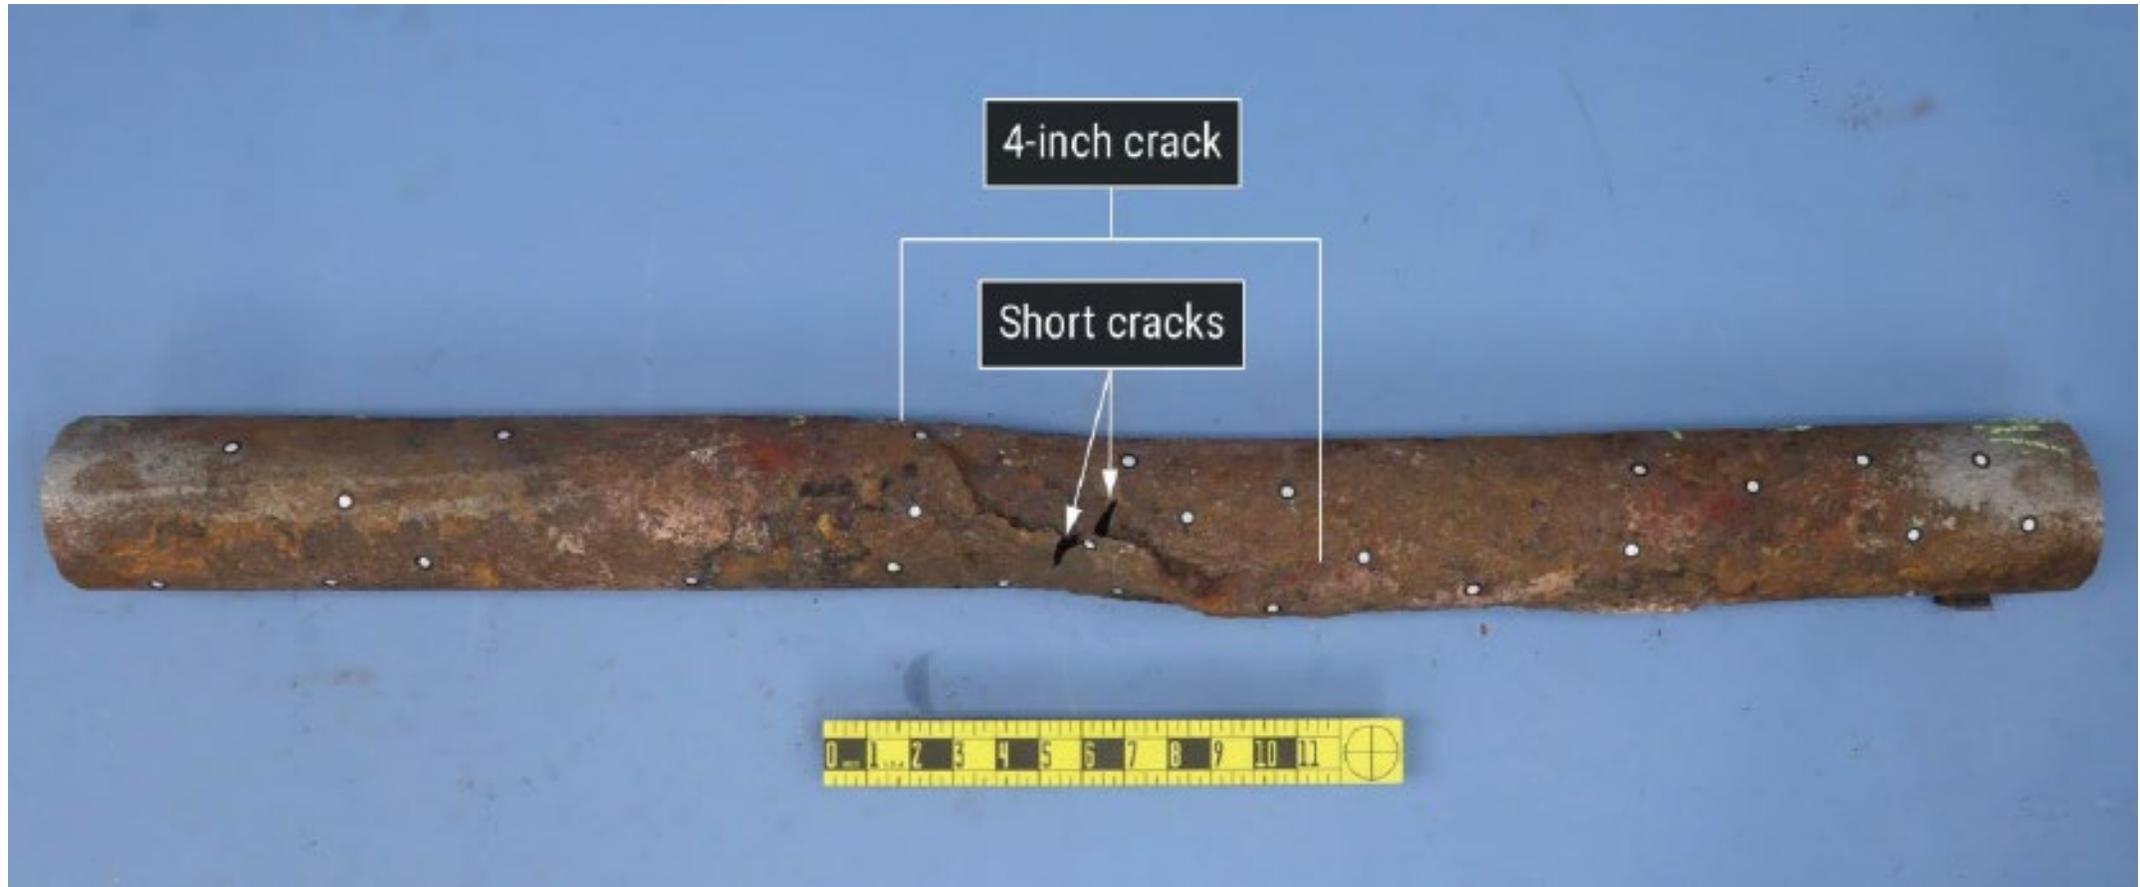
# Palmer Pipes – cracked steam pipe

- The retired service tee failed due to elevated ground temperatures from steam escaping R.M. Palmer Company's corroded underground steam pipe, located near the retired service tee.
- The steam pipe had been unmarked and cracked.

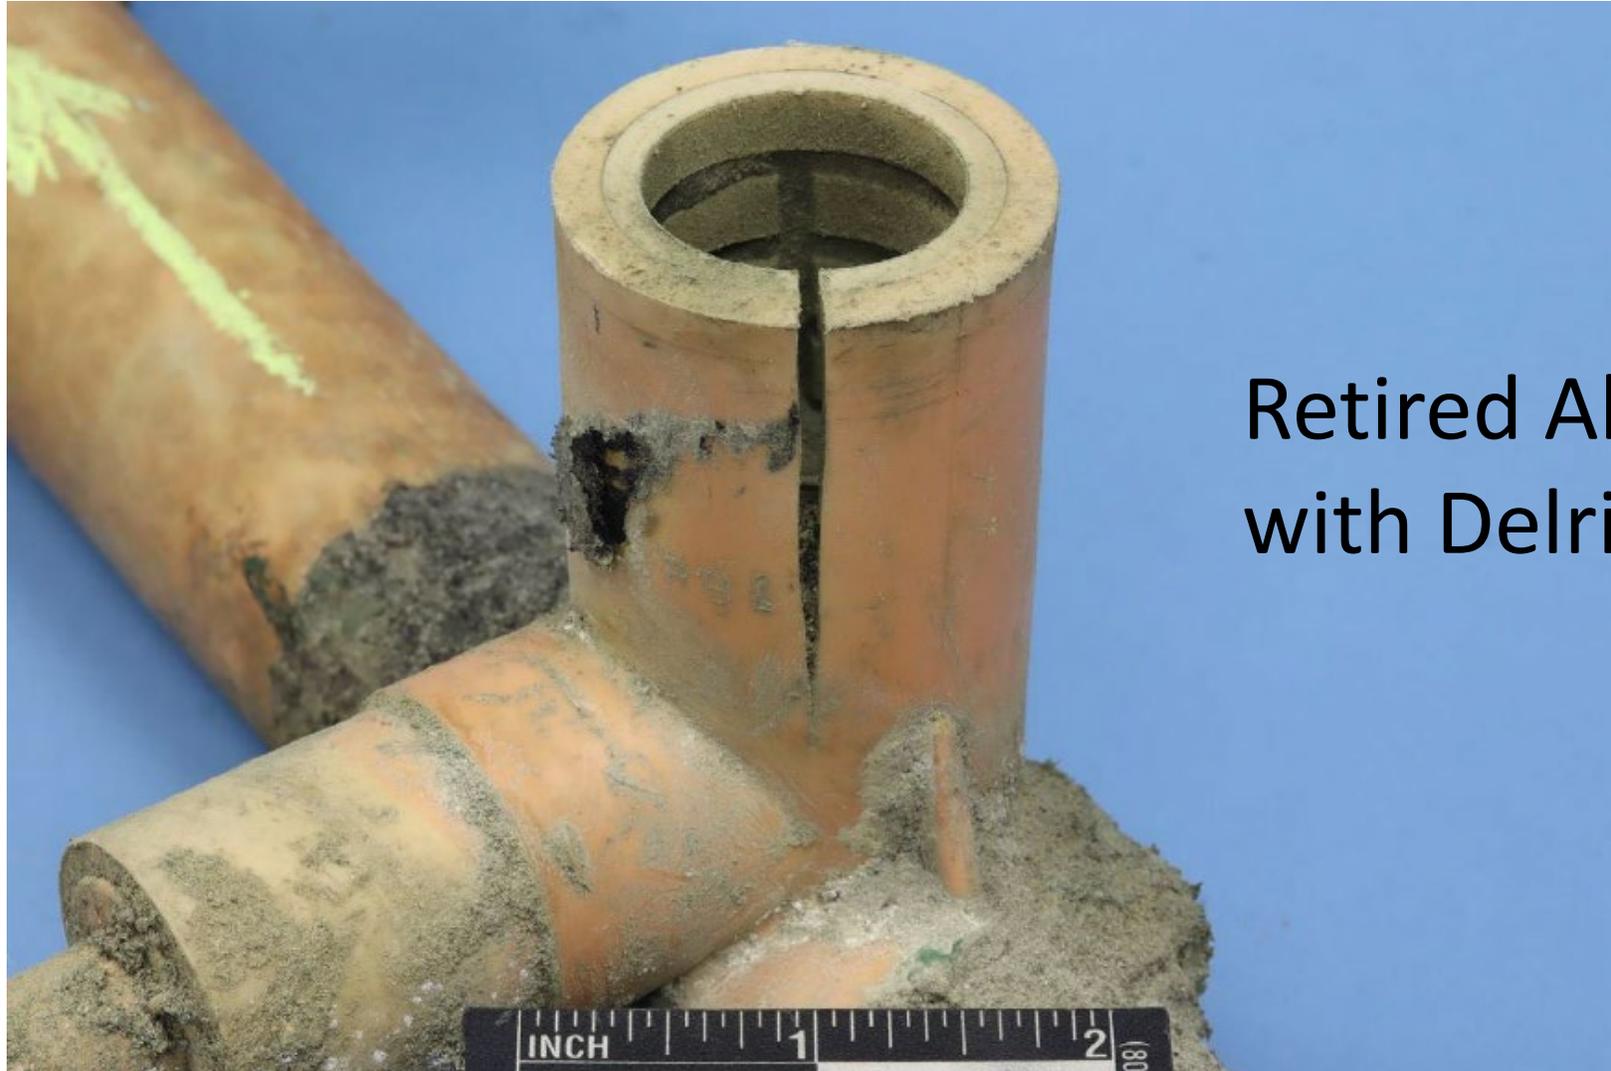
Retired Aldyl A Service Tee  
with Delrin insert

- The NTSB determines that the probable cause of the explosion was degradation of a retired 1982 Aldyl A service tee with a Delrin insert
- This failure allowed natural gas to migrate underground into the R.M. Palmer buildings where it was ignited by an unknown source

Issue an advisory bulletin that reviews the details of the March 24, 2023, natural gas–fueled explosion and fire in West Reading, Pennsylvania, and advises all regulated natural gas distribution pipeline operators **to address the risk associated with Aldyl A service tees with Delrin inserts**, including replacing or remediating them.

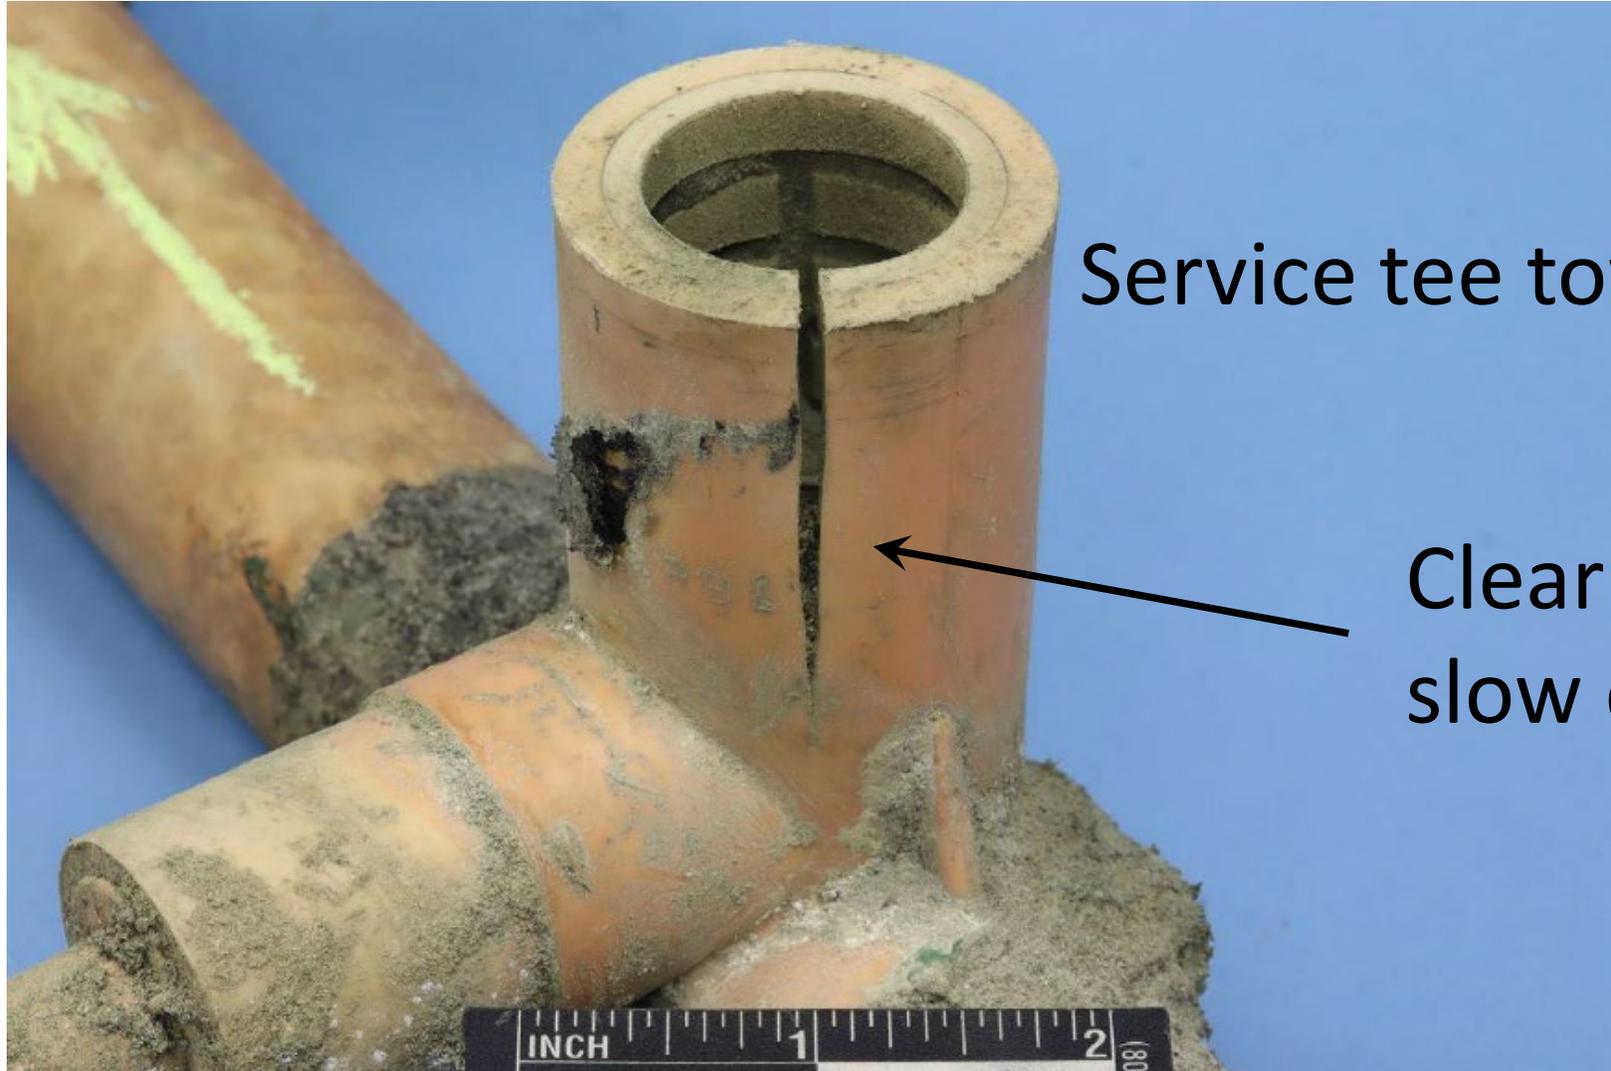
Service tee tower

← Clear evidence of  
slow crack growth

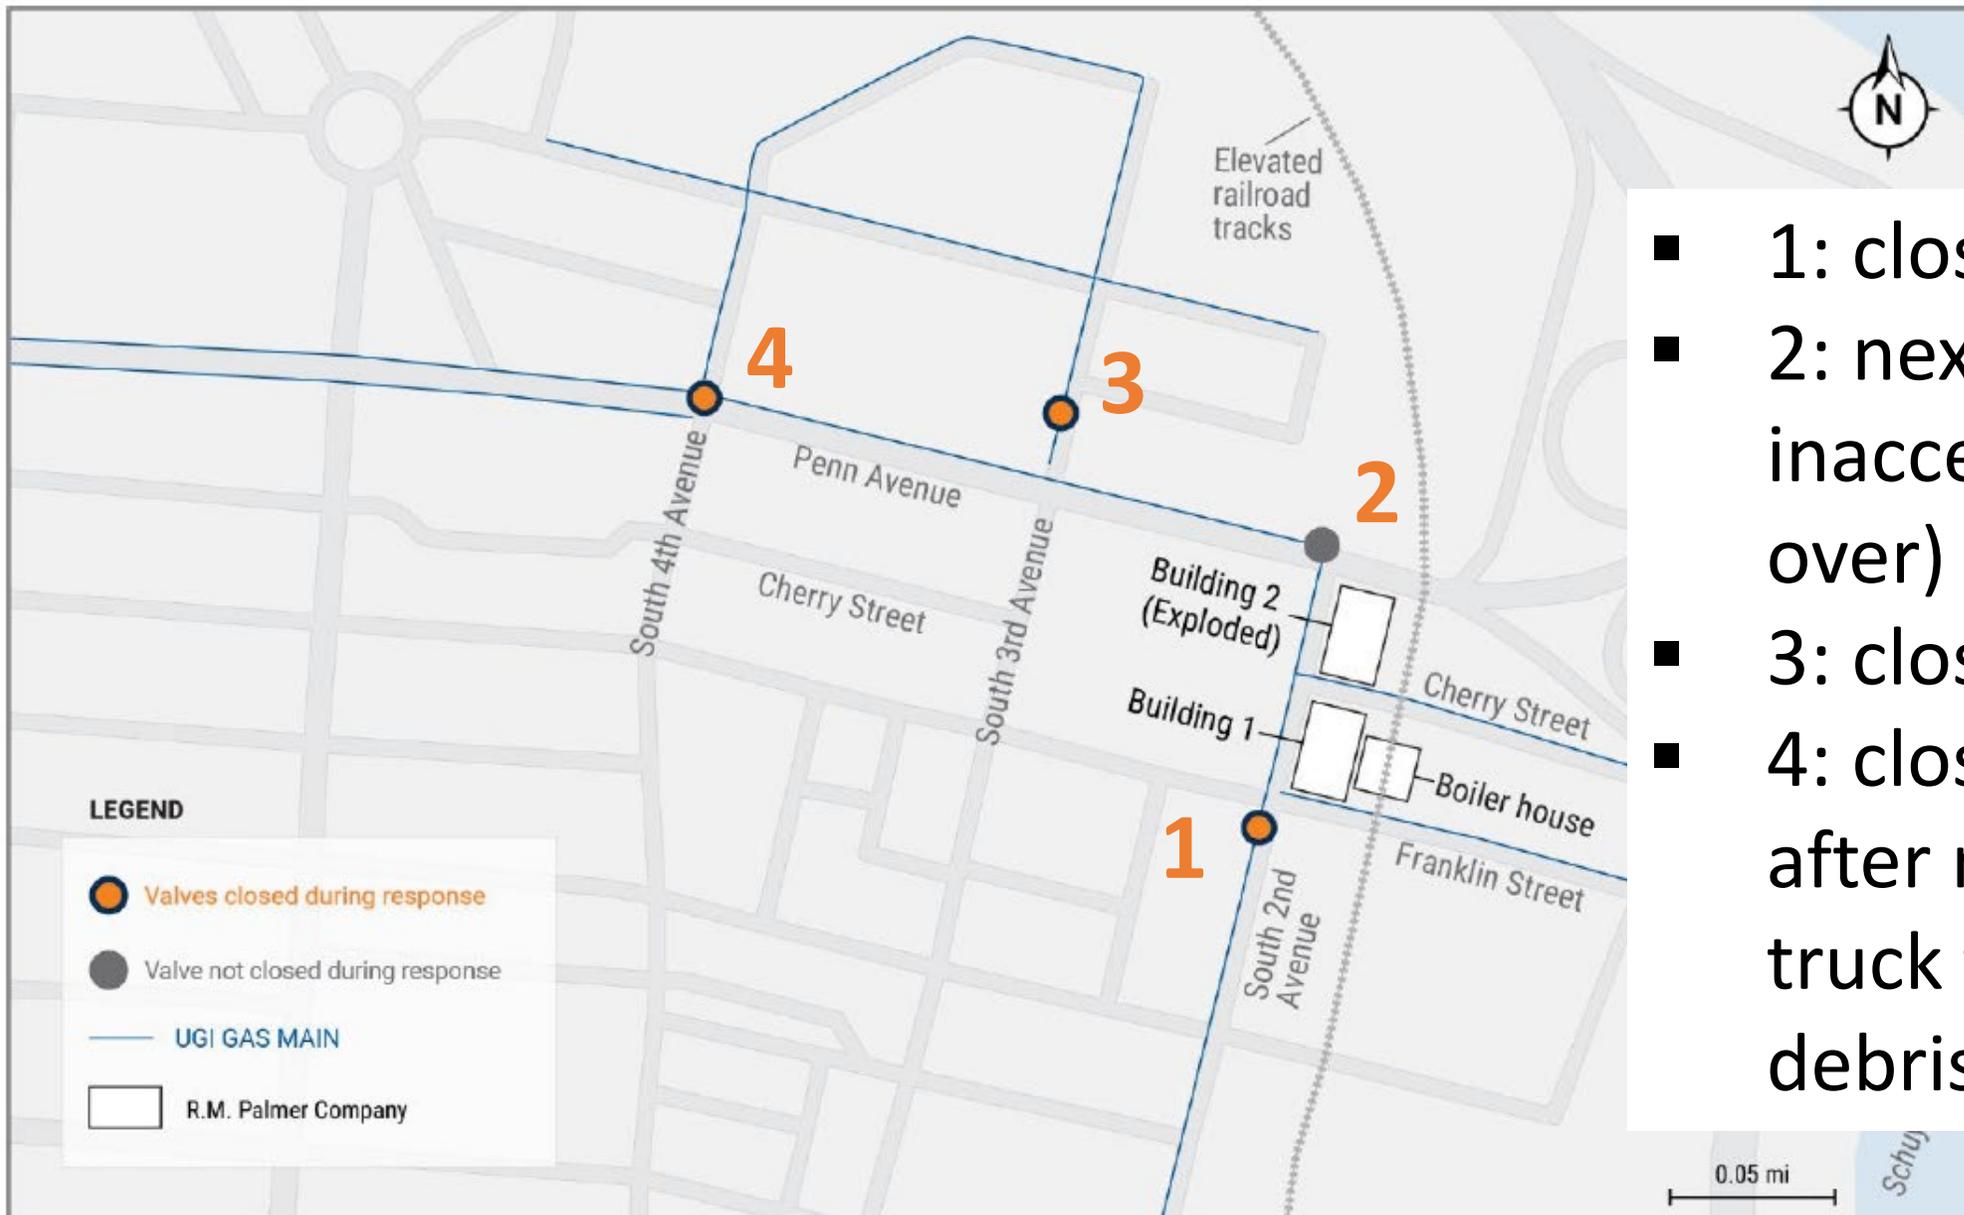
# UGI Emergency Response – Valves Closed

- 1: closed at 5:30
- 2: next valve inaccessible (paved over)
- 3: closed at 5:50
- 4: closed at 6:15 after requiring vac truck to clean out debris

- UGI Corporation did not effectively inspect and maintain its valves through its valve maintenance program, leading to a delay in shutting off gas to the affected area.

Assess the methodology used by natural gas pipeline operators to determine **where emergency valves should be located** to ensure the operators are properly considering consequences and emergency response times as well as population sizes.
