Wisconsin Incidents 1986 - Present

Wisconsin Pipeline Safety Seminar

Public Service Commission of Wisconsin

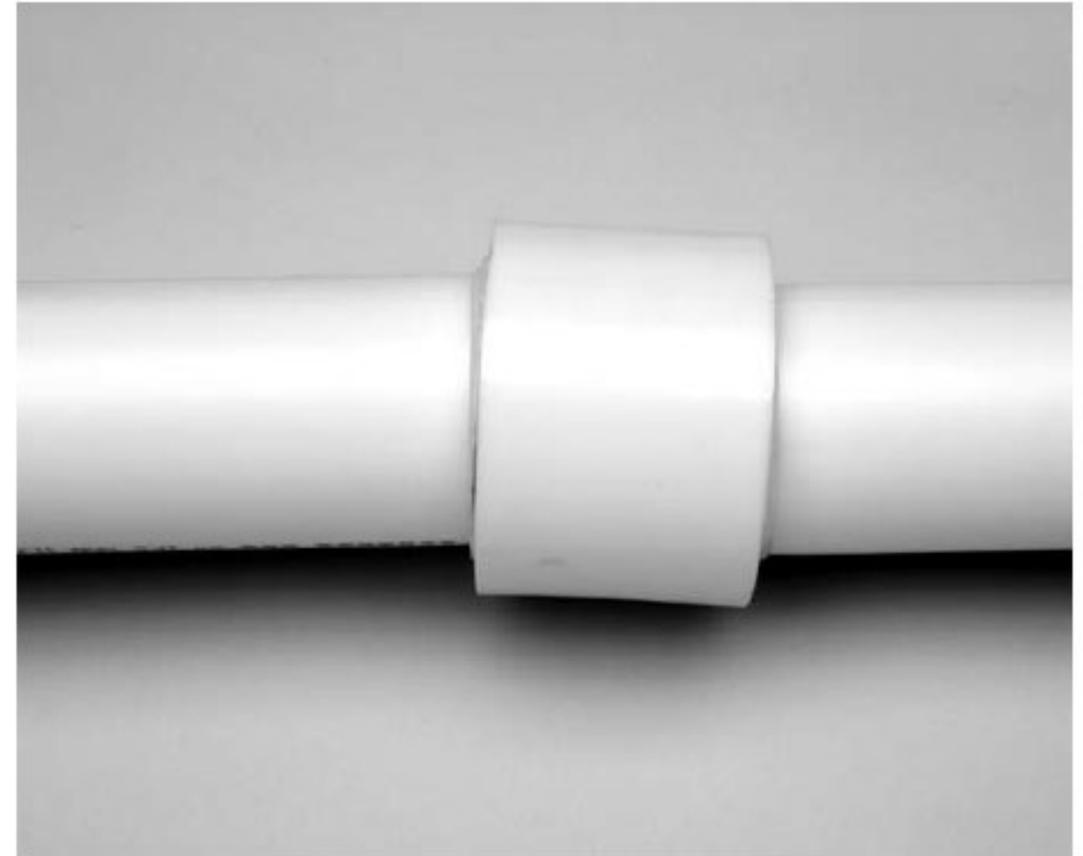
FIG. X2.3 Unacceptable due to angular misalignment

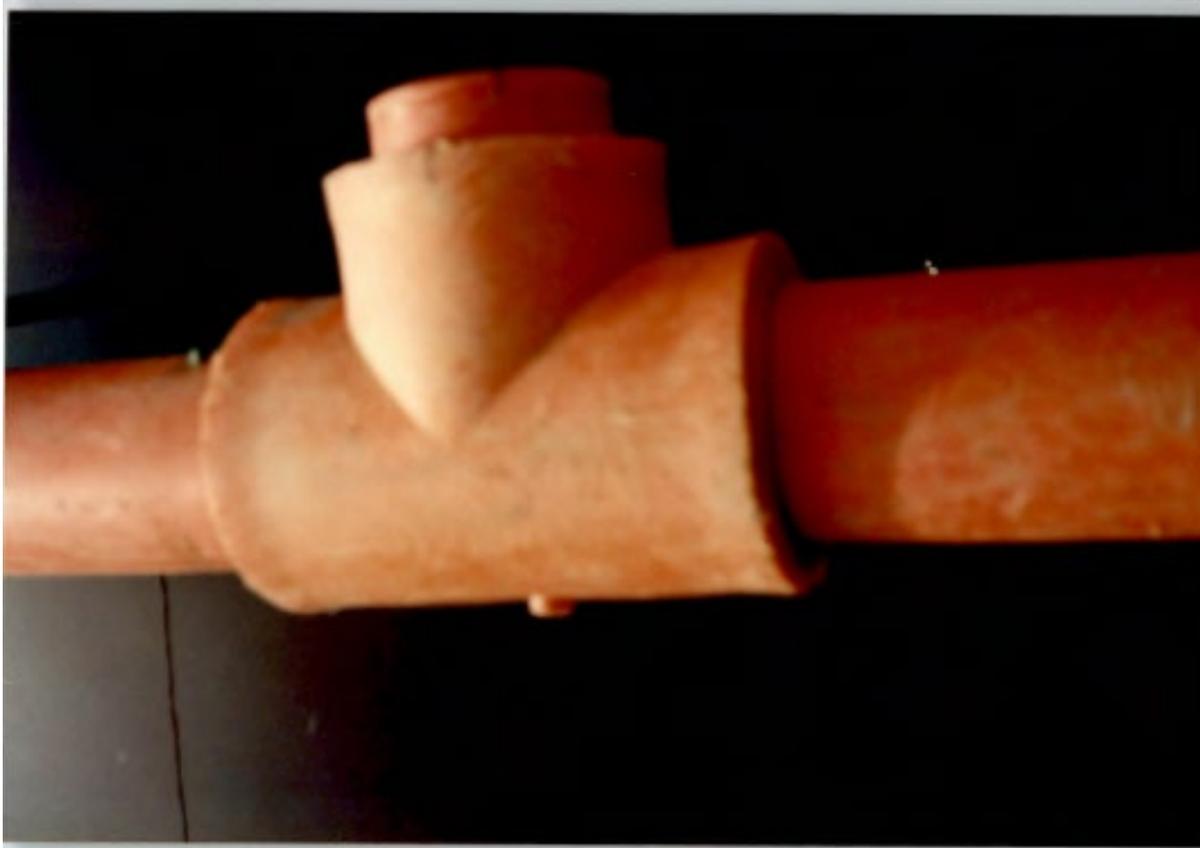
- Portion of the main going into the 3x3x3in tee was at an angle.
- This portion of main was cracked next to the tee.
- Portion of damaged main was below parking lot, heavier frost effects.
- There had been recent third-party excavation work for a new sewer lateral in November 1992.

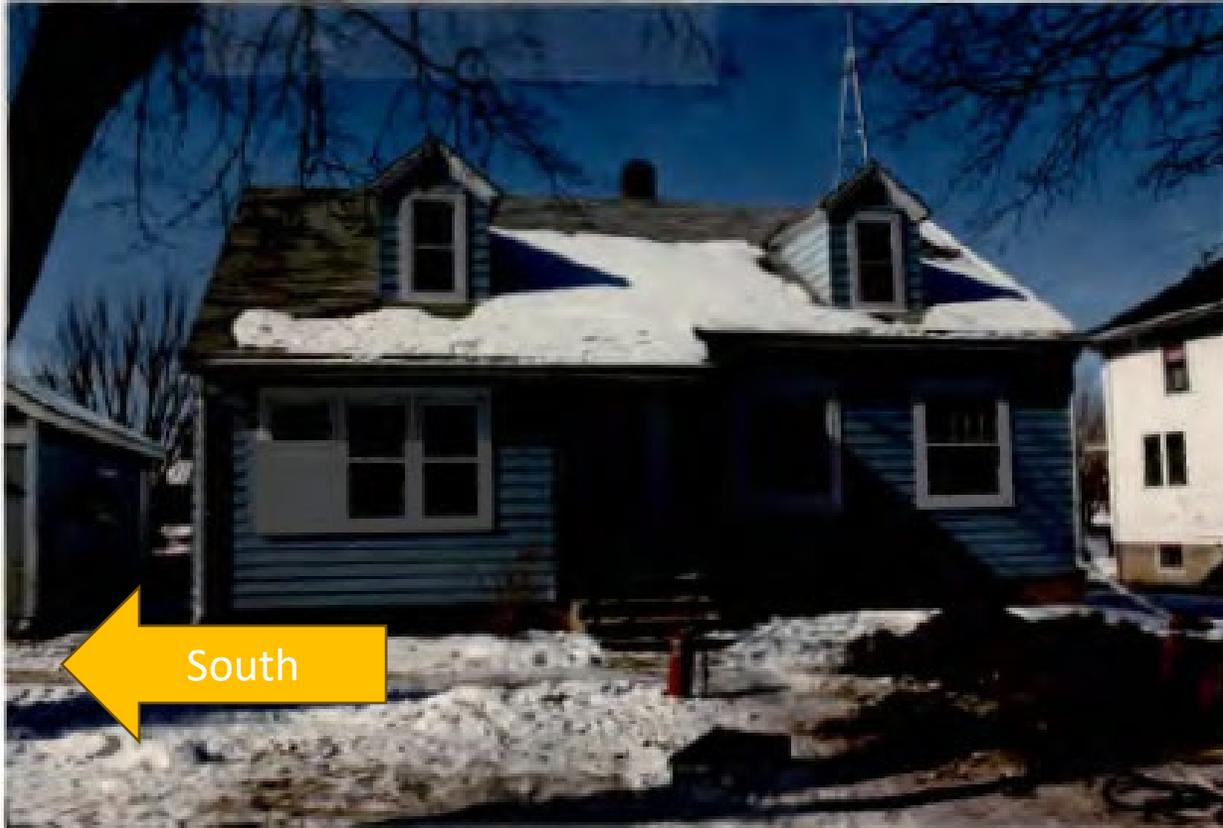
306 N. Finch St.

Hole where main was pinched off shown

- Bar-holes found many indications of gas in the ground.
- Fire department noticed that the destroyed home had a dirt basement.
- Welds that had been exposed were leak checked.
 - No indications found.
- Main depth – 28in
Frost depth – 33in

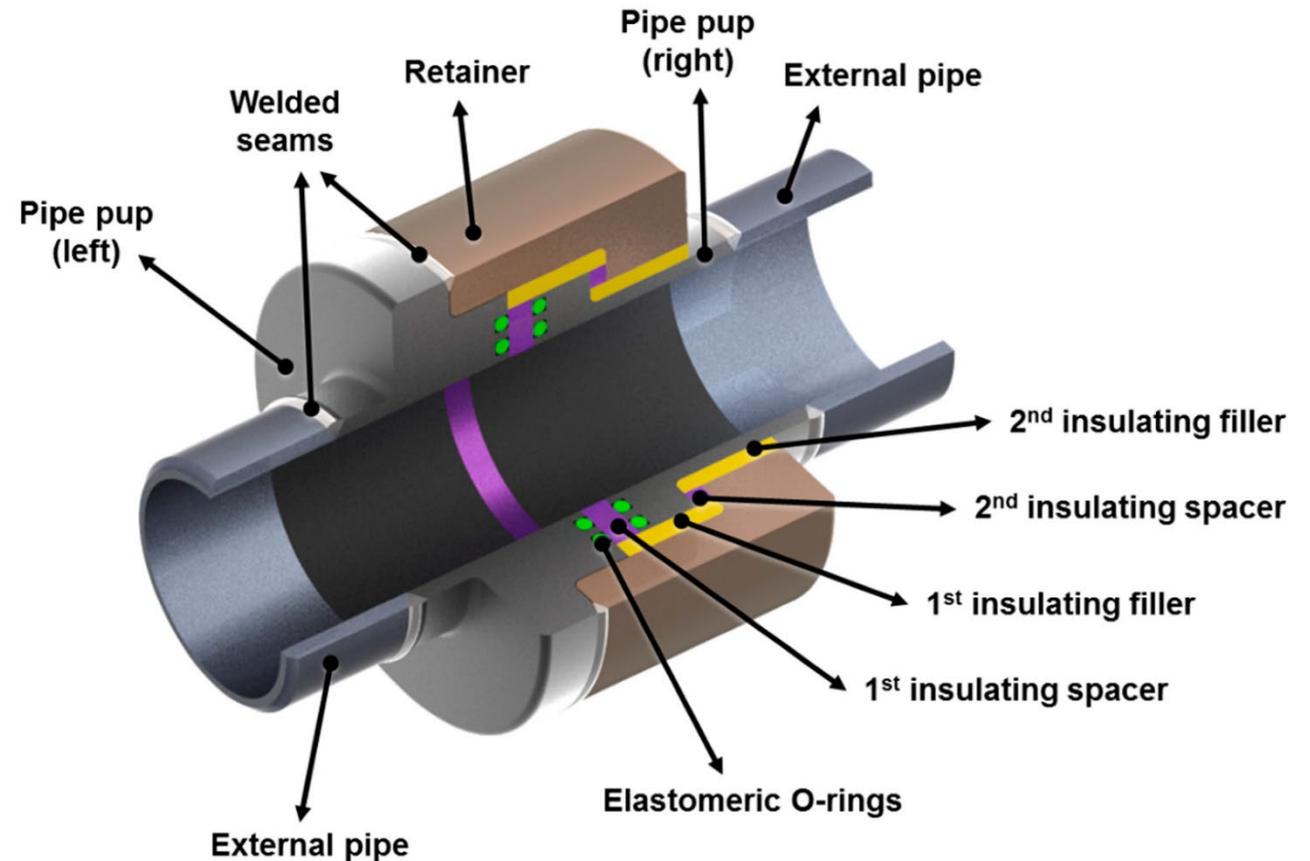
Example of coupling

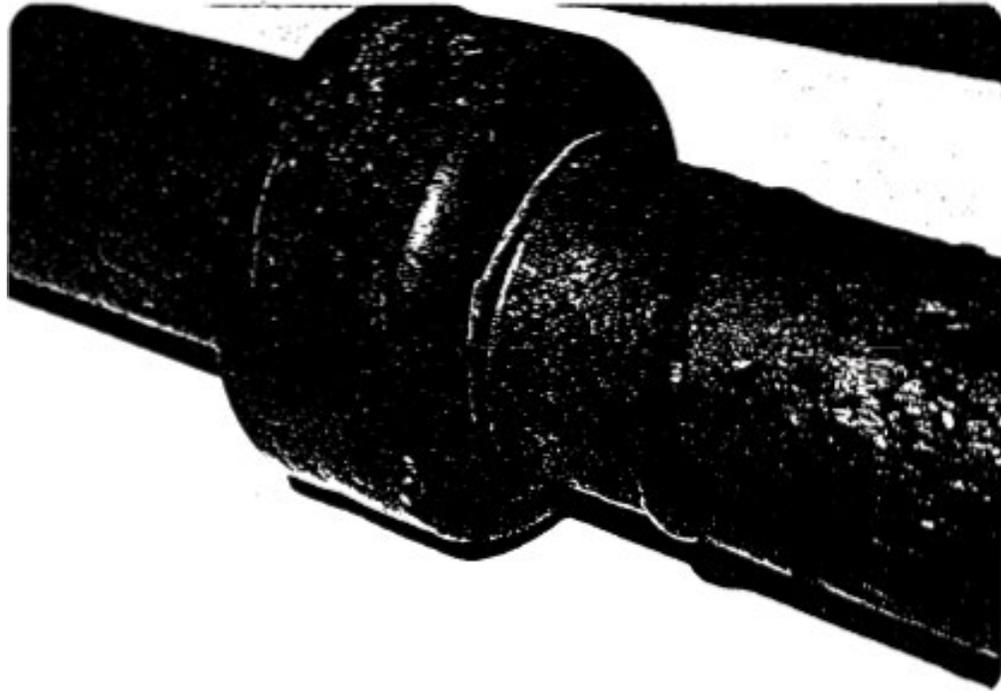
Fig. 3. Fracture at the radius of the forged flange.

- Corrosion found in the area of the fractured coupling surface.
- Cleavage Fracture mode – brittle failure.
- Coupling was forged.
- Chemistry of the low carbon steel coupling determined elevated levels of Phosphorus.

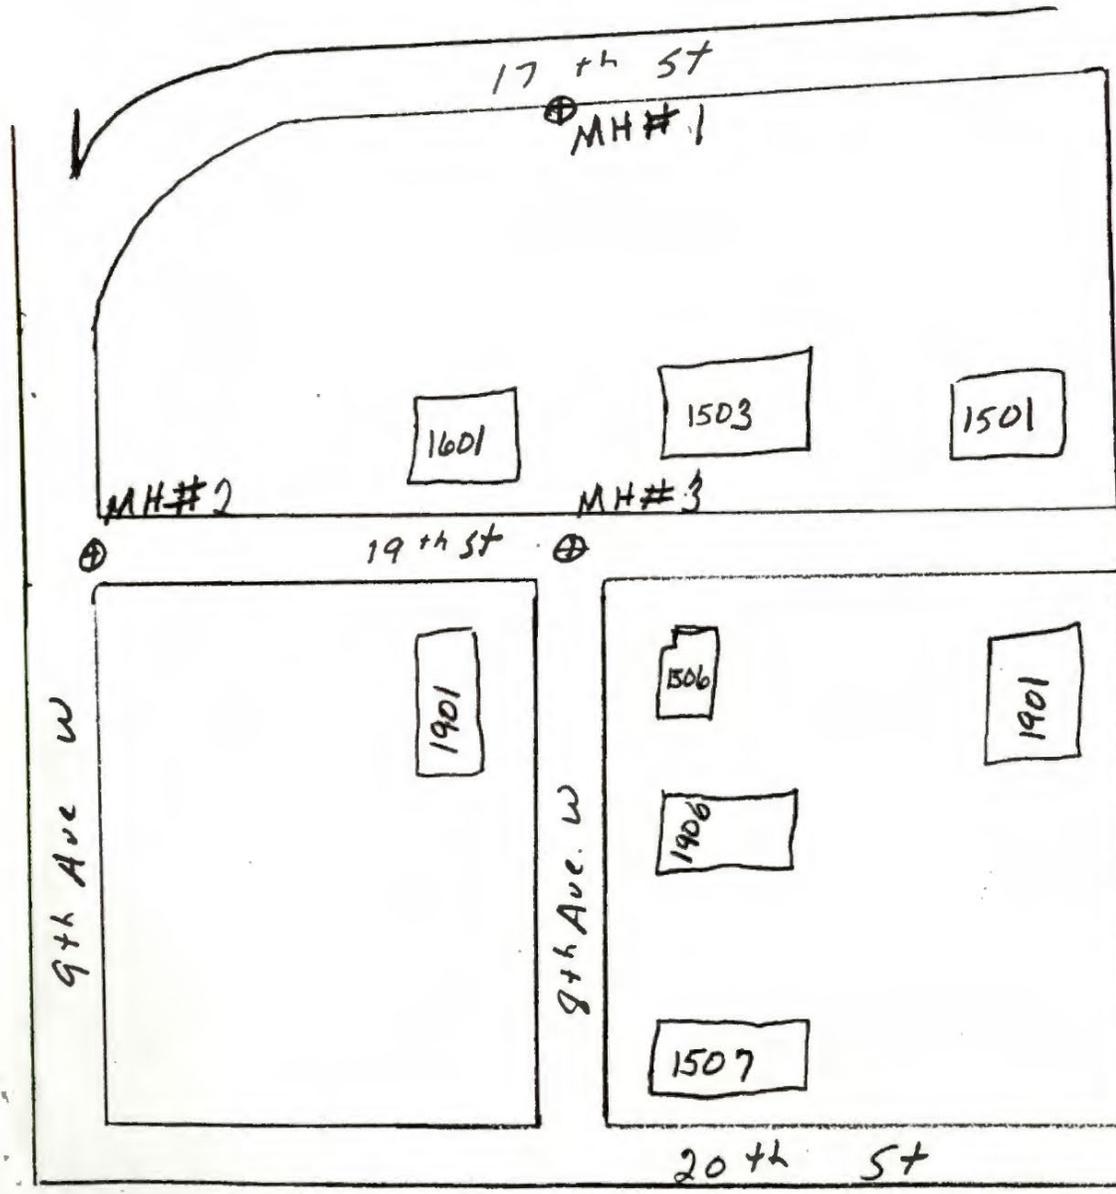
This shows the location of manholes probed with JW5159: 100% scale.

MH#3 - 60%. I then removed the cover and within 3 minutes concentration had dissipated to 0% we contacted the city and got 2 barricades and opened to allow ventilation.

* after testing the manholes and venting hole #3 I climbed down hole #3 and tested the four tiles going out of hole and found 0% in South-East and West and found 2% in tile going North.

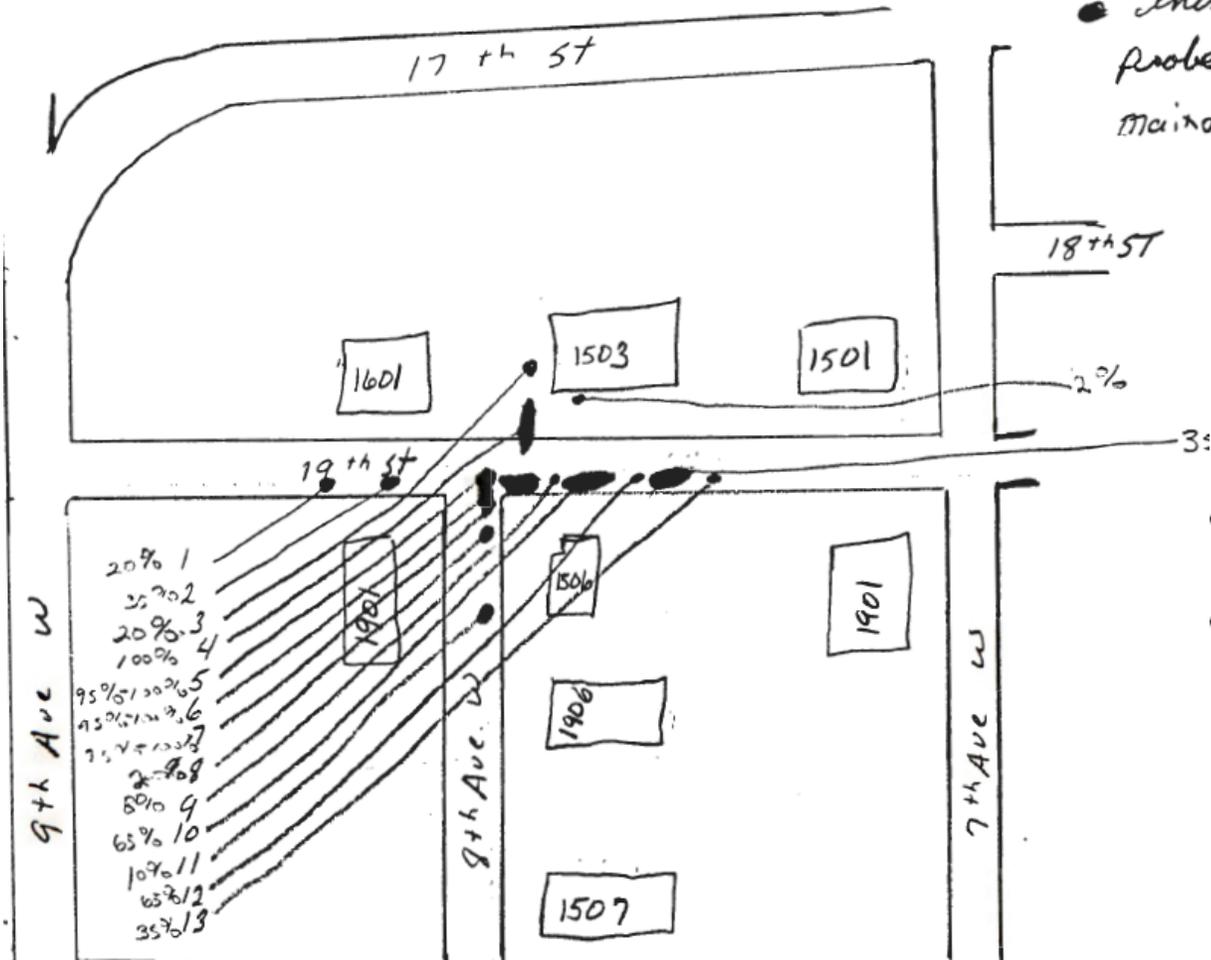
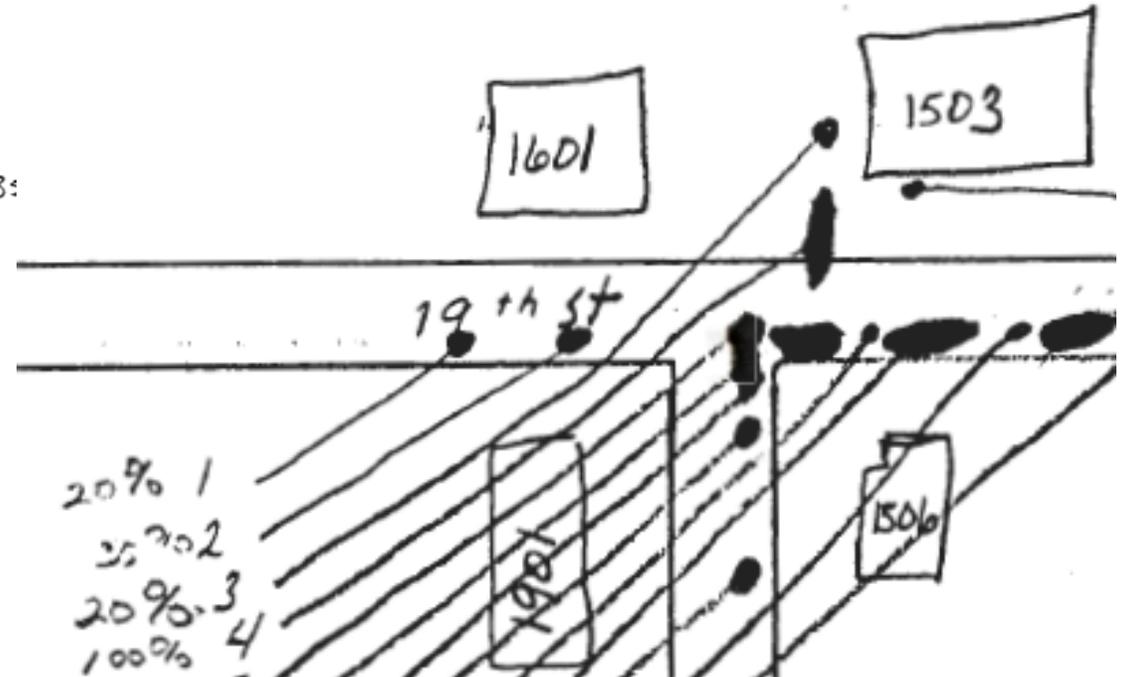
• This shows where the probed holes along the main and service were made.
 JW 525 166

- Barholing over the pipeline found a range of values of gas in air, up to 100%

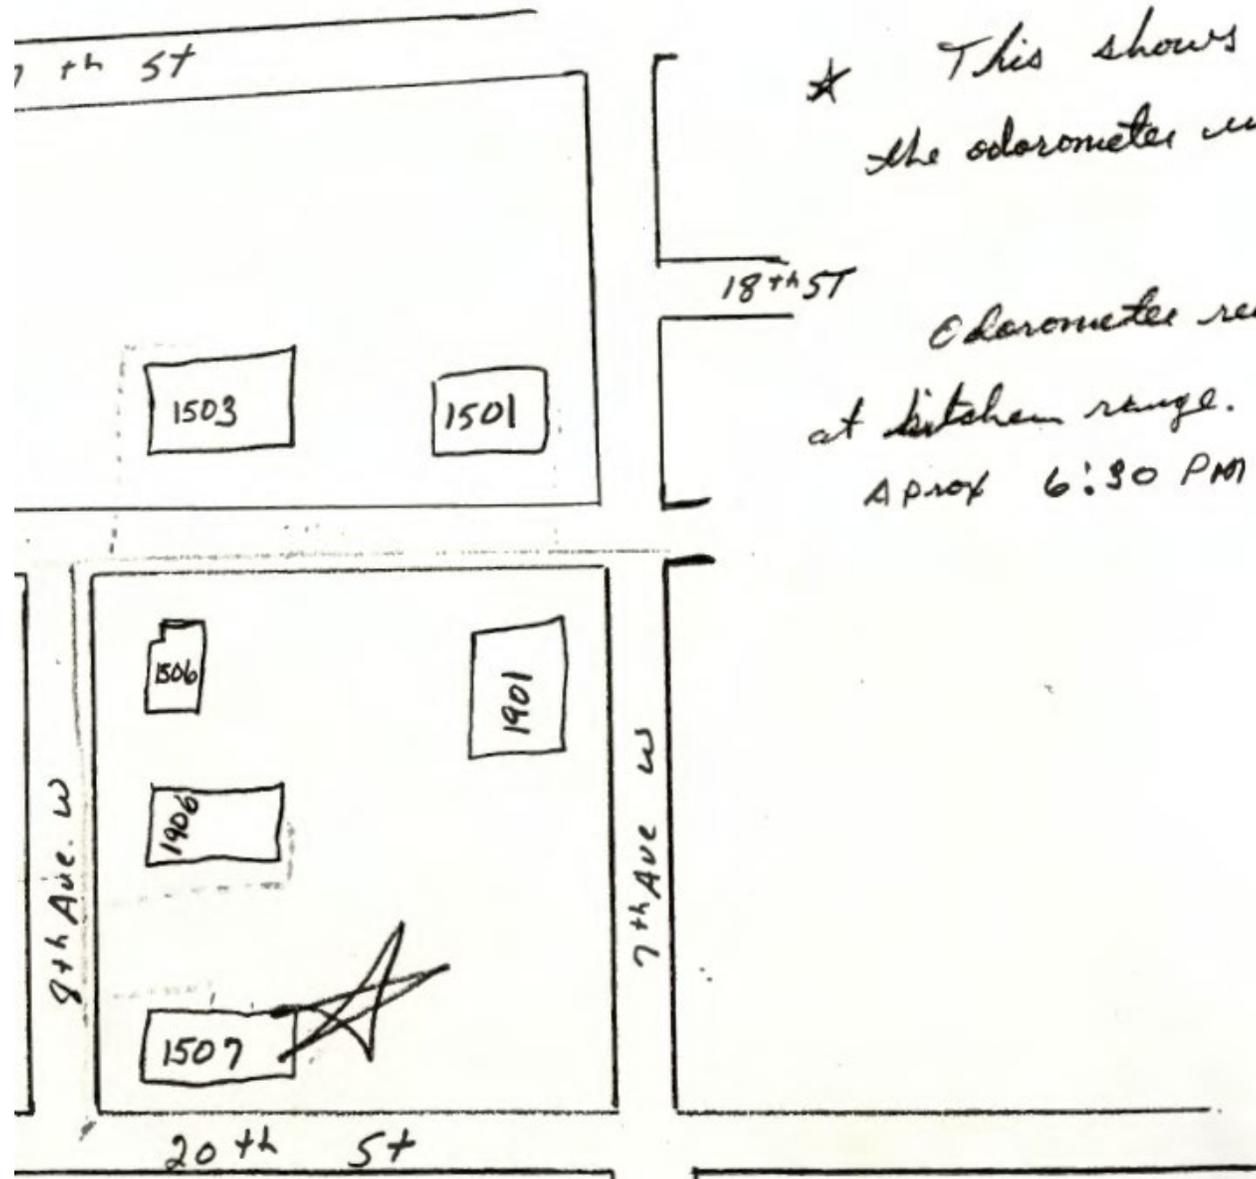
- Odorometer test had had found odorant to be acceptable.

* This shows where the odorometer was taken at kitchen range. Approx 6:30 PM.

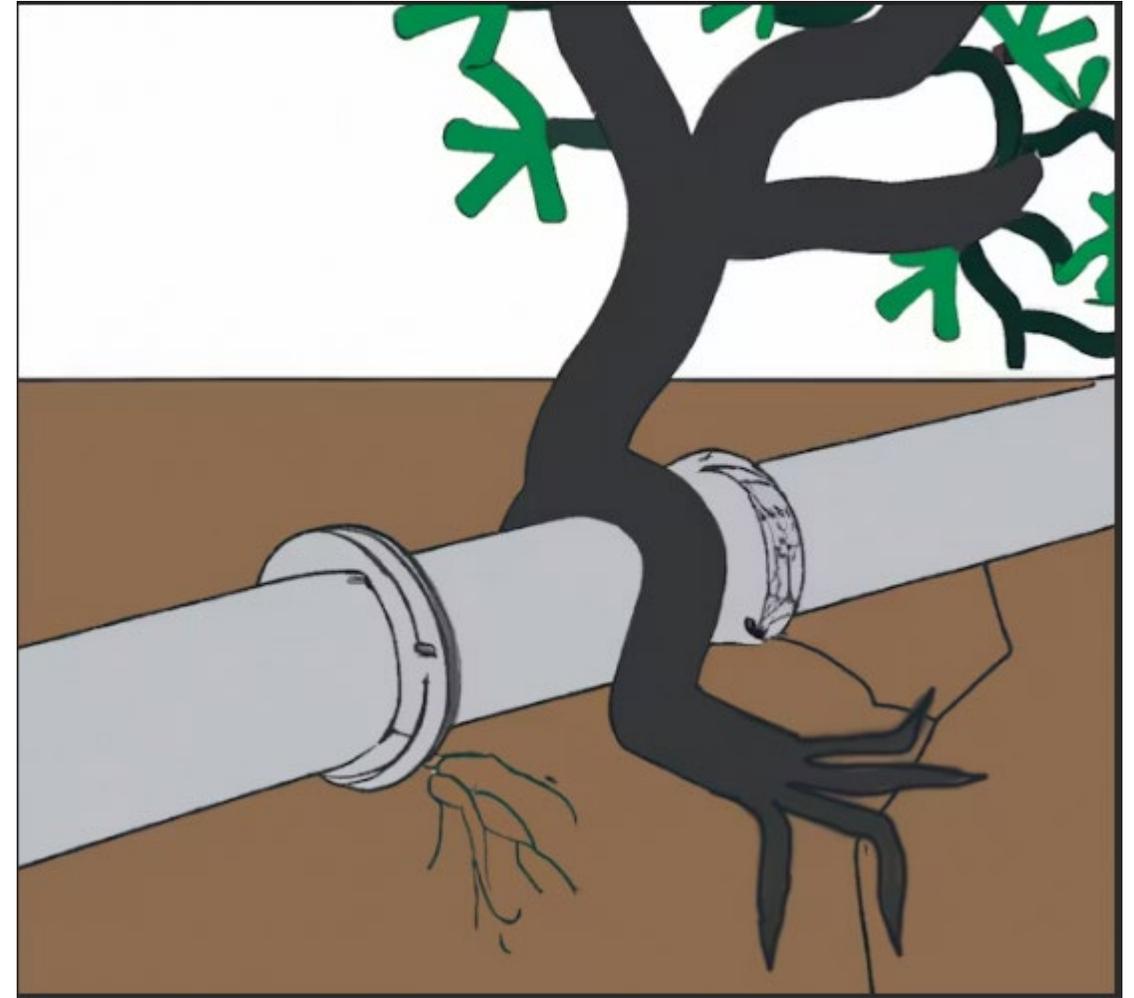
- The service line to house across the street was replaced. In the area of the leak, a tree root had followed along the service under the street. The service line was partly embedded in the tree root. Service depth was 25" below grade.
- The leak was 85 feet from the destroyed house. The ground had 6"-12" of frost, making the crawlspace the path of least resistance.
- The operator believed the service leaked at a rate of 150 SCF/Hr.

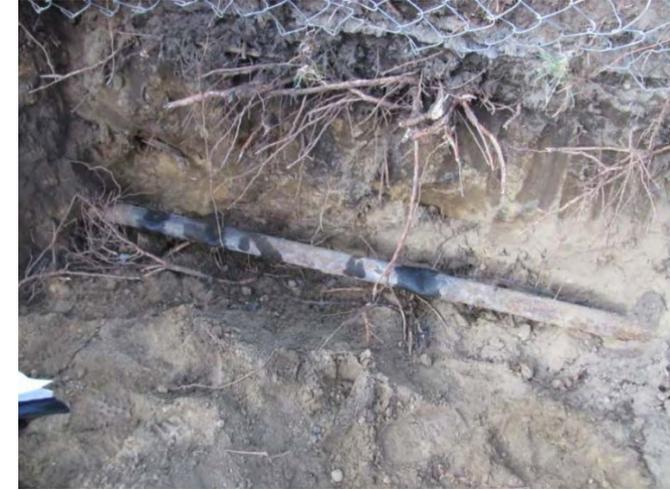
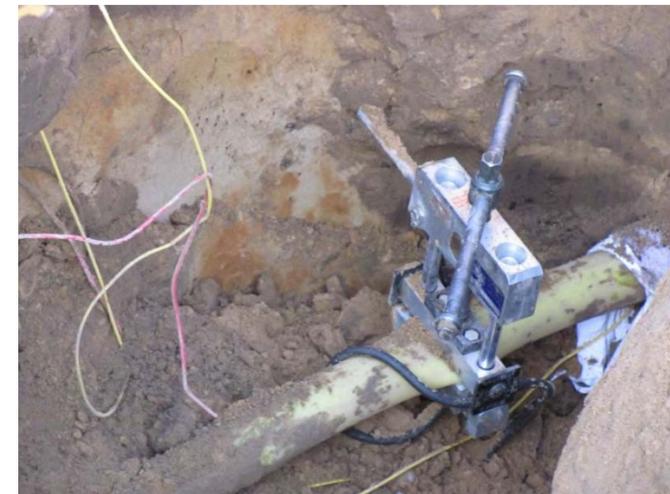
- 1:50 pm attempt to squeeze steel main upstream
 - Each attempt resulted in seam failures
- 2:58 pm squeezed plastic main further upstream
- 3:05 pm found no gas freely flowing at leak location
- 4:30 pm excavated leak location and found failed threaded coupling
- Continued leak surveys to the next day
- Bar-hole tested leak location daily for 8 days
 - Repeated detection of gas
 - Soil was excavated, replaced, and no more gas was detected

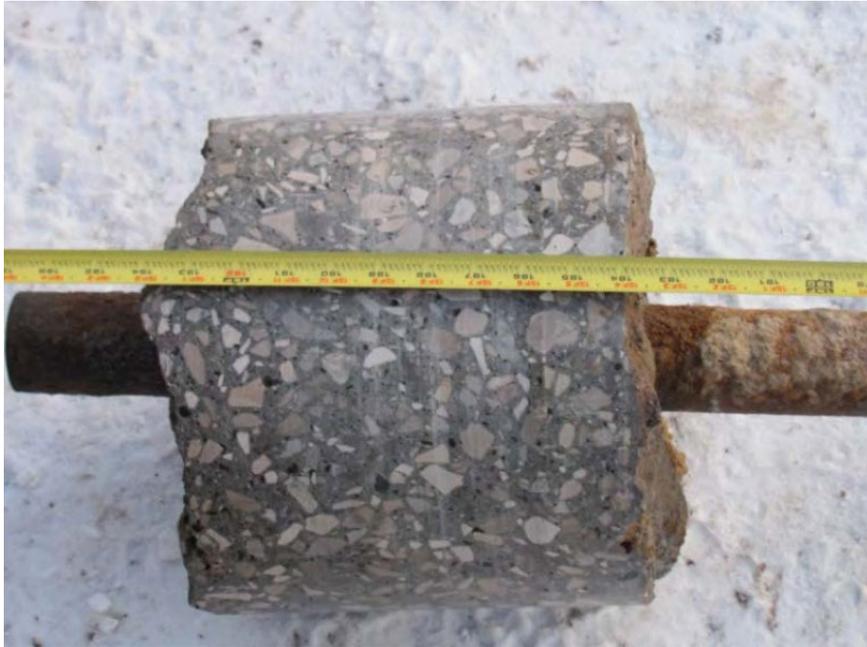
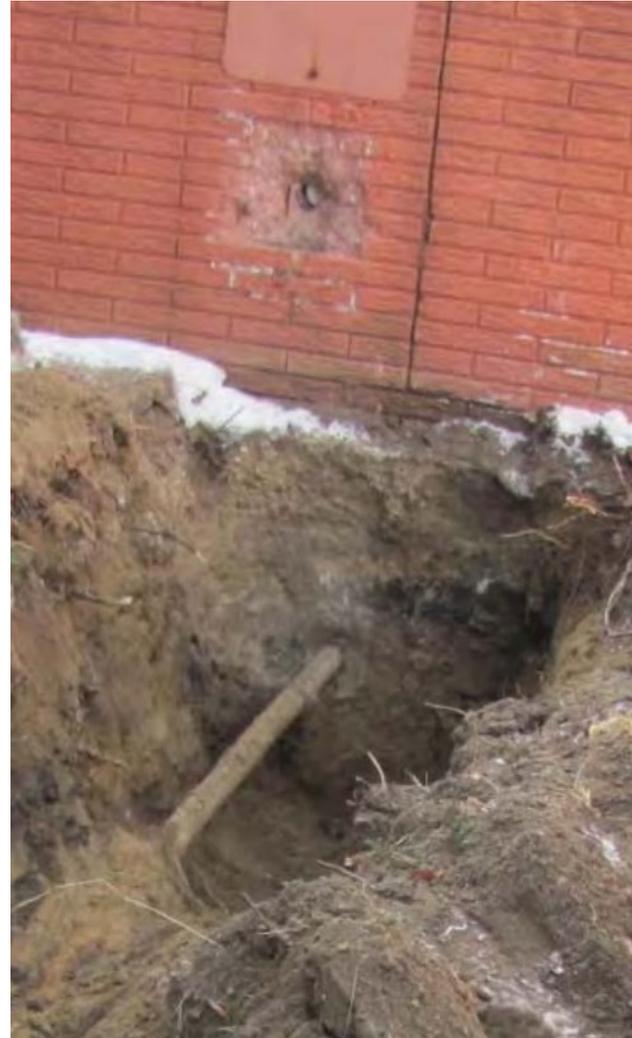
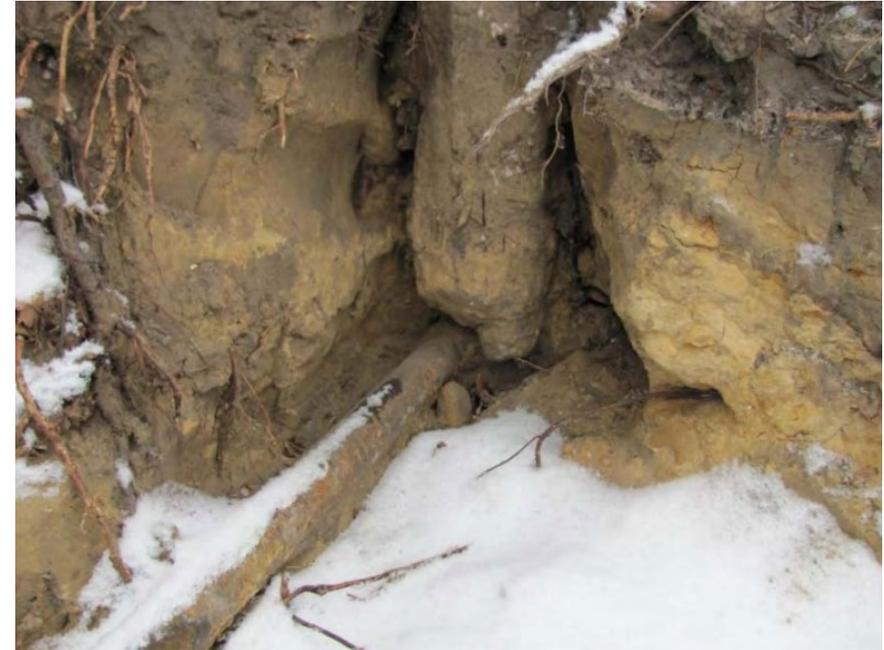
- Concluded that damage to the meter manifold was due to explosion
 - Regulator and meter show no sign of fire exposure
- Multiple concrete footings for fenceposts rested on the gas main
- Used cameras and smoke to inspect sections of sewer system
 - Smoke permeated through foundation walls
 - Potential vacuum pulling gas toward building
- All lines connected to the failure point passed pressure tests
 - Rule out cause from any other leaks
- Main was excavated both sides of the concrete wall
 - East Side: Deflection of 4-³/₄ inches upward and 6-¹/₂ inches south
 - East Side: Prominent bend observed
 - West Side: Minimal bend slope downward 1 inch to failure point

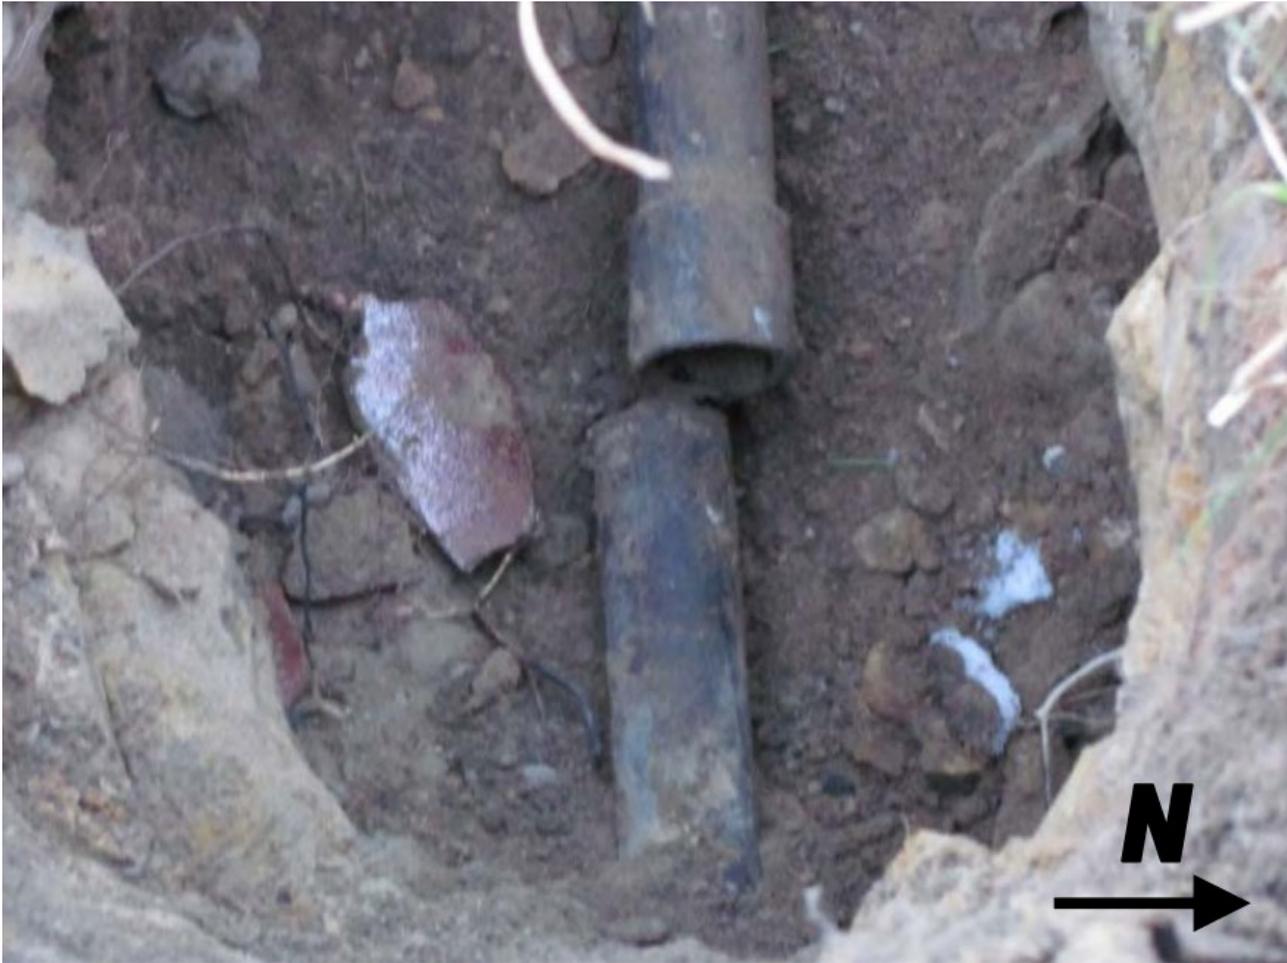
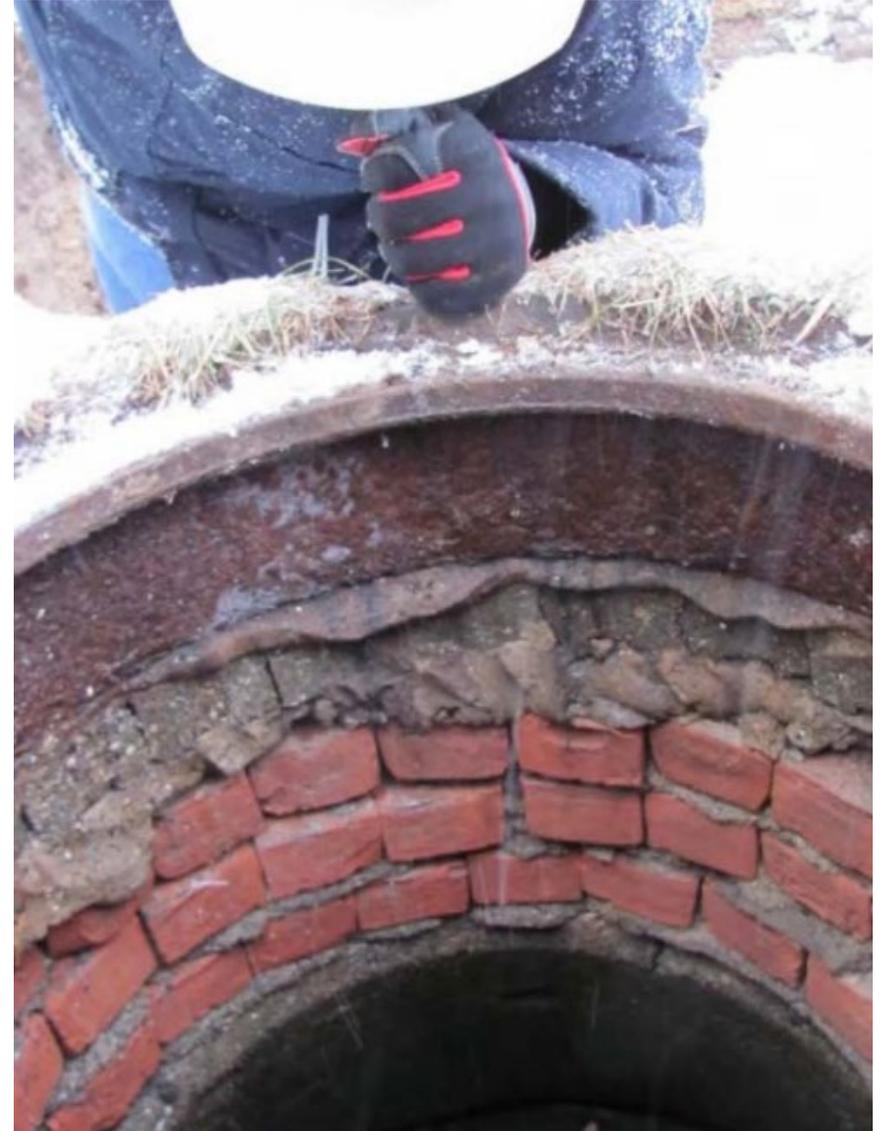
- Conducted:
 - Visual examination
 - Photographing of samples
 - Tensile testing
 - Hardness testing
 - Metallurgical examination
 - Radiographic examination
 - Scanning electronic microscopic examination
 - Physical measurements
 - Collection of soil samples from the pipe
- Engineering and stress load analysis
 - Estimated 1,200 lbs necessary to yield the pipe at the threaded coupling by 2 inches
 - Misalignment of the pipe would estimate an actual load significantly higher
 - Separation occurred due to rapid crack propagation (no cyclic fatigue detected)
- Metallurgical examination determined separation was due to material overload condition
 - Crack initiated in threaded portion of coupling are spread around entire circumference

- Overstress of the threaded and coupled joint on 2-inch bare steel main
 - Main was directly encased into concrete wall footing (no sleeve)
 - Chain-link fence with concrete footings installed directly above the gas main
 - Joint separated and misaligned by 2.5 inches
- Installation of sanitary sewer system directly next to the gas main
 - Migration of gas through sewer system into the furniture store
 - Contributed to external forces on the gas main
- Failure of Operator to identify and document the encroachment on the main
 - Form of 3rd party damage
- Reported Sinkhole in the vicinity of the main failure
 - Settlement of soil may have contributed to external forces on main
- Inadequate leak response by the Operator
