Wayne, MI Pipeline Failure

December 29th, 2010

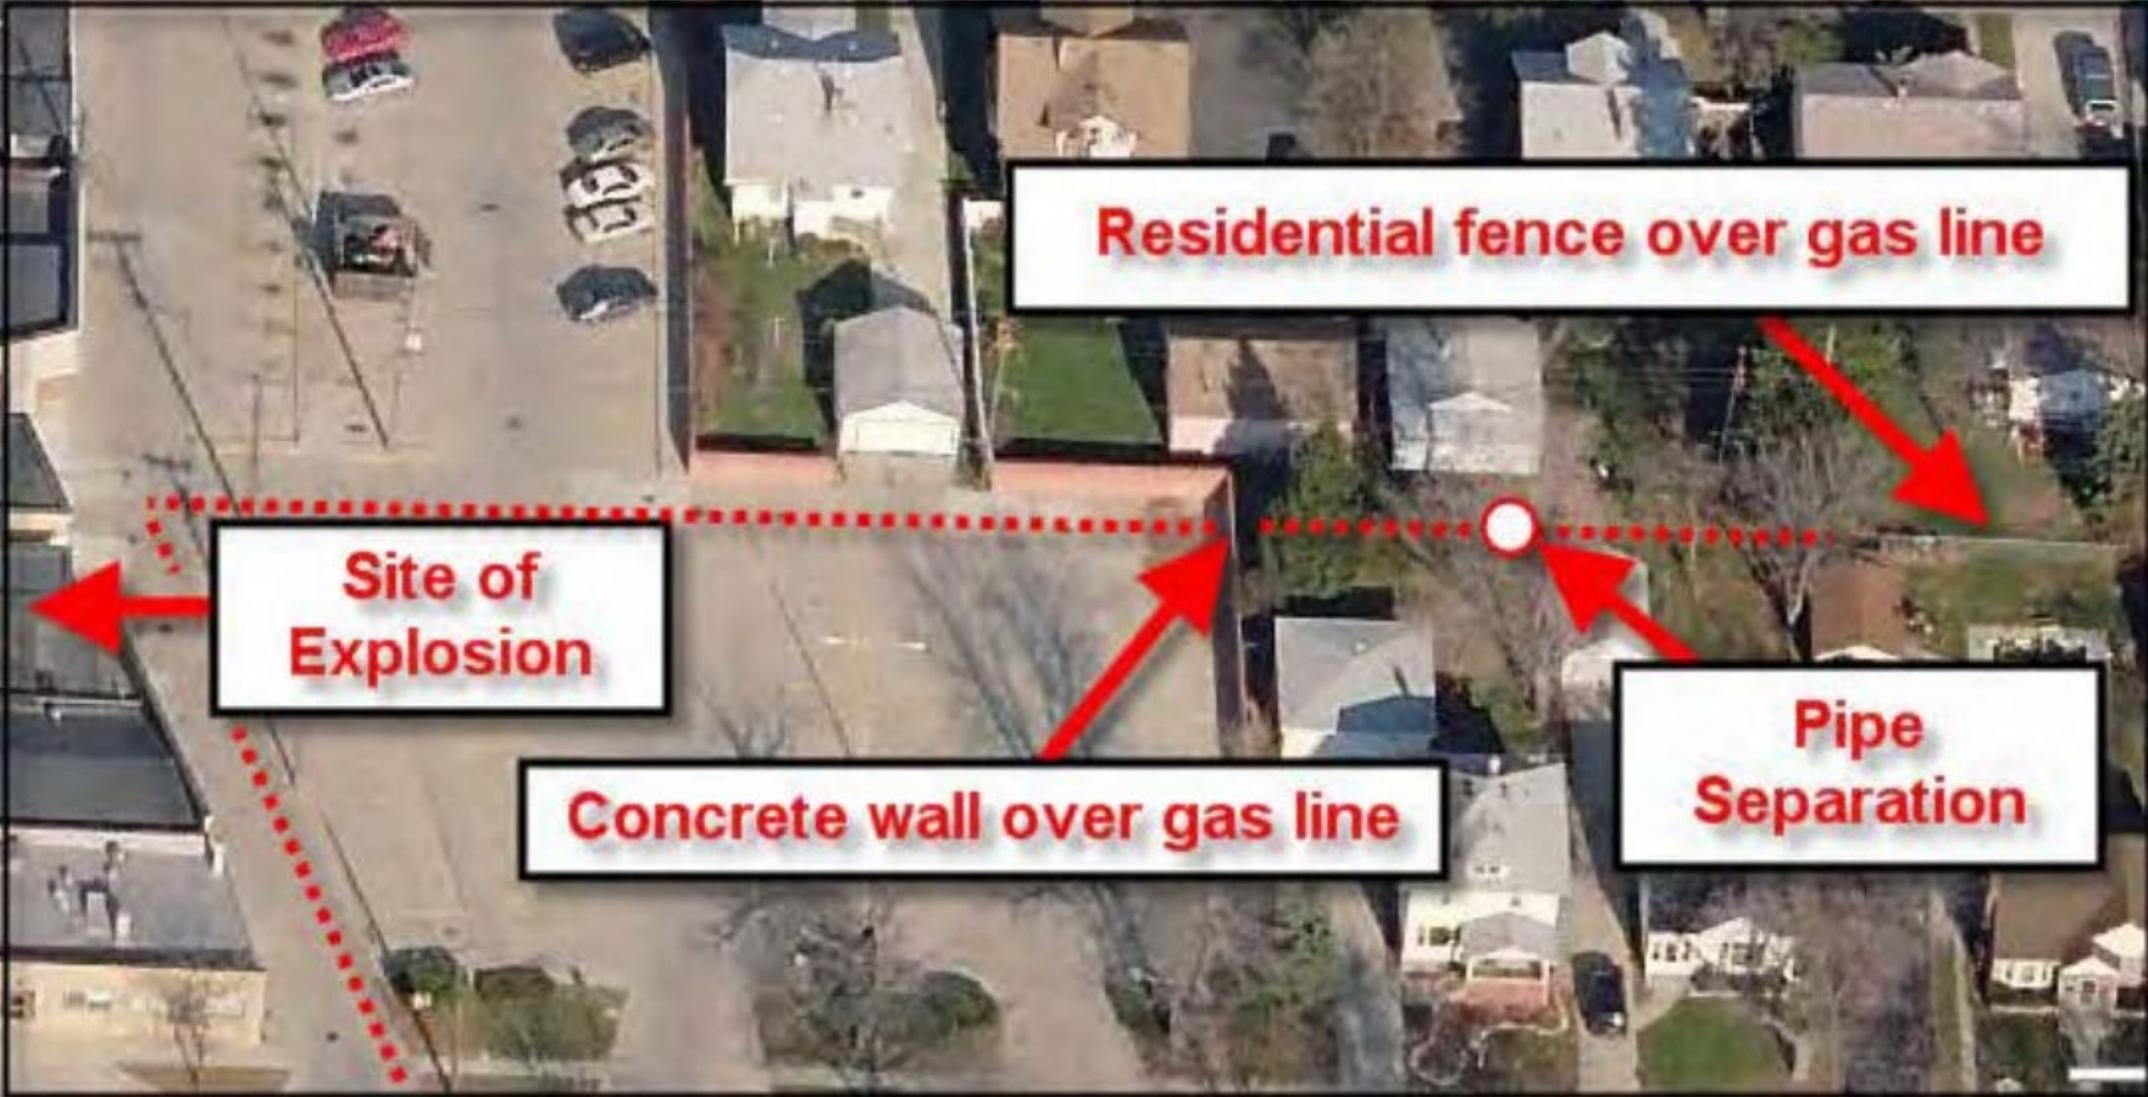
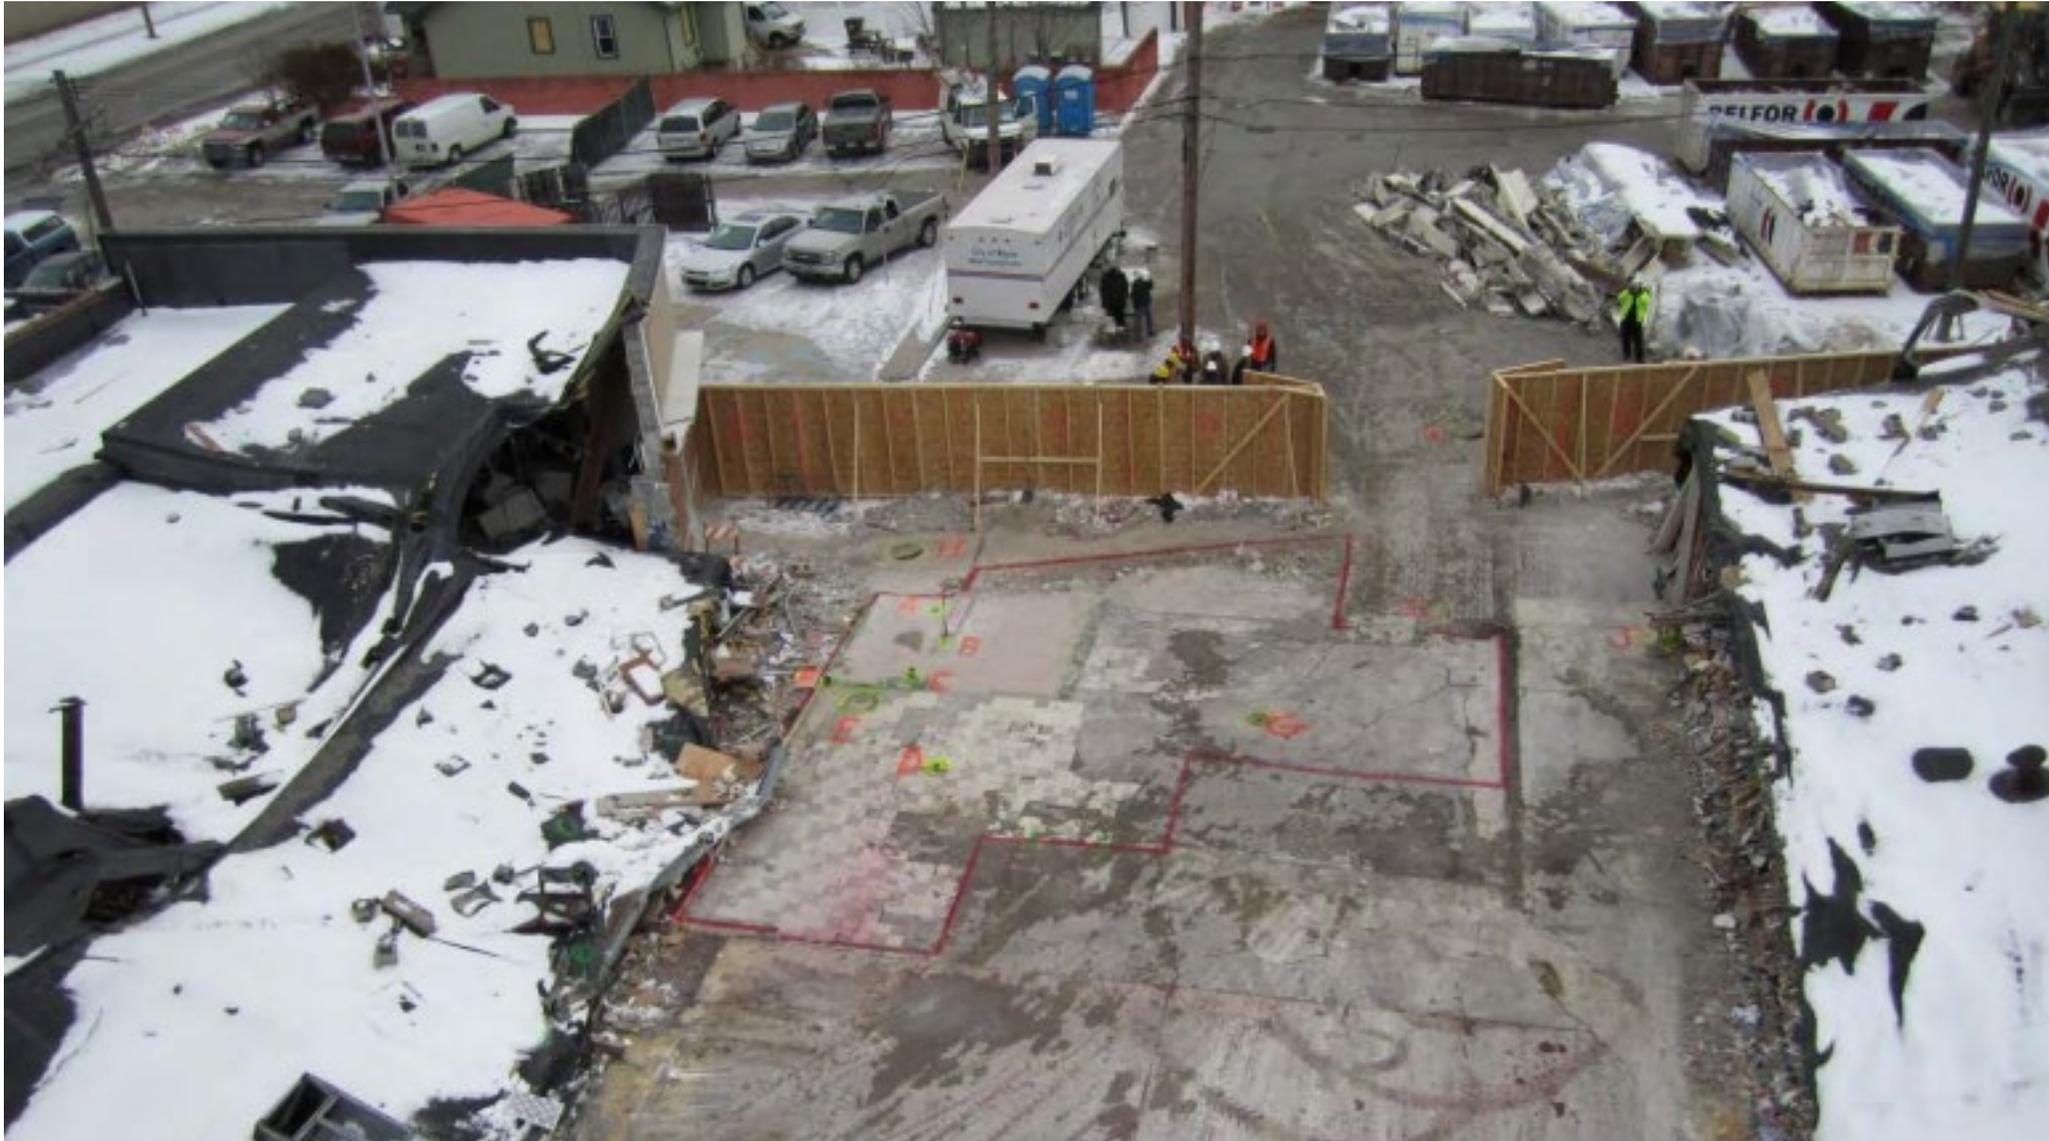
Incident Area

- Gas main located in abandoned alley/right-of-way
 - 2” bare steel
 - Cathodically Unprotected
 - Installed in 1940
- Residential Fence built above gas main in ROW
- Concrete wall built directly around gas main
- Sanitary sewer directly next to gas main
 - Travel parallel for 233 ft to back of furniture store
 - Manhole 18 in from failure

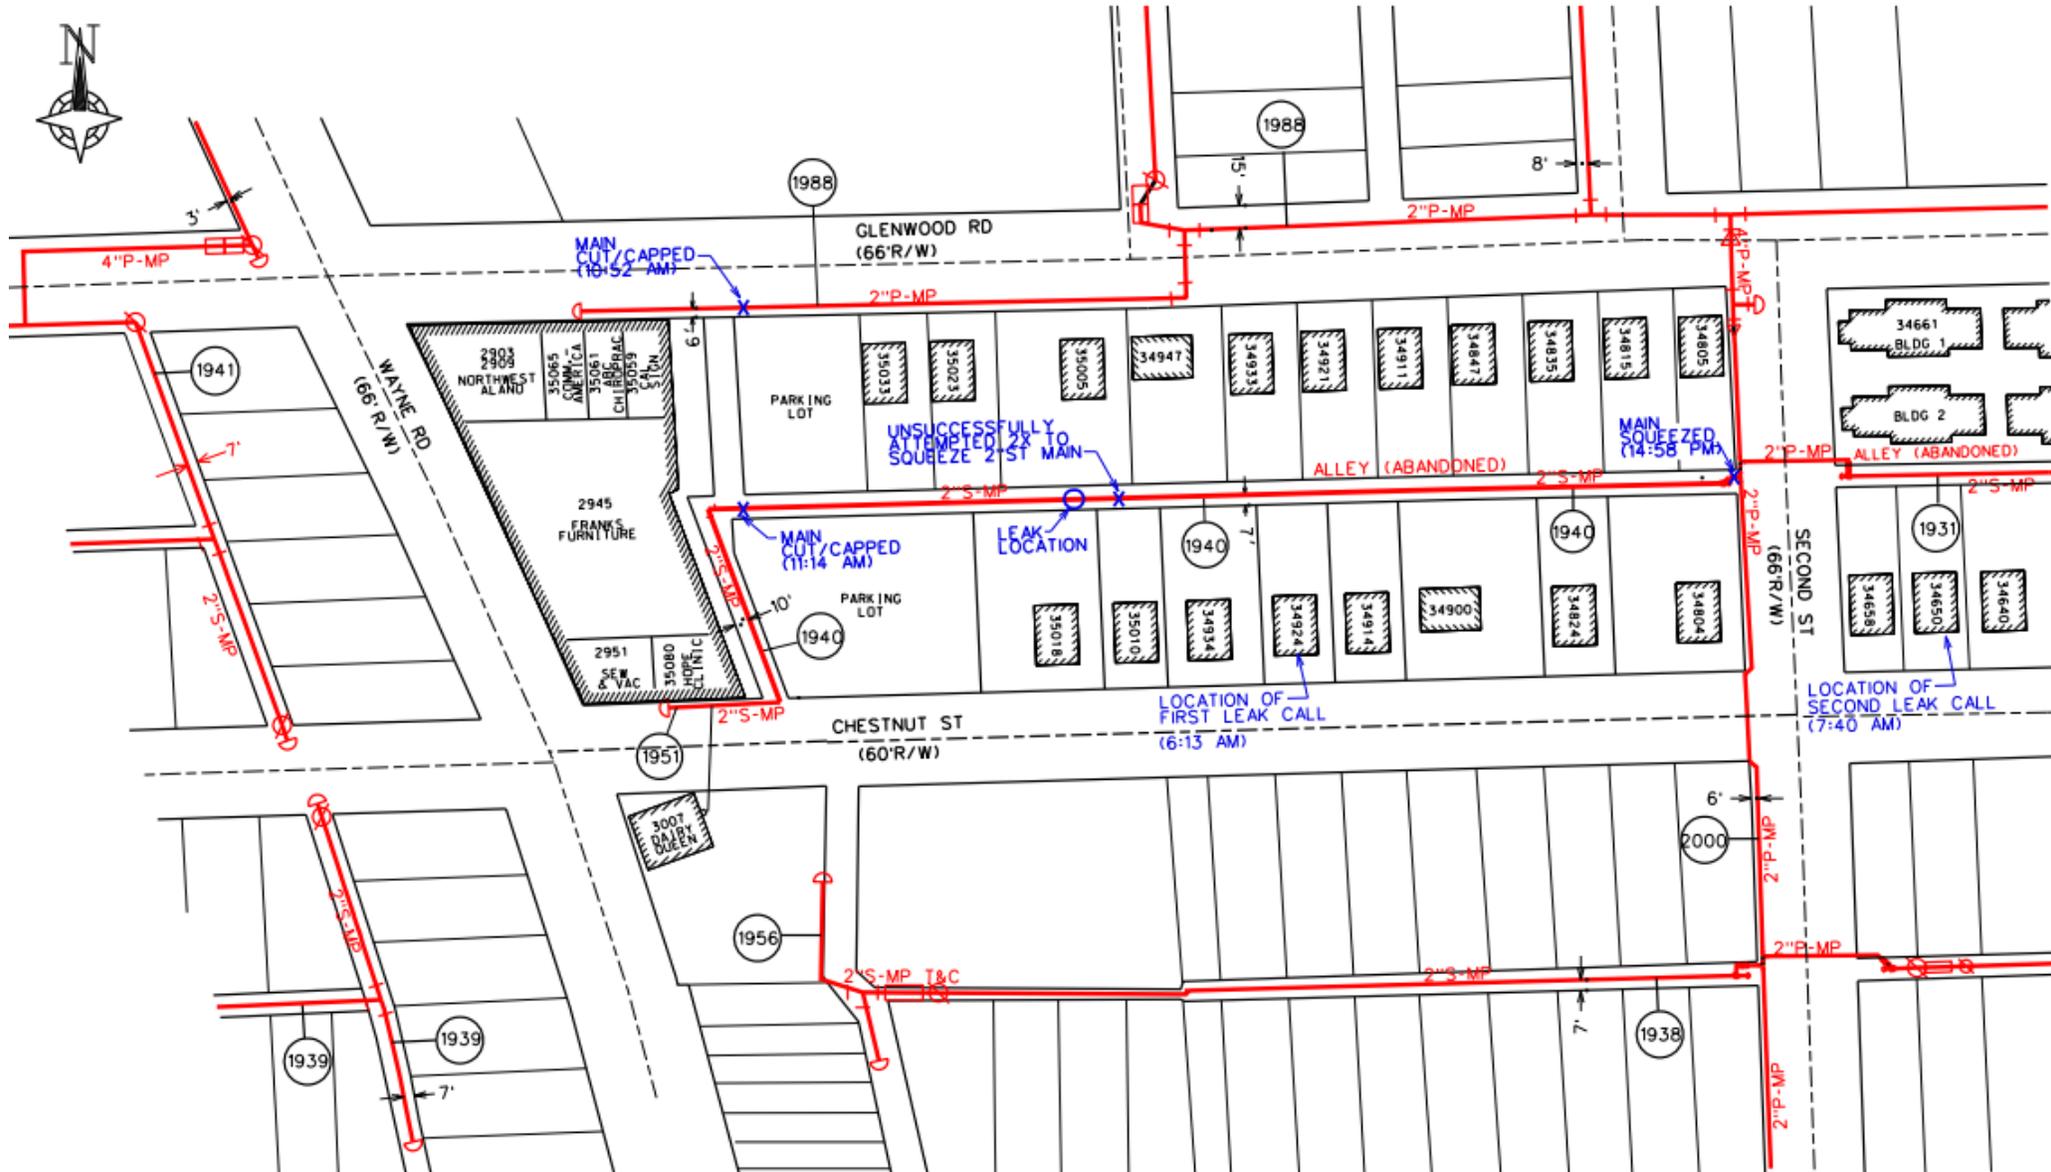
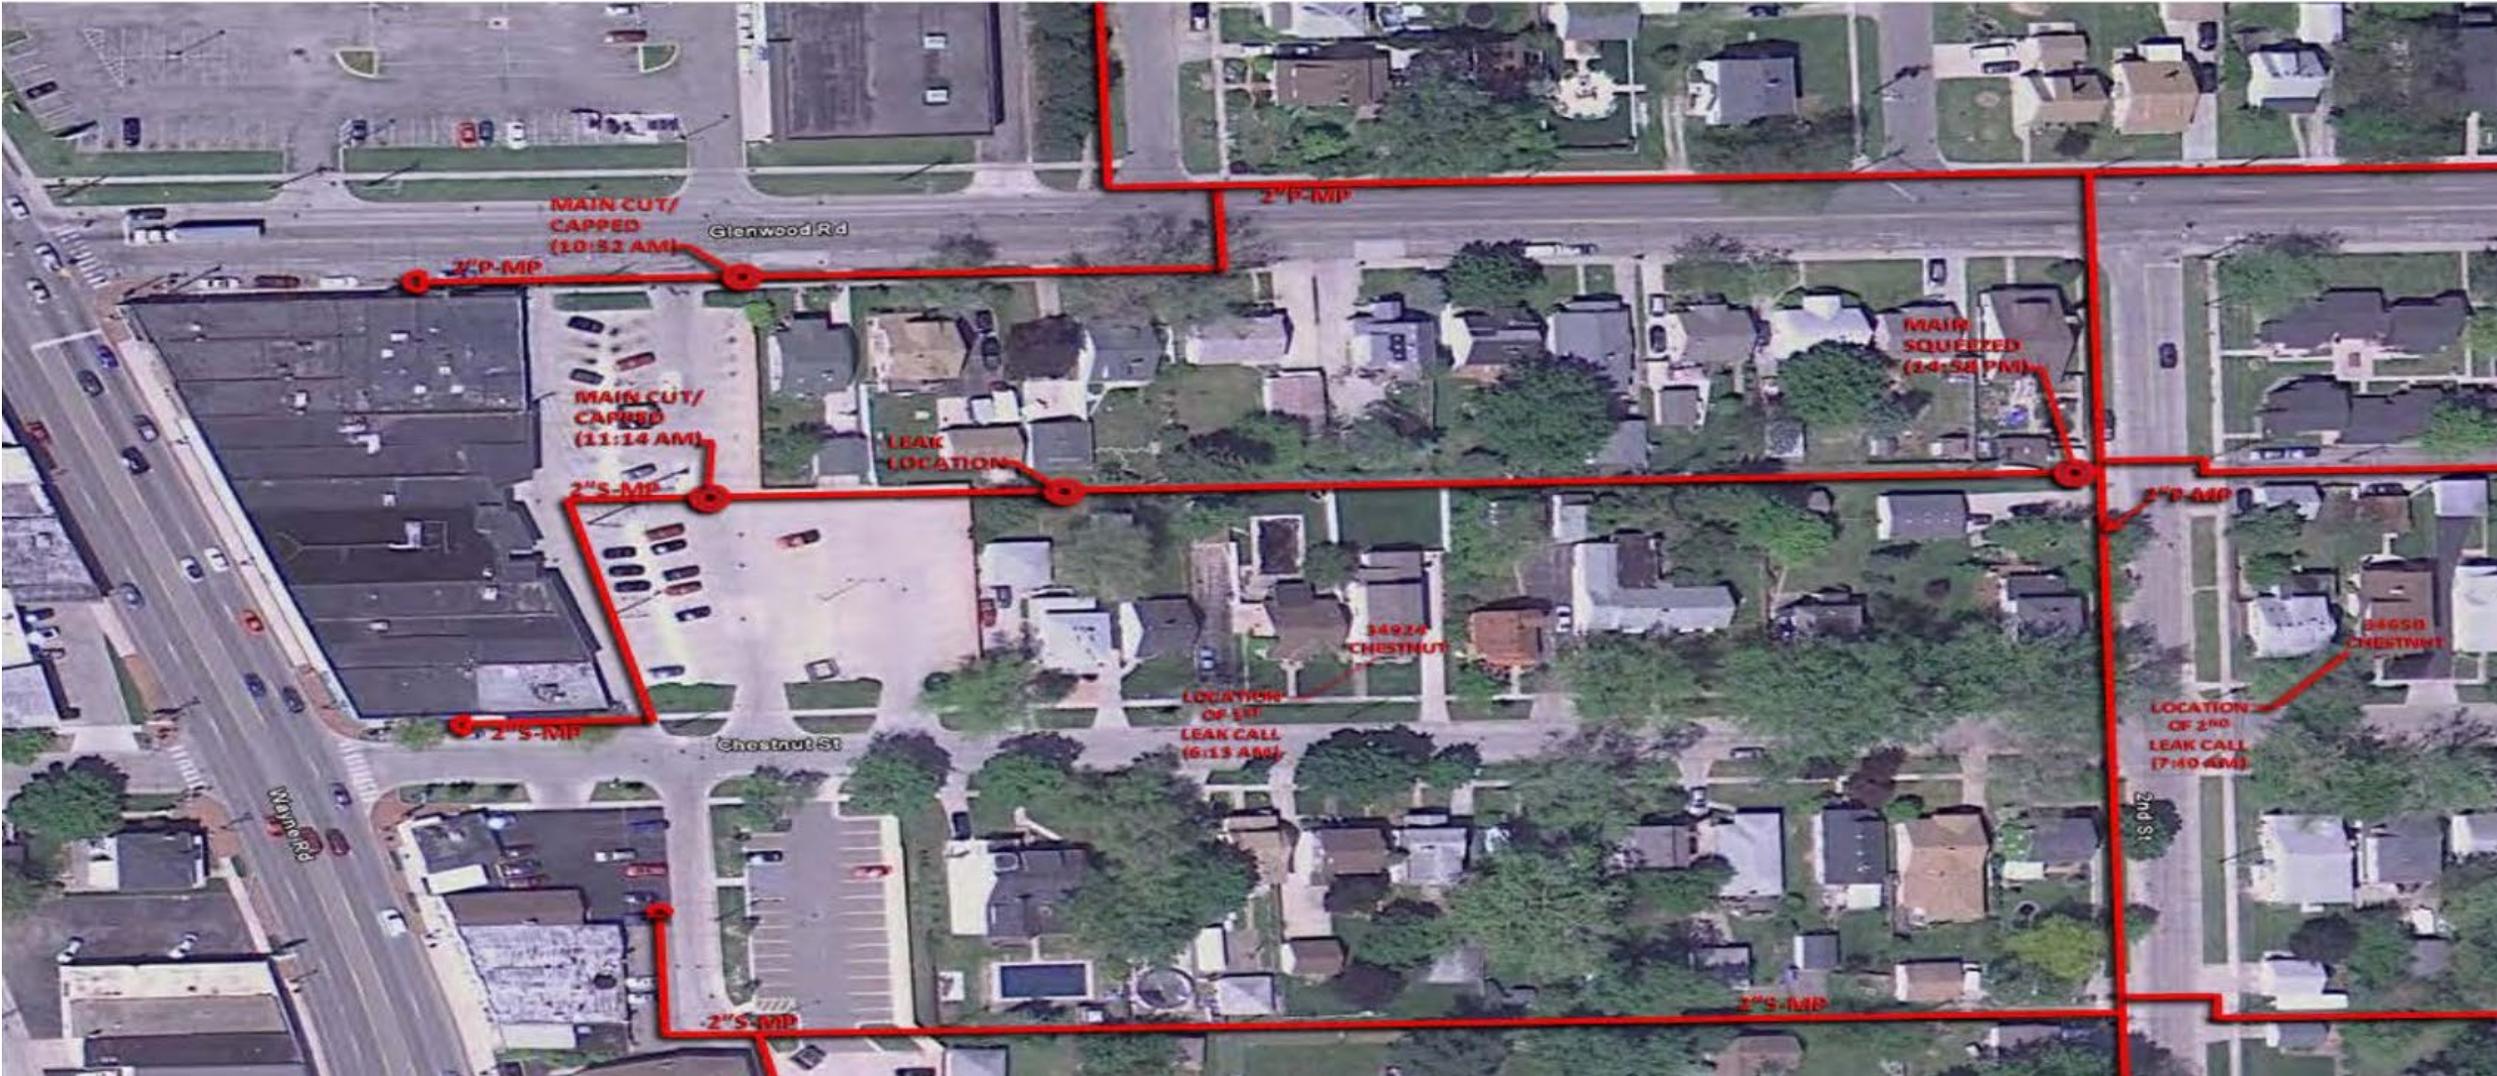
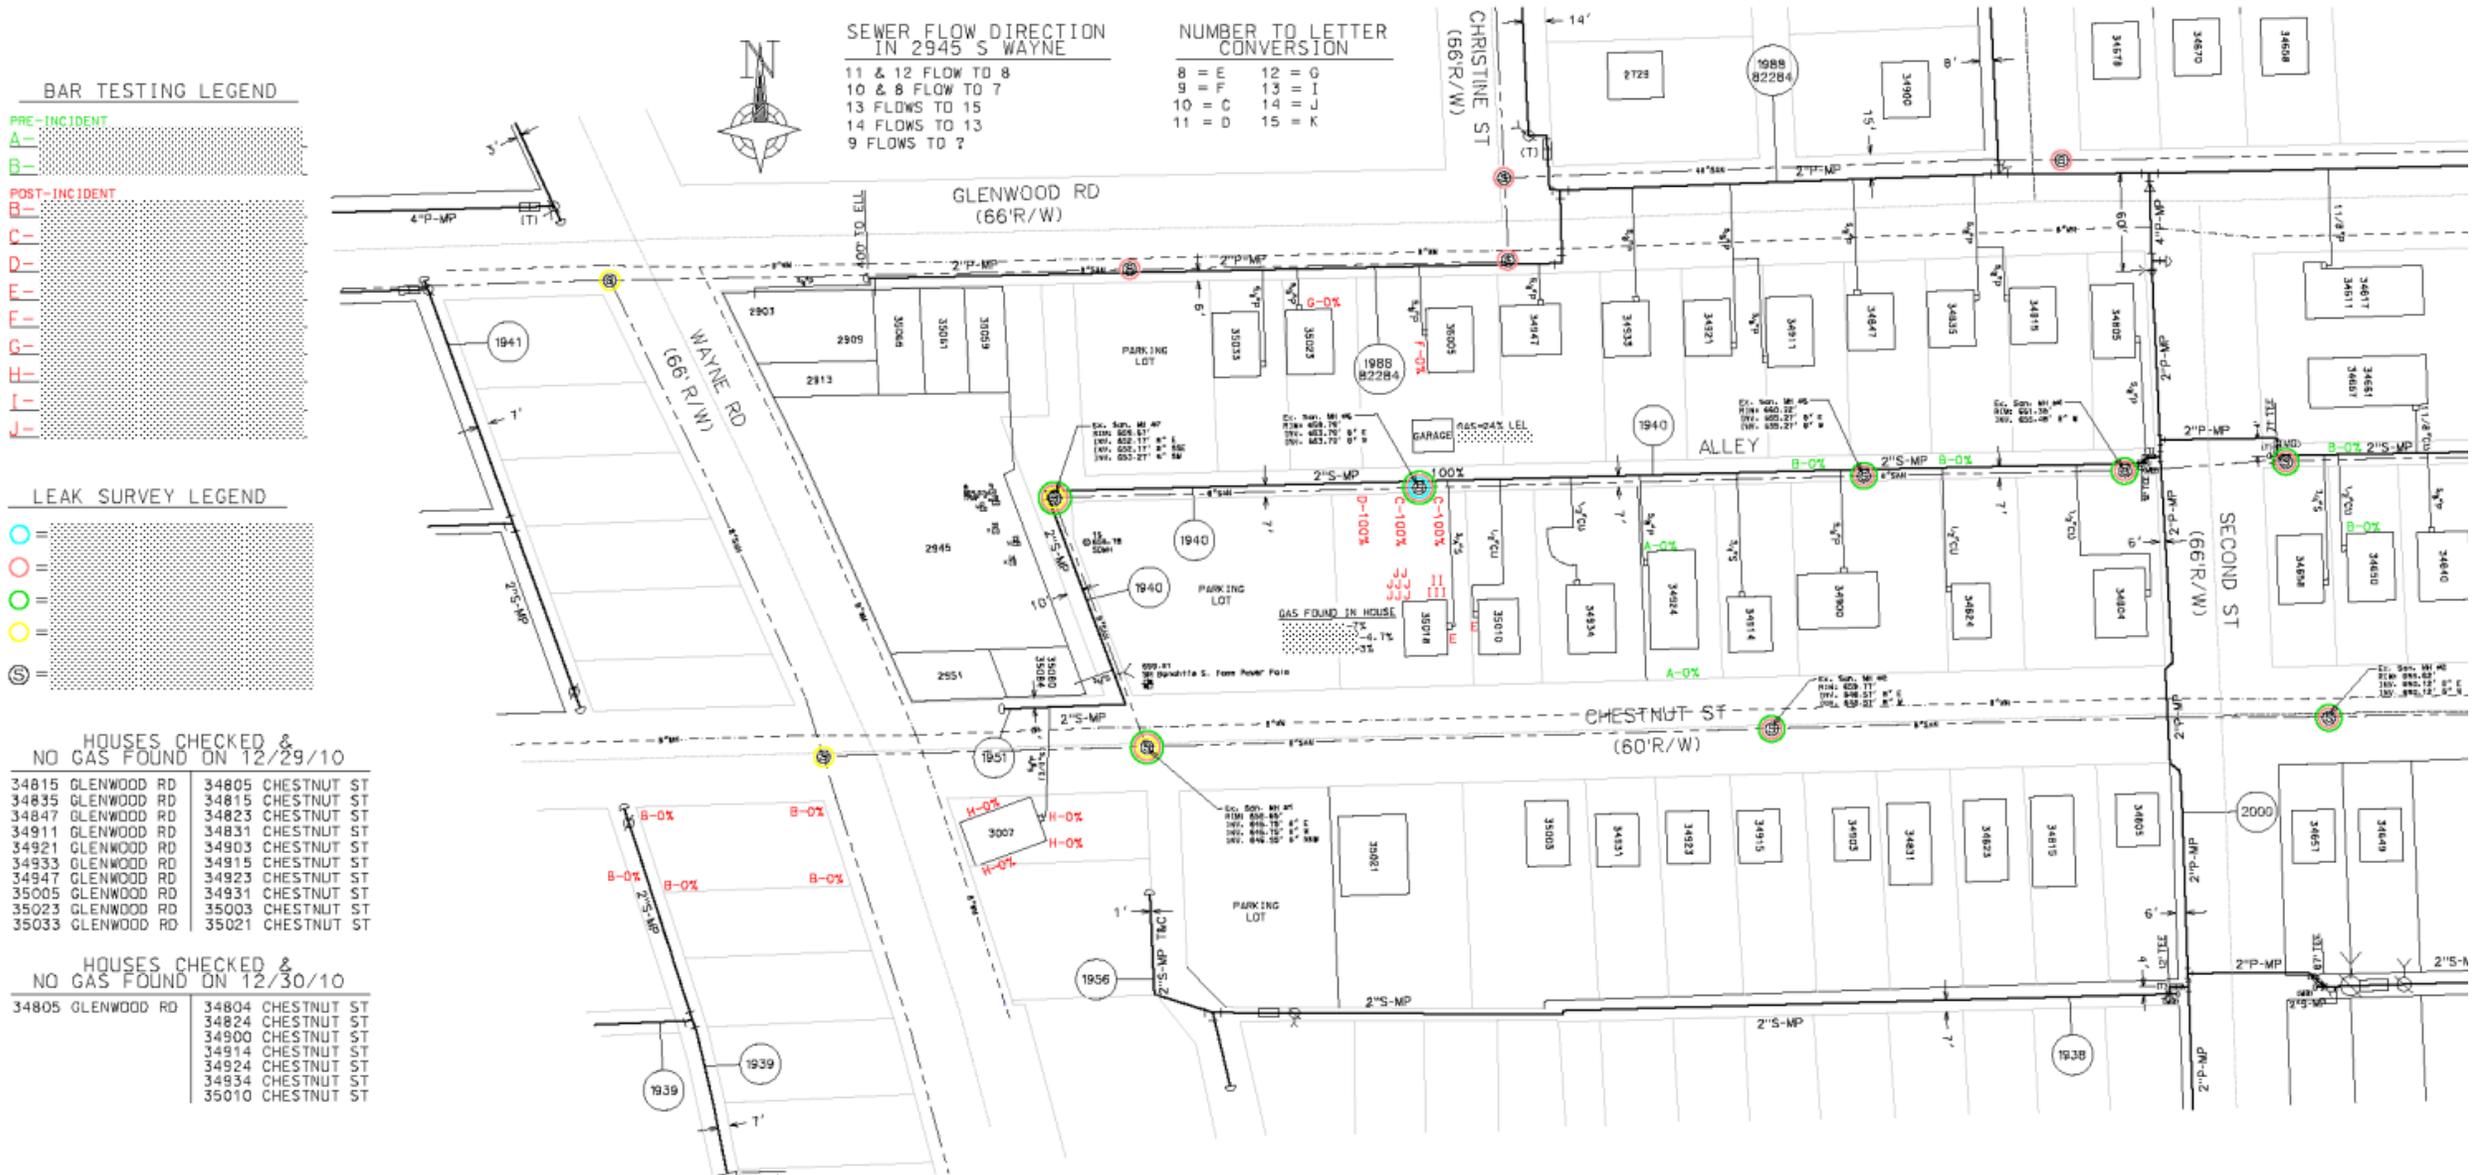
Leak Calls

- 6:13am, employee arrived at 6:40
- Inside air readings
- Bar hole testing at service riser
- Fittings inspected with gas detector
- Shadow testing on meter
- Investigated manhole and neighboring houses
- No positive reads, or unusual gas flows detected
- Notified occupant of results
- Drove around neighborhood with windows down
- Completed work order and left at 7:00am
 - No leaks detected but occasionally smelt gas in air

- 7:04am, employee arrived 8:02am
- Fire department on site
- Took air reads around the house
 - No positive reads, no smell
- Bar hole test from riser to main connection
 - No positive reads, no smell
- Bar hole test along main to the West (down wind)
 - No positive reads
 - Sporadically smelt gas
- Air reads driving west down the street
 - No positive reads, continues smelling gas
- Contacted supervisor for support with mobile leak detection unit
 - Explosion occurred before unit was dispatched

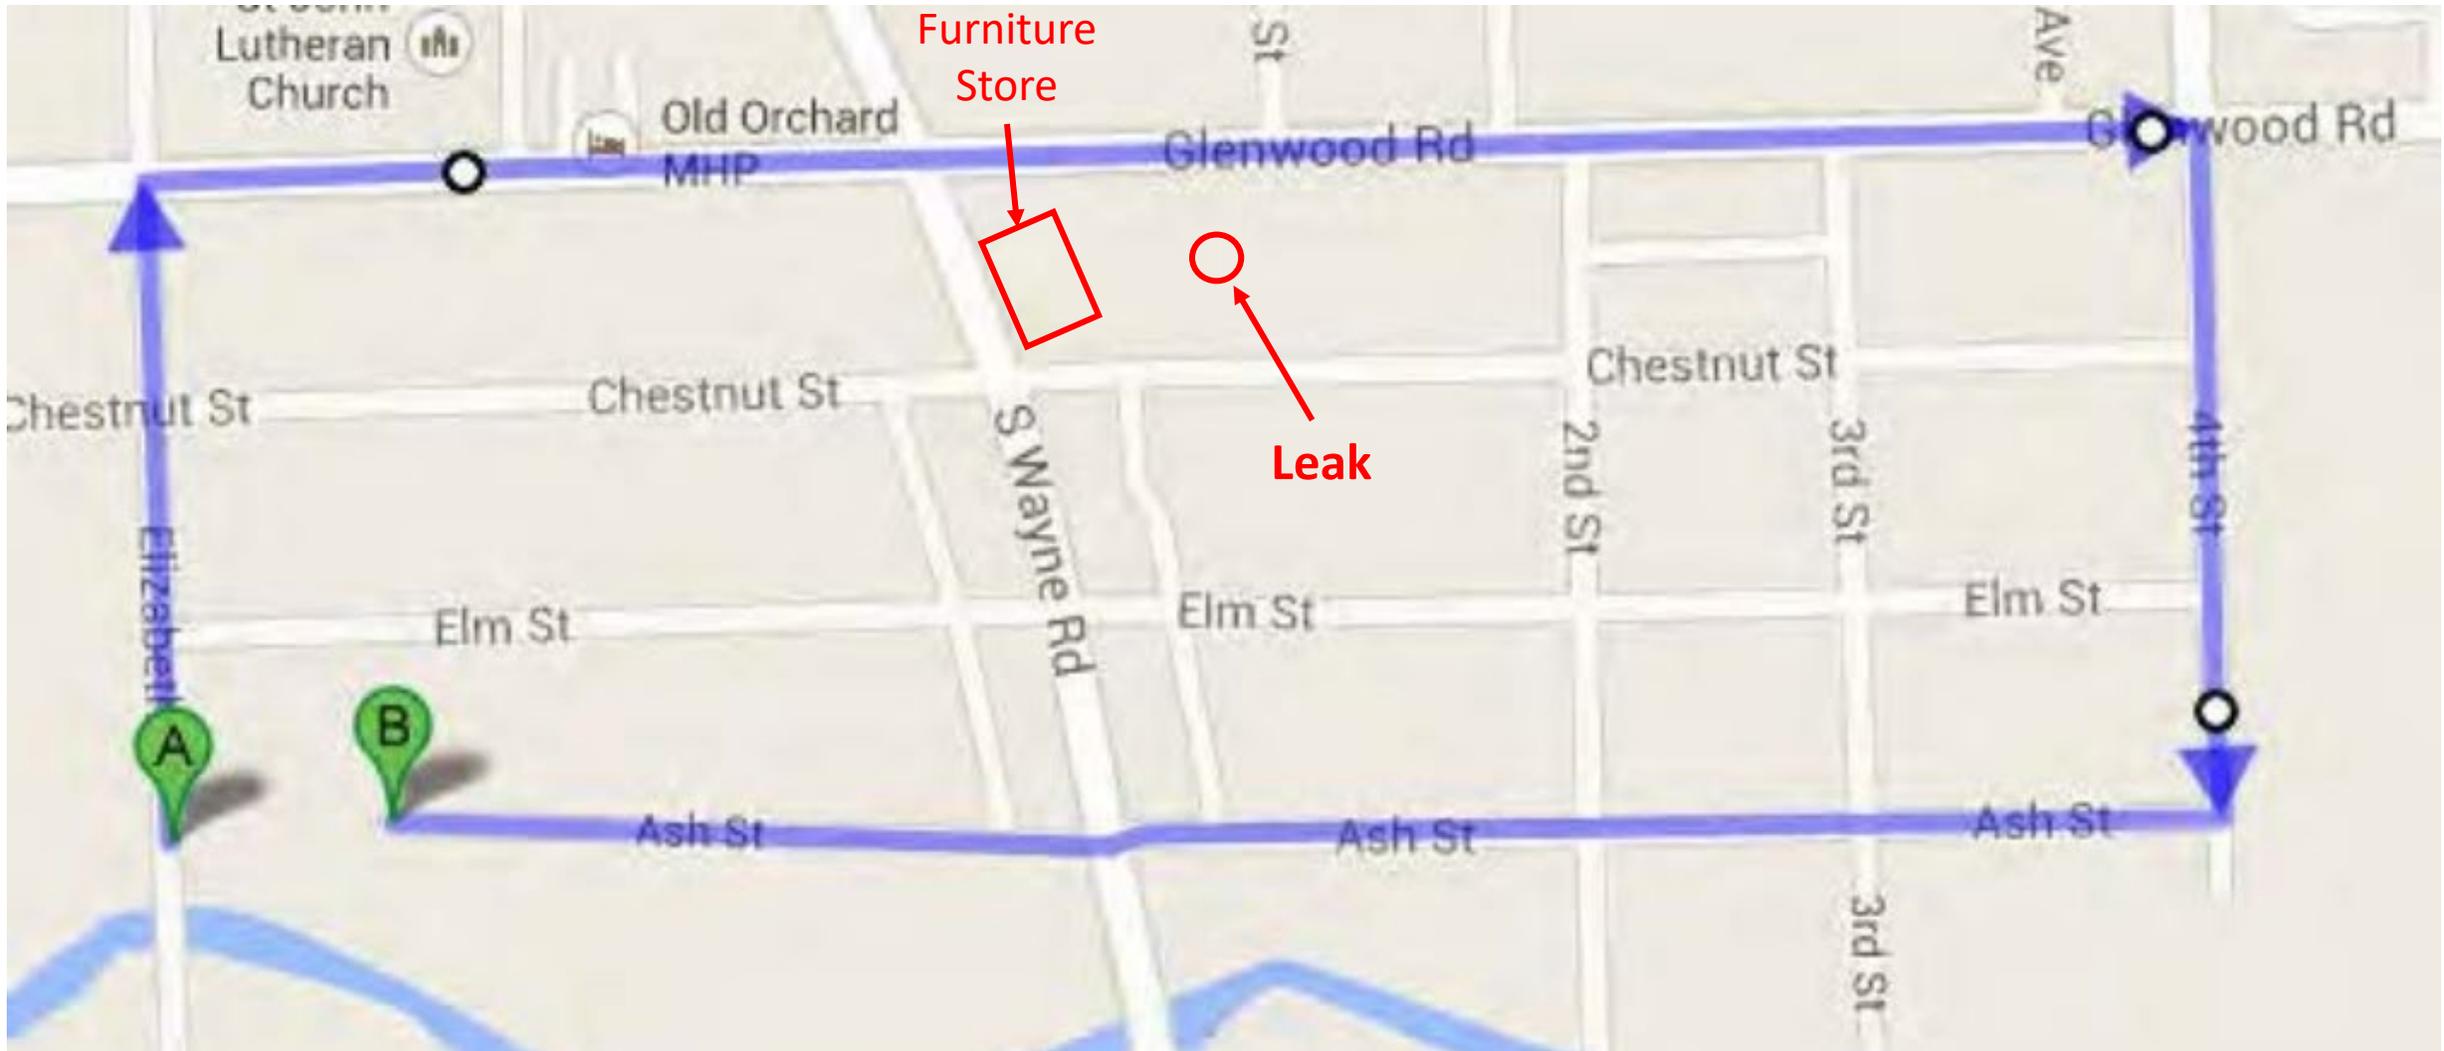
Evacuation Zone

- Between 12:30 pm and 1:30 pm the leak source was found
 - 100% gas read in sanitary sewer manhole east of furniture store
- Bar-hole tested above 2-inch steel main near sewer
 - 100% gas read and gas noted to be blowing out of the hole
- Hand dug over leak location
- Removed sewer cover to vent
- Adjacent blocks evacuated
- Removed manhole covers in 6 block radius
- Bar-hole and gas in air testing done in vicinity of leak
 - Gas discovered in house on parallel street at 7% LEL
 - Gas discovered in garage on same street at 24% LEL
 - Gas migrated underground from main failure to houses

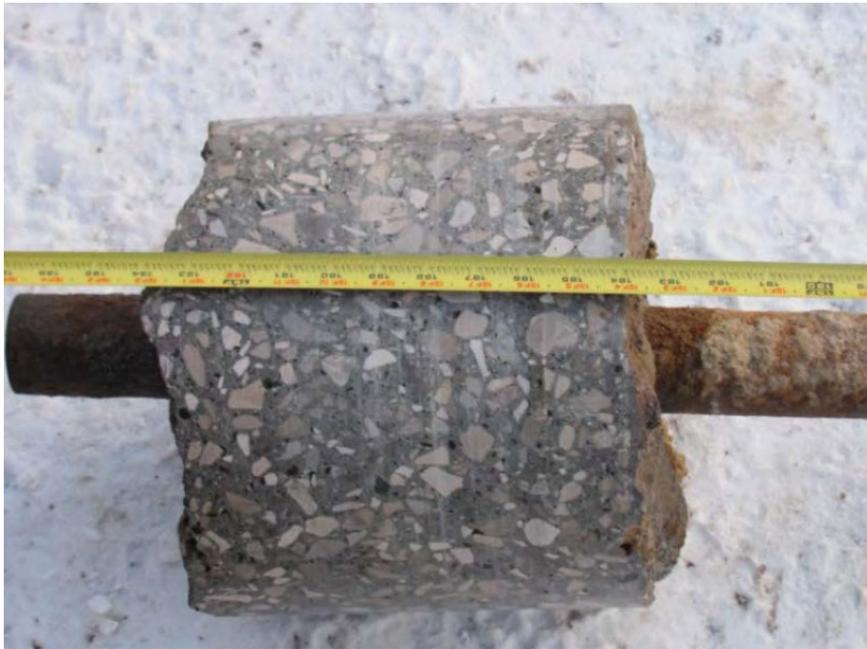
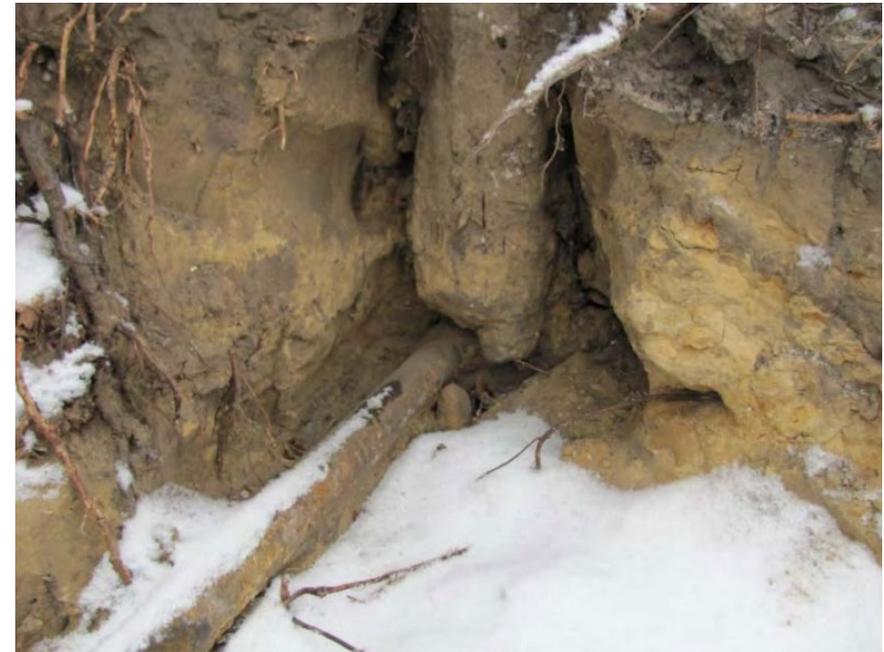
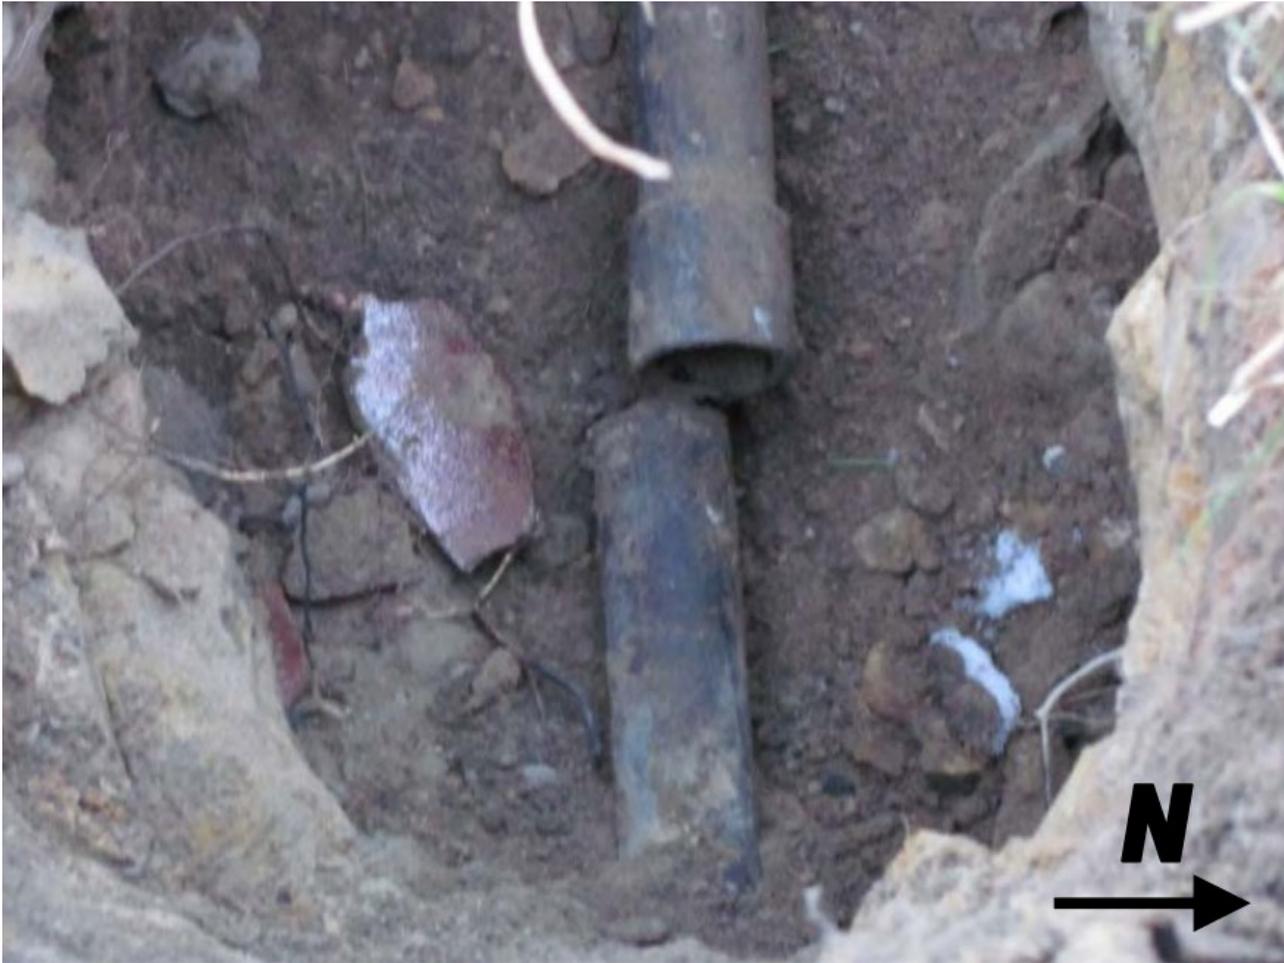
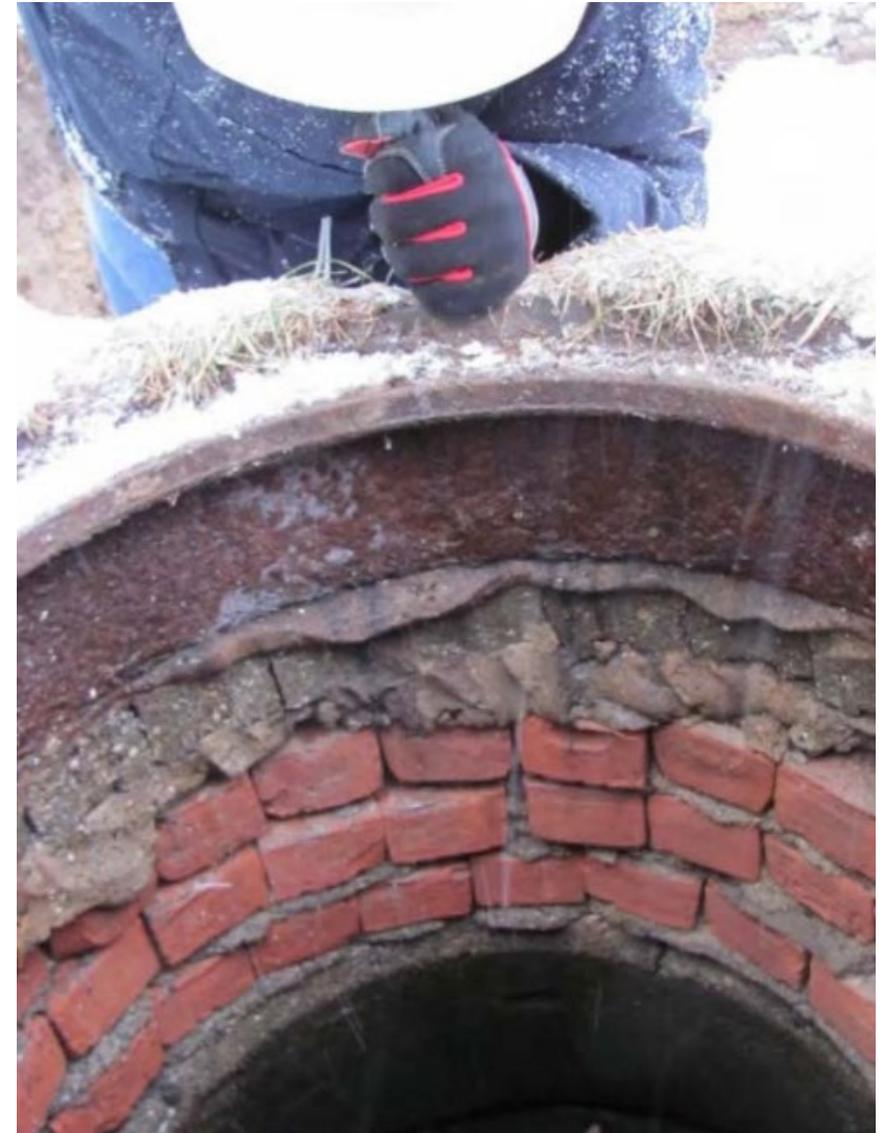
MPSC Investigation

- Concluded that damage to the meter manifold was due to explosion
 - Regulator and meter show no sign of fire exposure
- Multiple concrete footings for fenceposts rested on the gas main
- Used cameras and smoke to inspect sections of sewer system
 - Smoke permeated through foundation walls
 - Potential vacuum pulling gas toward building
- All lines connected to the failure point passed pressure tests
 - Rule out cause from any other leaks
- Main was excavated both sides of the concrete wall
 - East Side: Deflection of 4-³/₄ inches upward and 6-¹/₂ inches south
 - East Side: Prominent bend observed
 - West Side: Minimal bend slope downward 1 inch to failure point

- Conducted:
 - Visual examination
 - Photographing of samples
 - Tensile testing
 - Hardness testing
 - Metallurgical examination
 - Radiographic examination
 - Scanning electronic microscopic examination
 - Physical measurements
 - Collection of soil samples from the pipe
- Engineering and stress load analysis
 - Estimated 1,200 lbs necessary to yield the pipe at the threaded coupling by 2 inches
 - Misalignment of the pipe would estimate an actual load significantly higher
 - Separation occurred due to rapid crack propagation (no cyclic fatigue detected)
- Metallurgical examination determined separation was due to material overload condition
 - Crack initiated in threaded portion of coupling are spread around entire circumference

- Overstress of the threaded and coupled joint on 2-inch bare steel main
 - Main was directly encased into concrete wall footing (no sleeve)
 - Chain-link fence with concrete footings installed directly above the gas main
 - Joint separated and misaligned by 2.5 inches
- Installation of sanitary sewer system directly next to the gas main
 - Migration of gas through sewer system into the furniture store
 - Contributed to external forces on the gas main
- Failure of Operator to identify and document the encroachment on the main
 - Form of 3rd party damage
- Reported Sinkhole in the vicinity of the main failure
 - Settlement of soil may have contributed to external forces on main
- Inadequate leak response by the Operator
