WI-PSC Conference February 2024

Accident Investigation
Division (AID)

Case Study
Atmos Energy
Dallas, Texas
Gas Migration
One Fatality and
Three Injuries
February 23, 2018

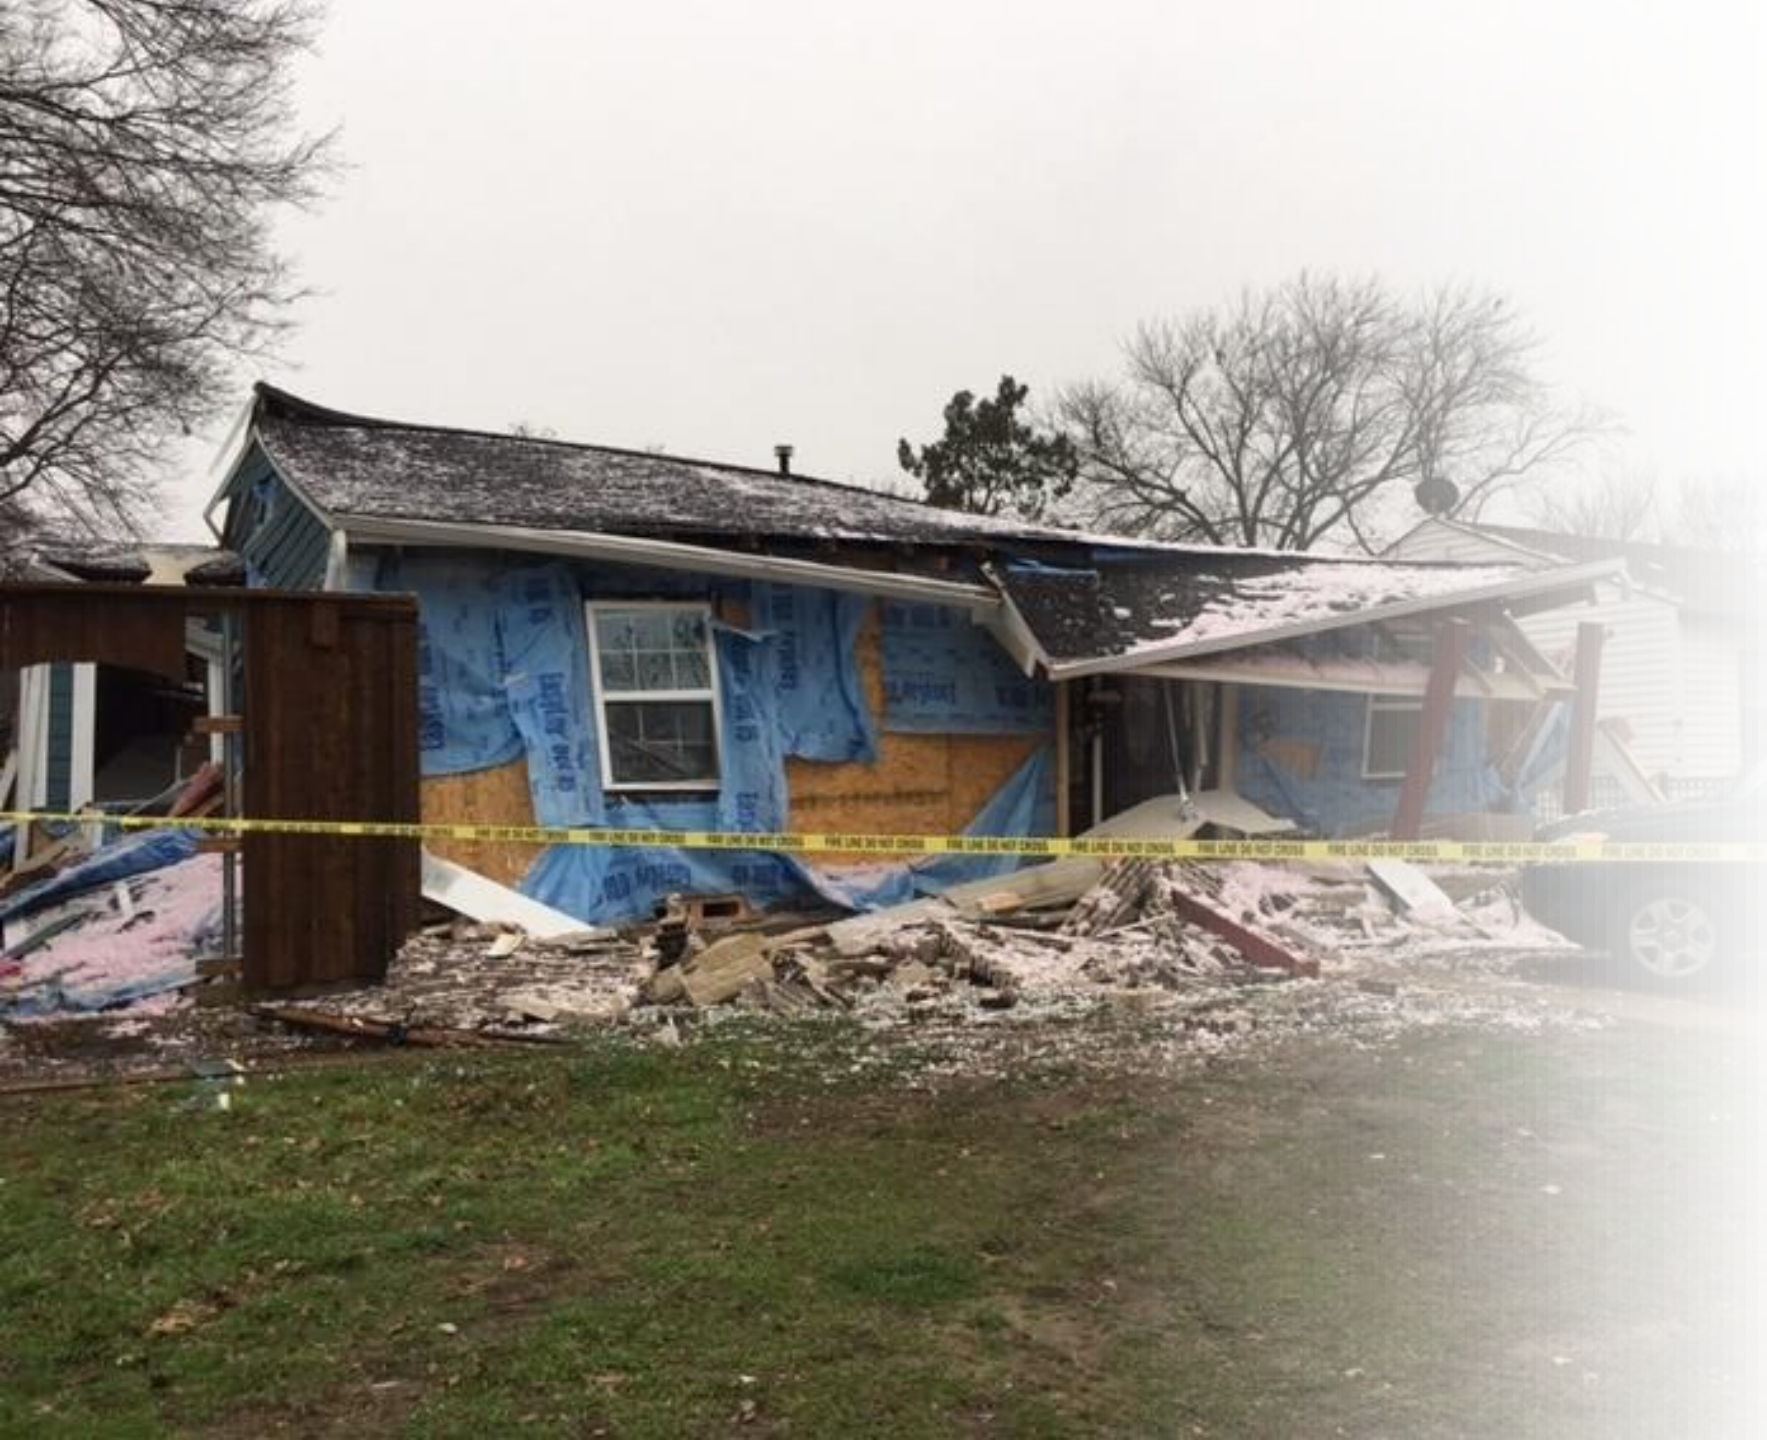
* Each bar represents 1-hour. 5 hours of heavy rain capped the gas plume. Leak was graded 3 months prior to explosion.

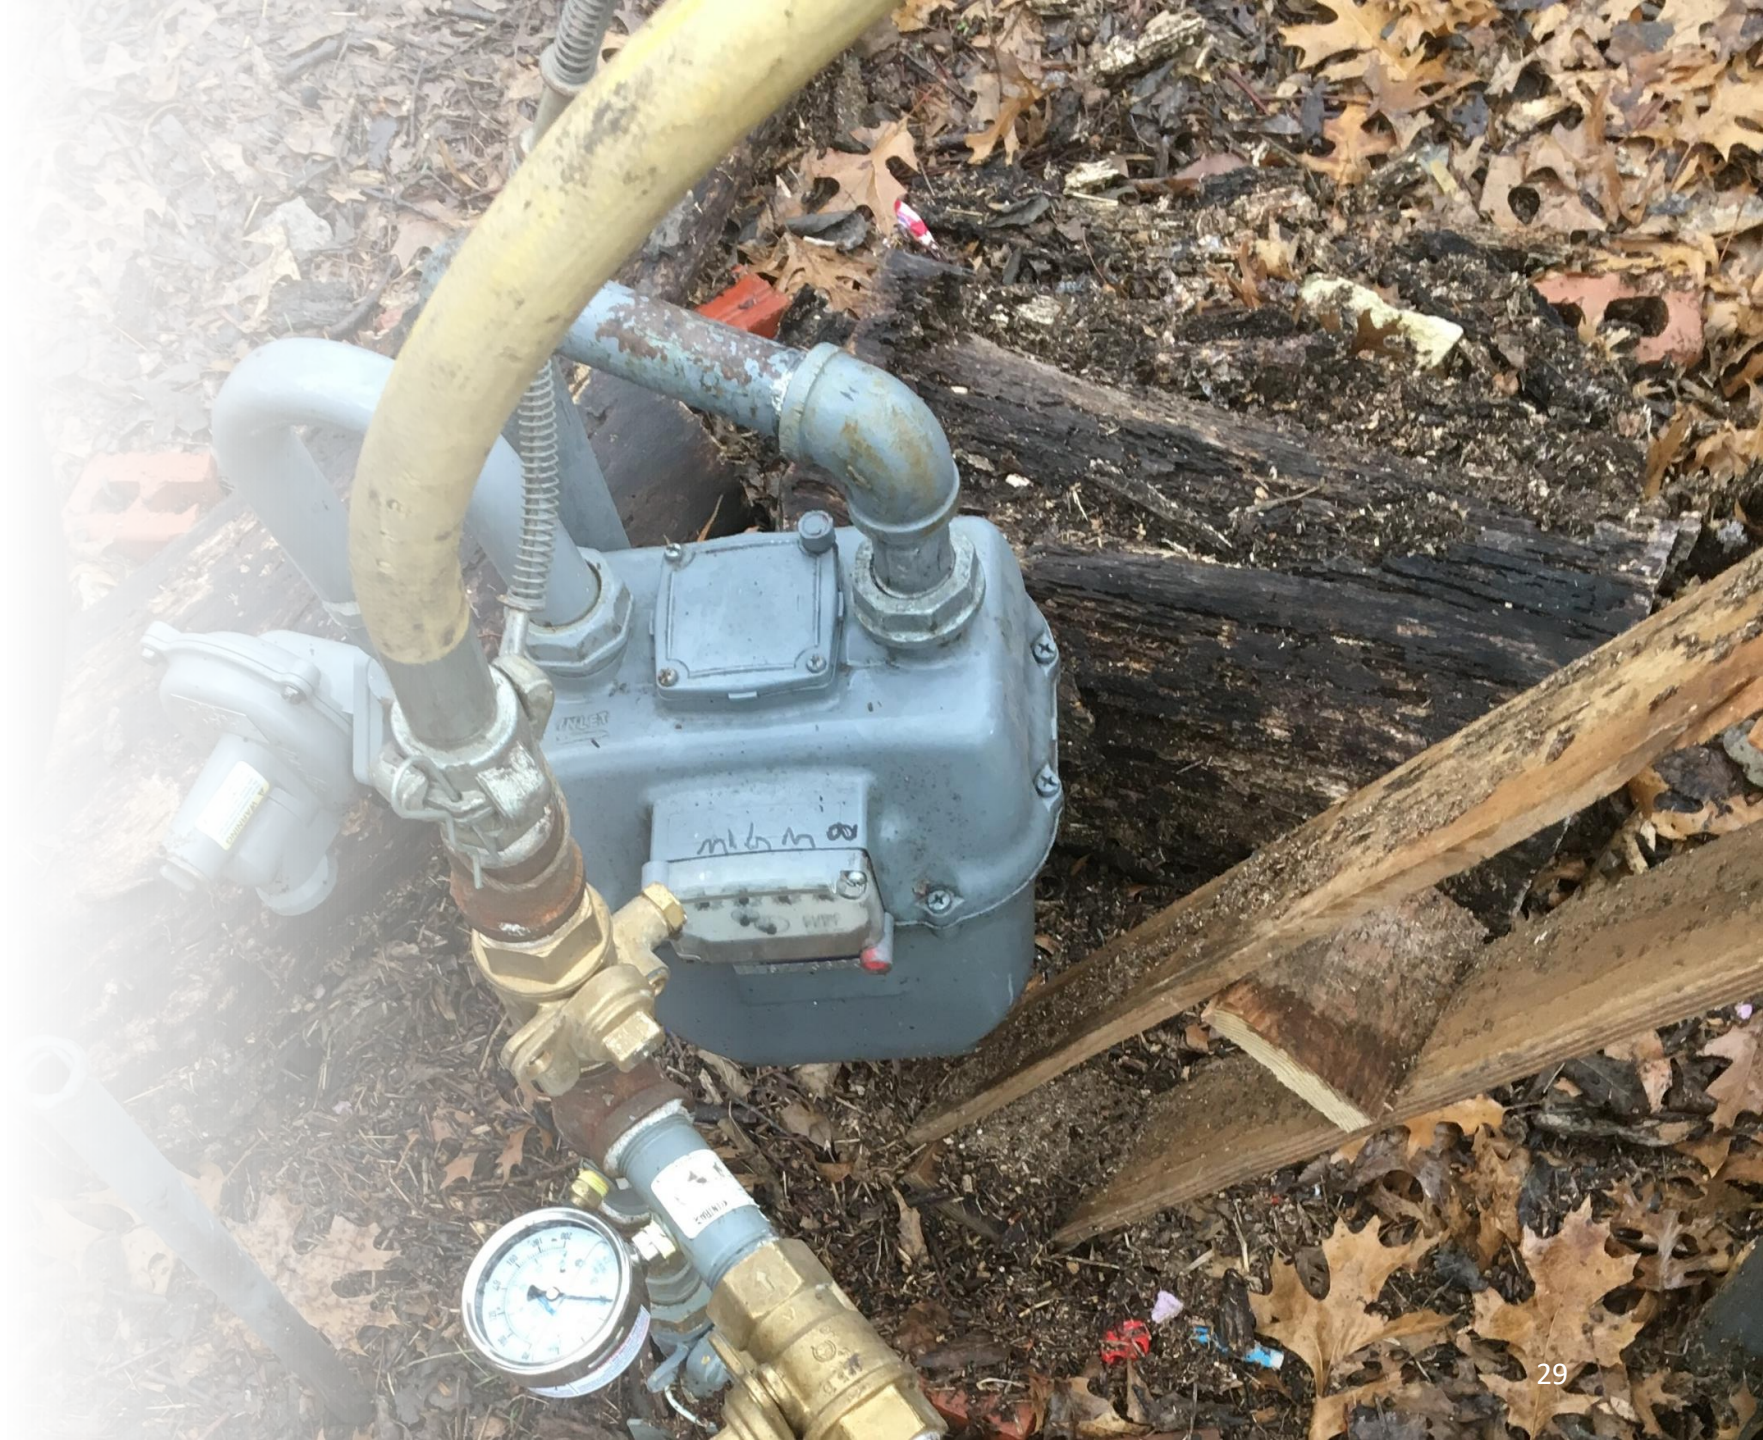
Mains and services capped and ready for pressure testing.

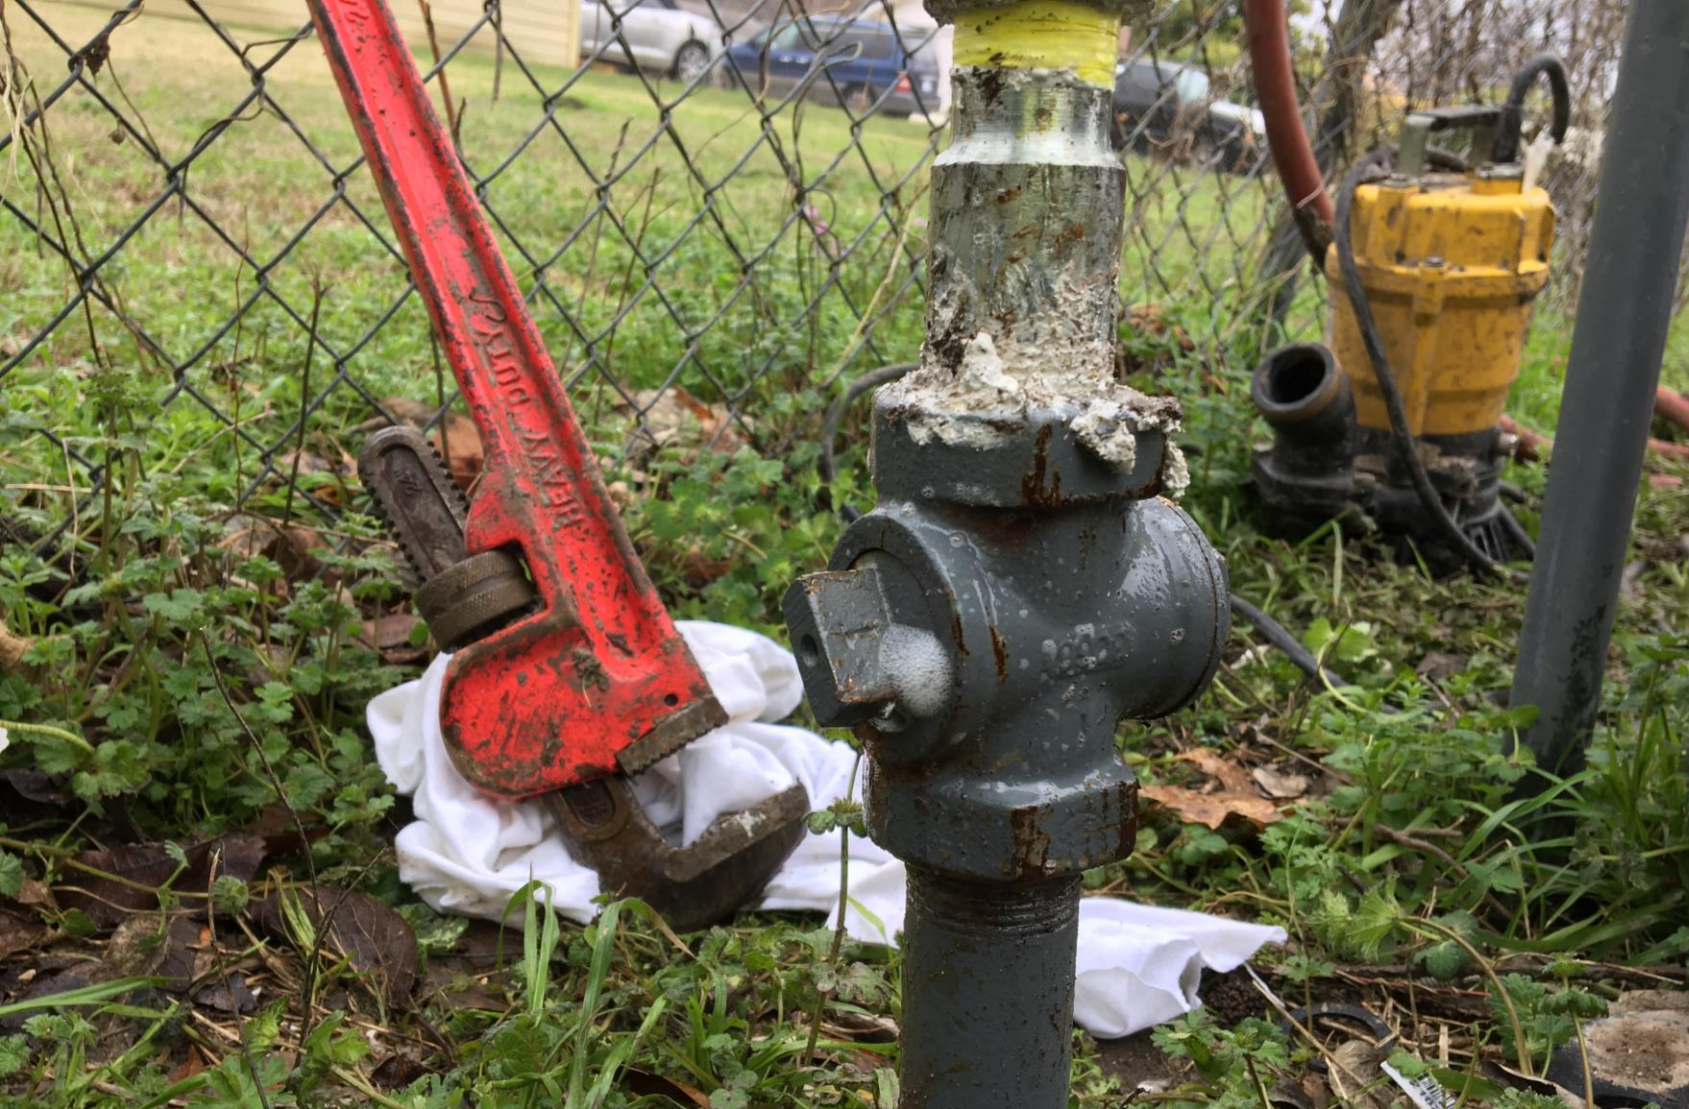
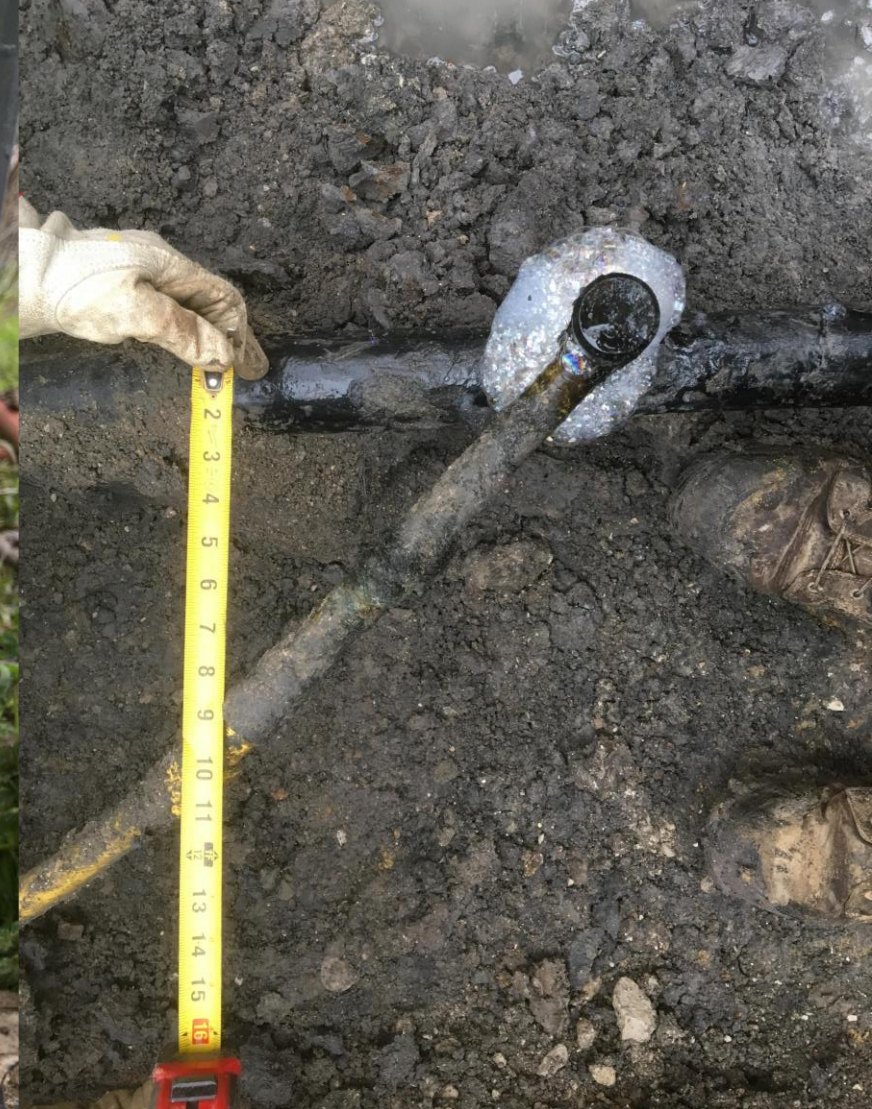
Leaks at service tee and stopcock. Some leaks will cause test pressure failures but are not hazardous. The flow rate will be inadequate to migrate any distance. Flow rate testing pipelines that fail pressure tests should be performed prior to exposing buried leaks.

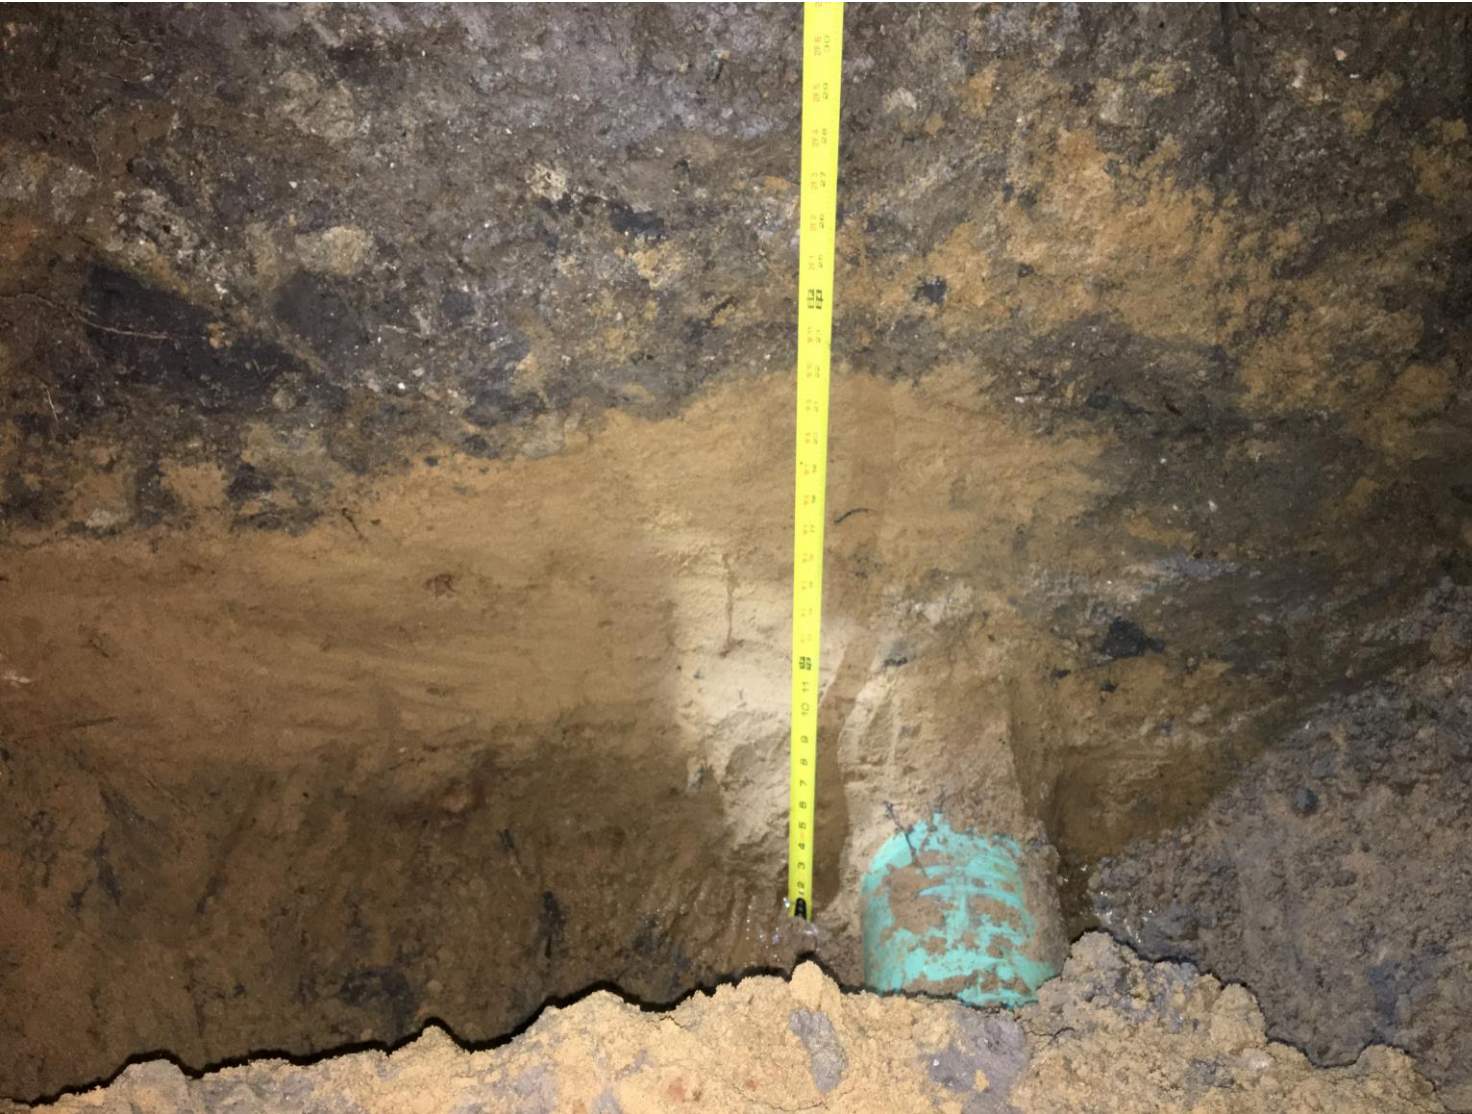
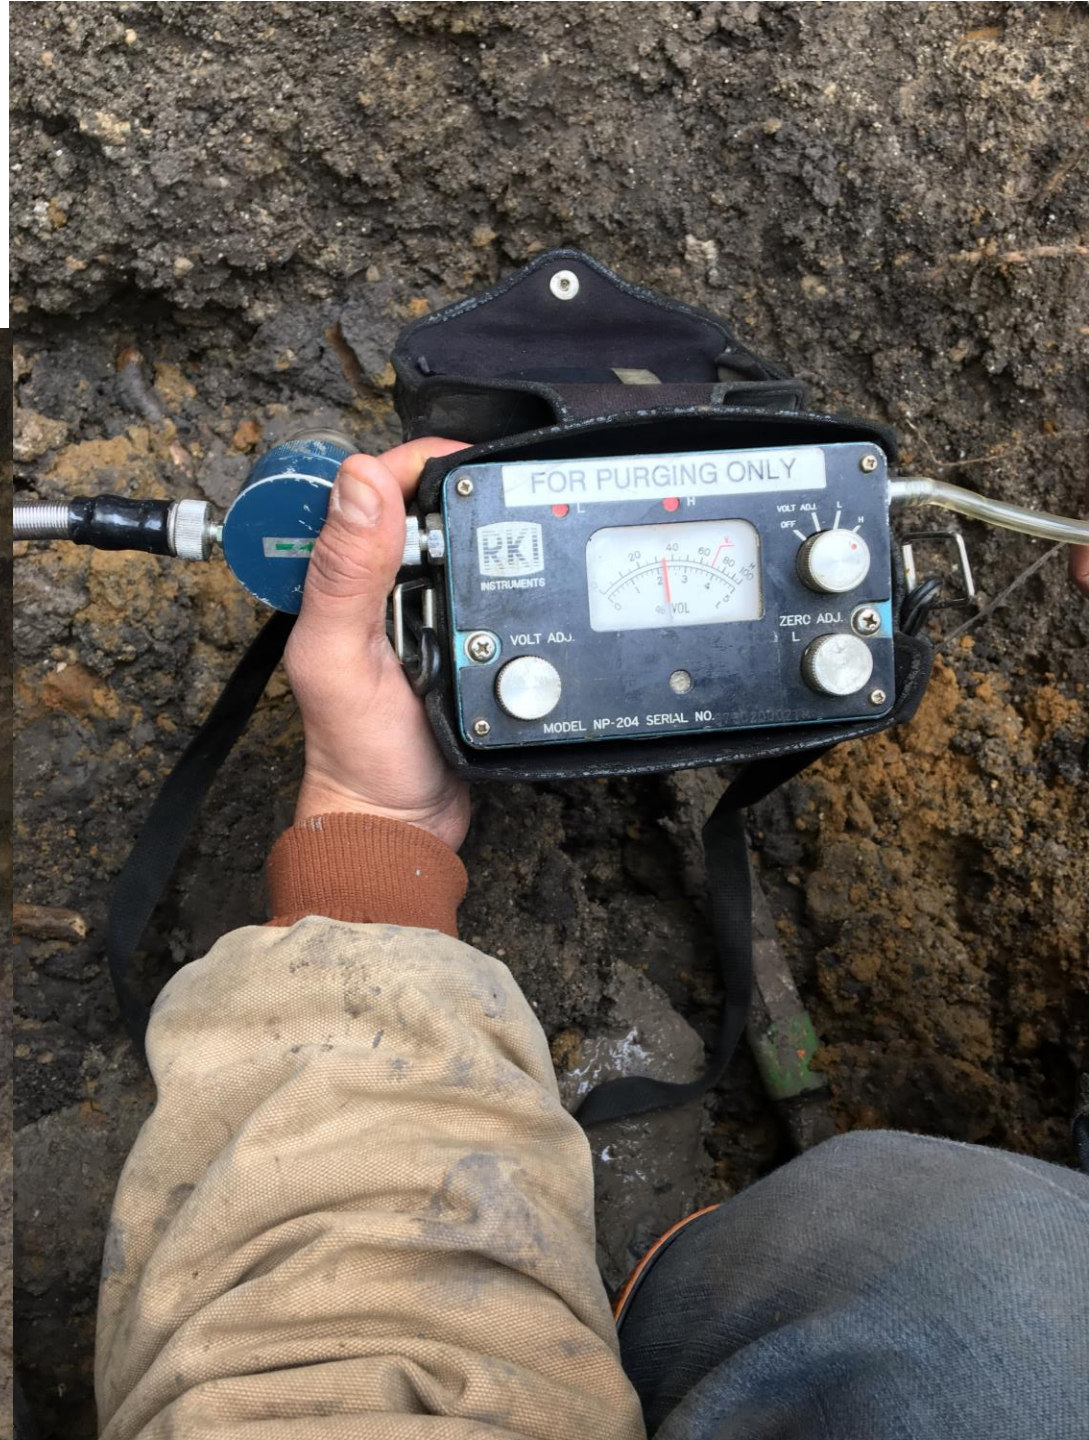
During excavation pay close attention to what is being dug up. Evidence can be anywhere. Sand bedding for sewer line was conduit for gas migration. Test and document to confirm theory. CGI shows 35% LEL, 9 days after the gas was shut-off.

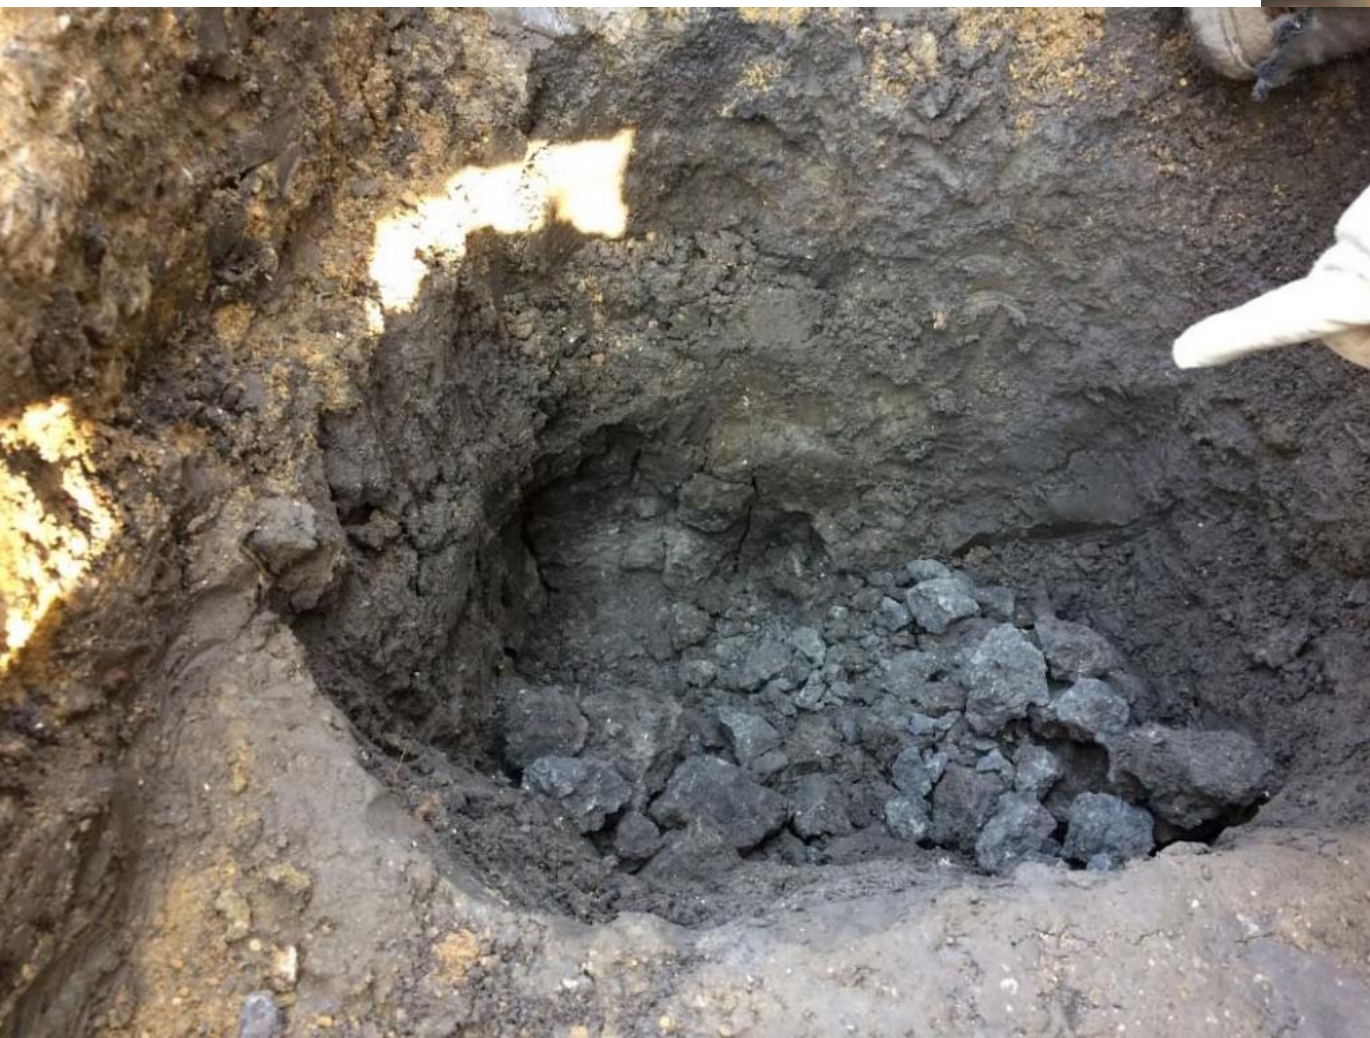
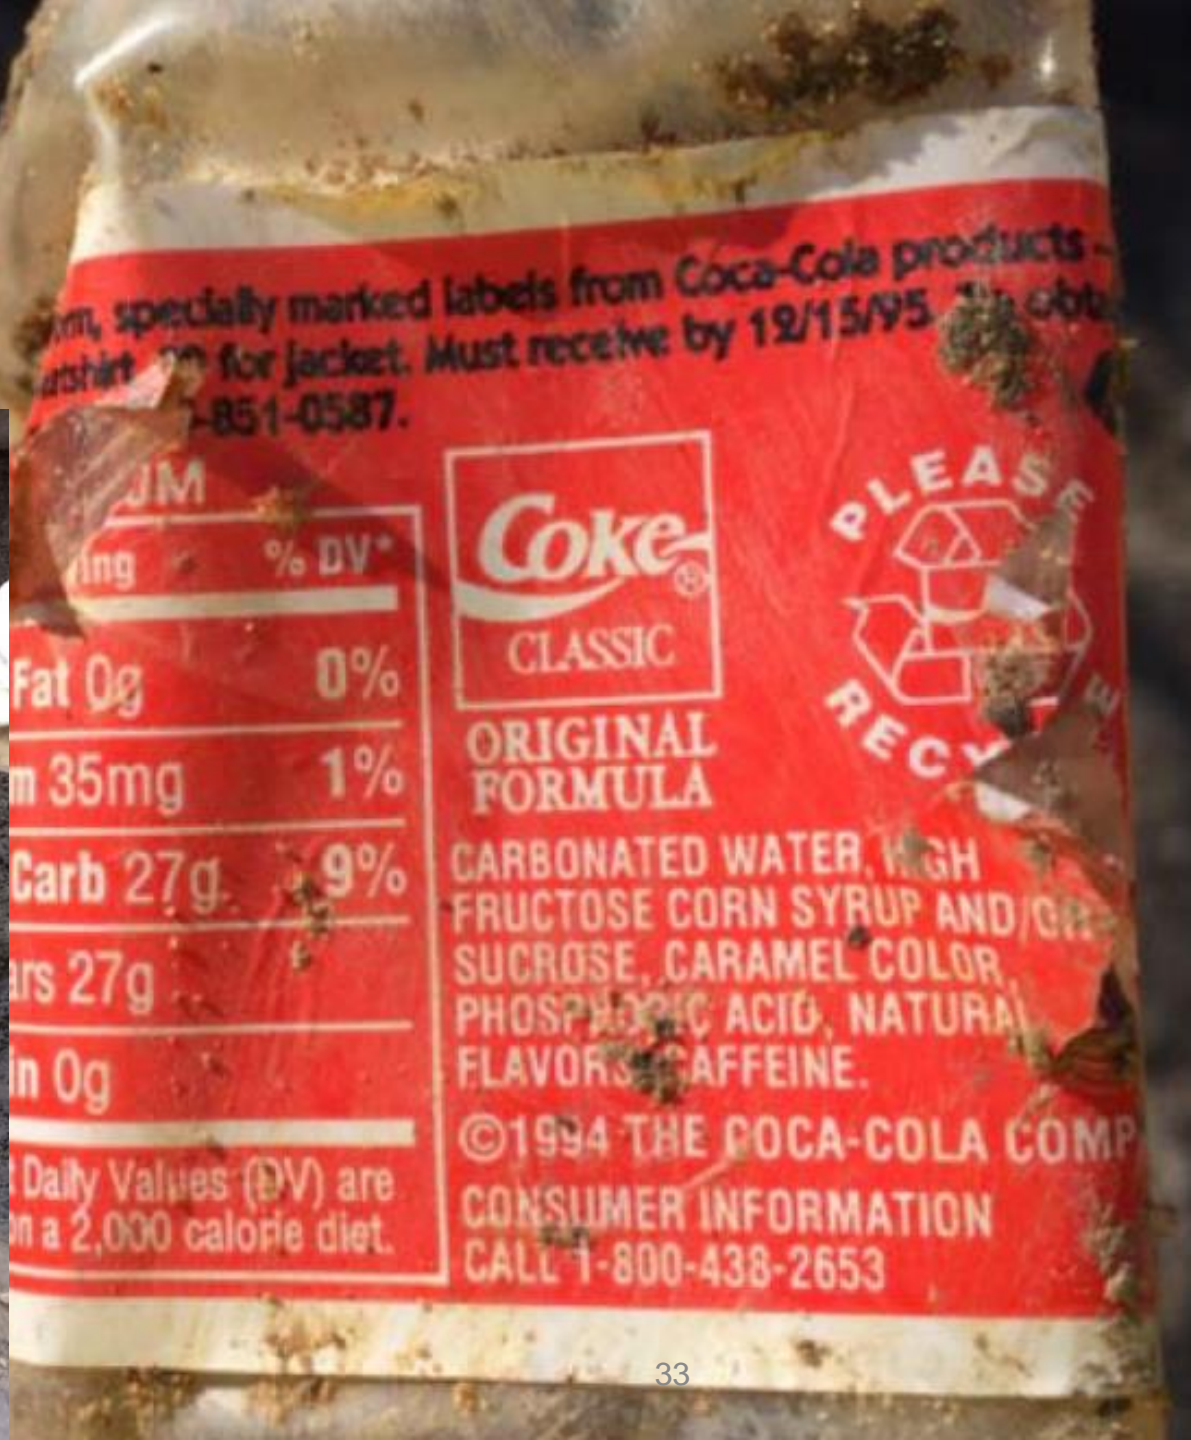
Evidence can be anywhere. Soil will discolor from the release of natural gas, dry out and scrub odorant. A dated coke bottle found next to main failure. Date corresponds to sewer installation.

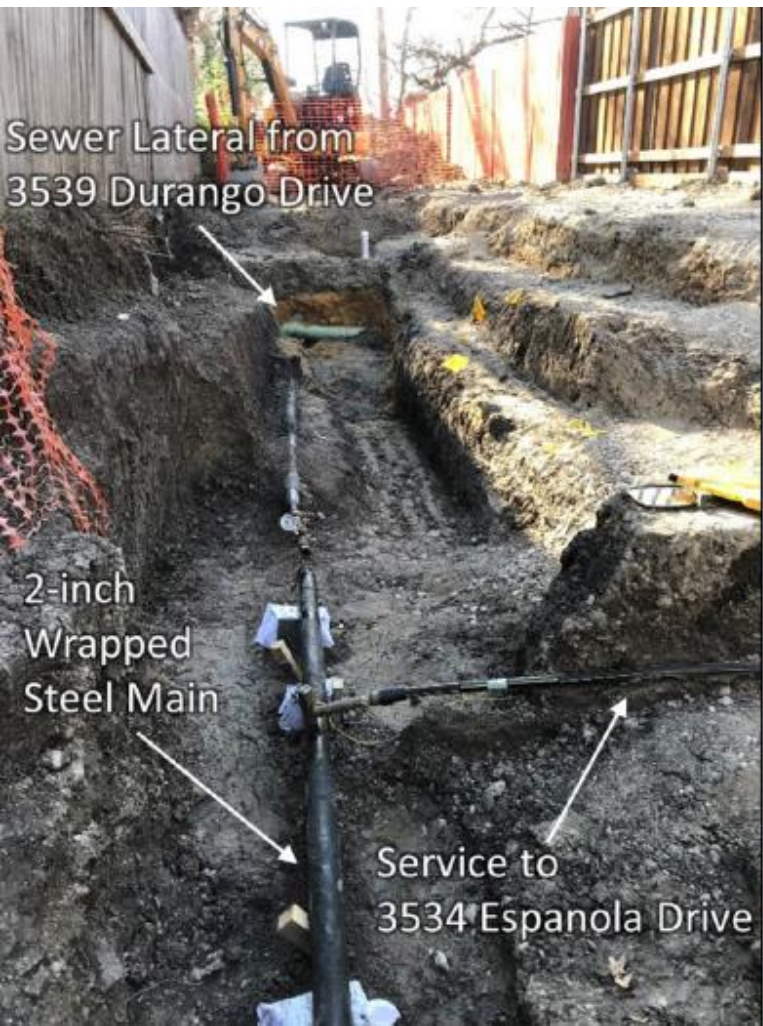
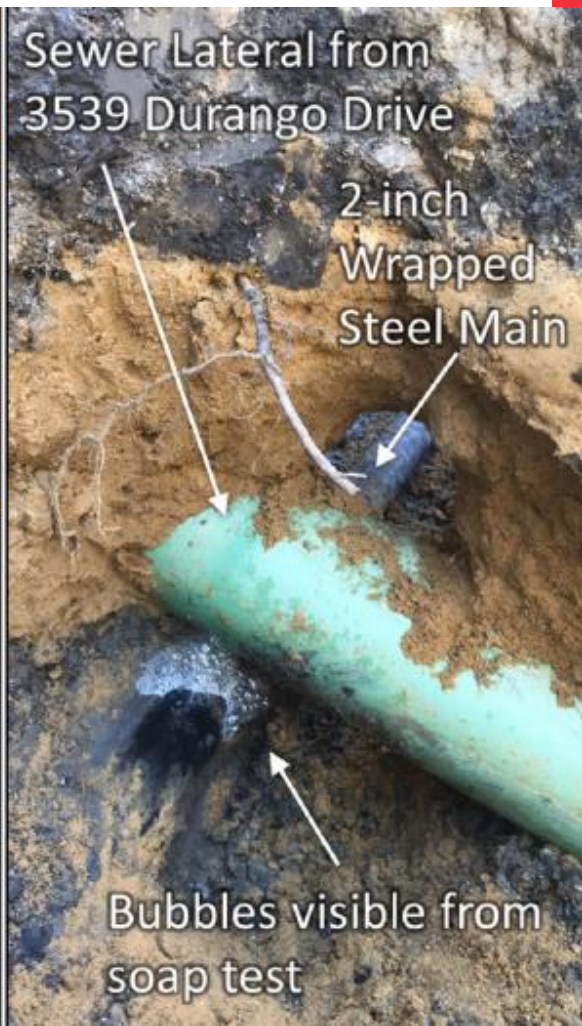
Source of the gas was identified at a location where a sewer main was installed in 1995, with only 2-inches of clearance. The line was dented and gouged with excavation equipment and failed 23 years later as a circumferential crack.

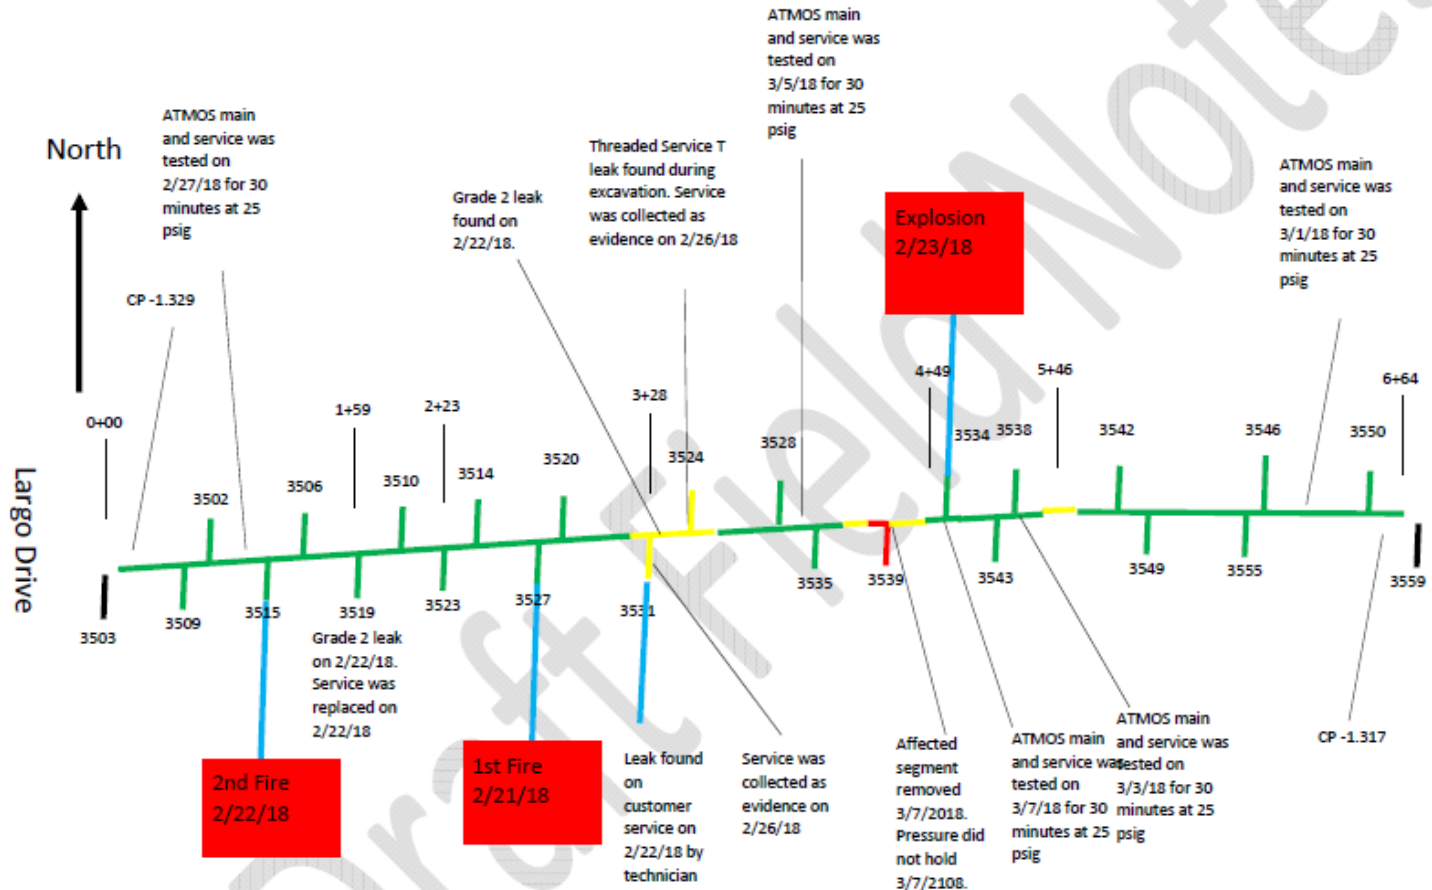
Overview of gas main and service in alley between Espanola and Durango Updated March 7, 2018

Document the details as it paints a picture. 664 feet of pipe tested with multiple leaks identified. Only one was large enough to result in the migration.

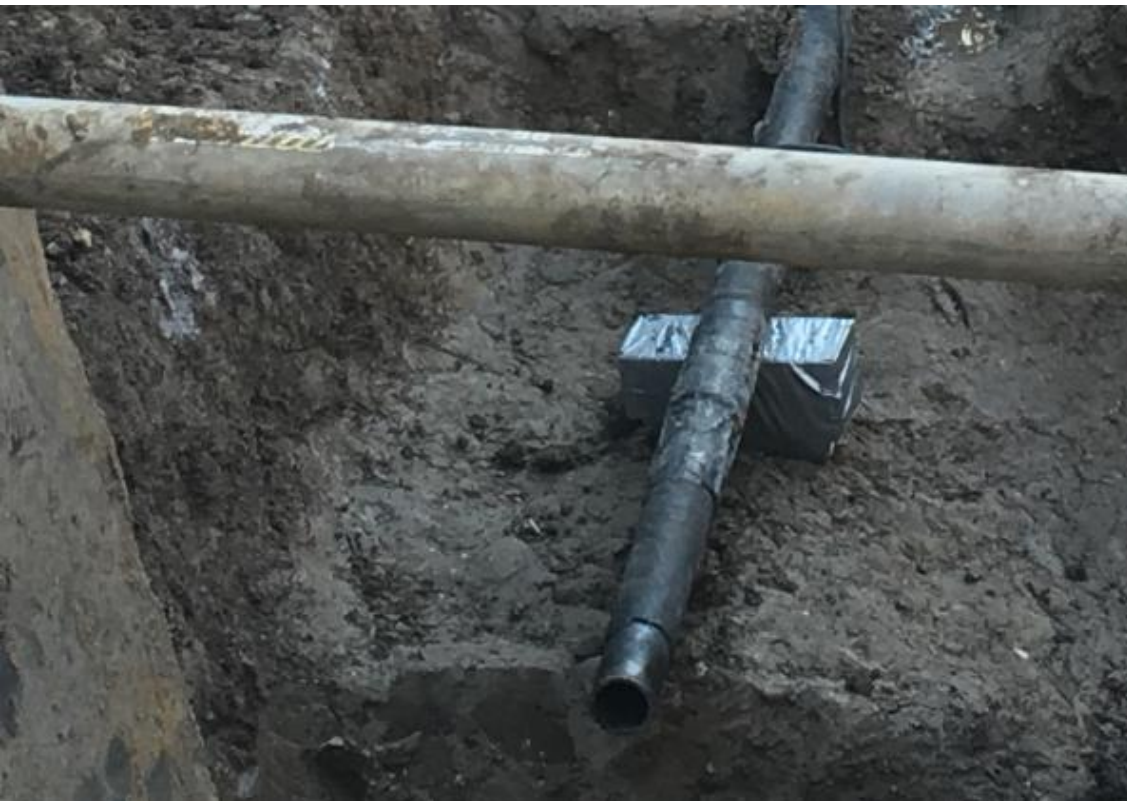
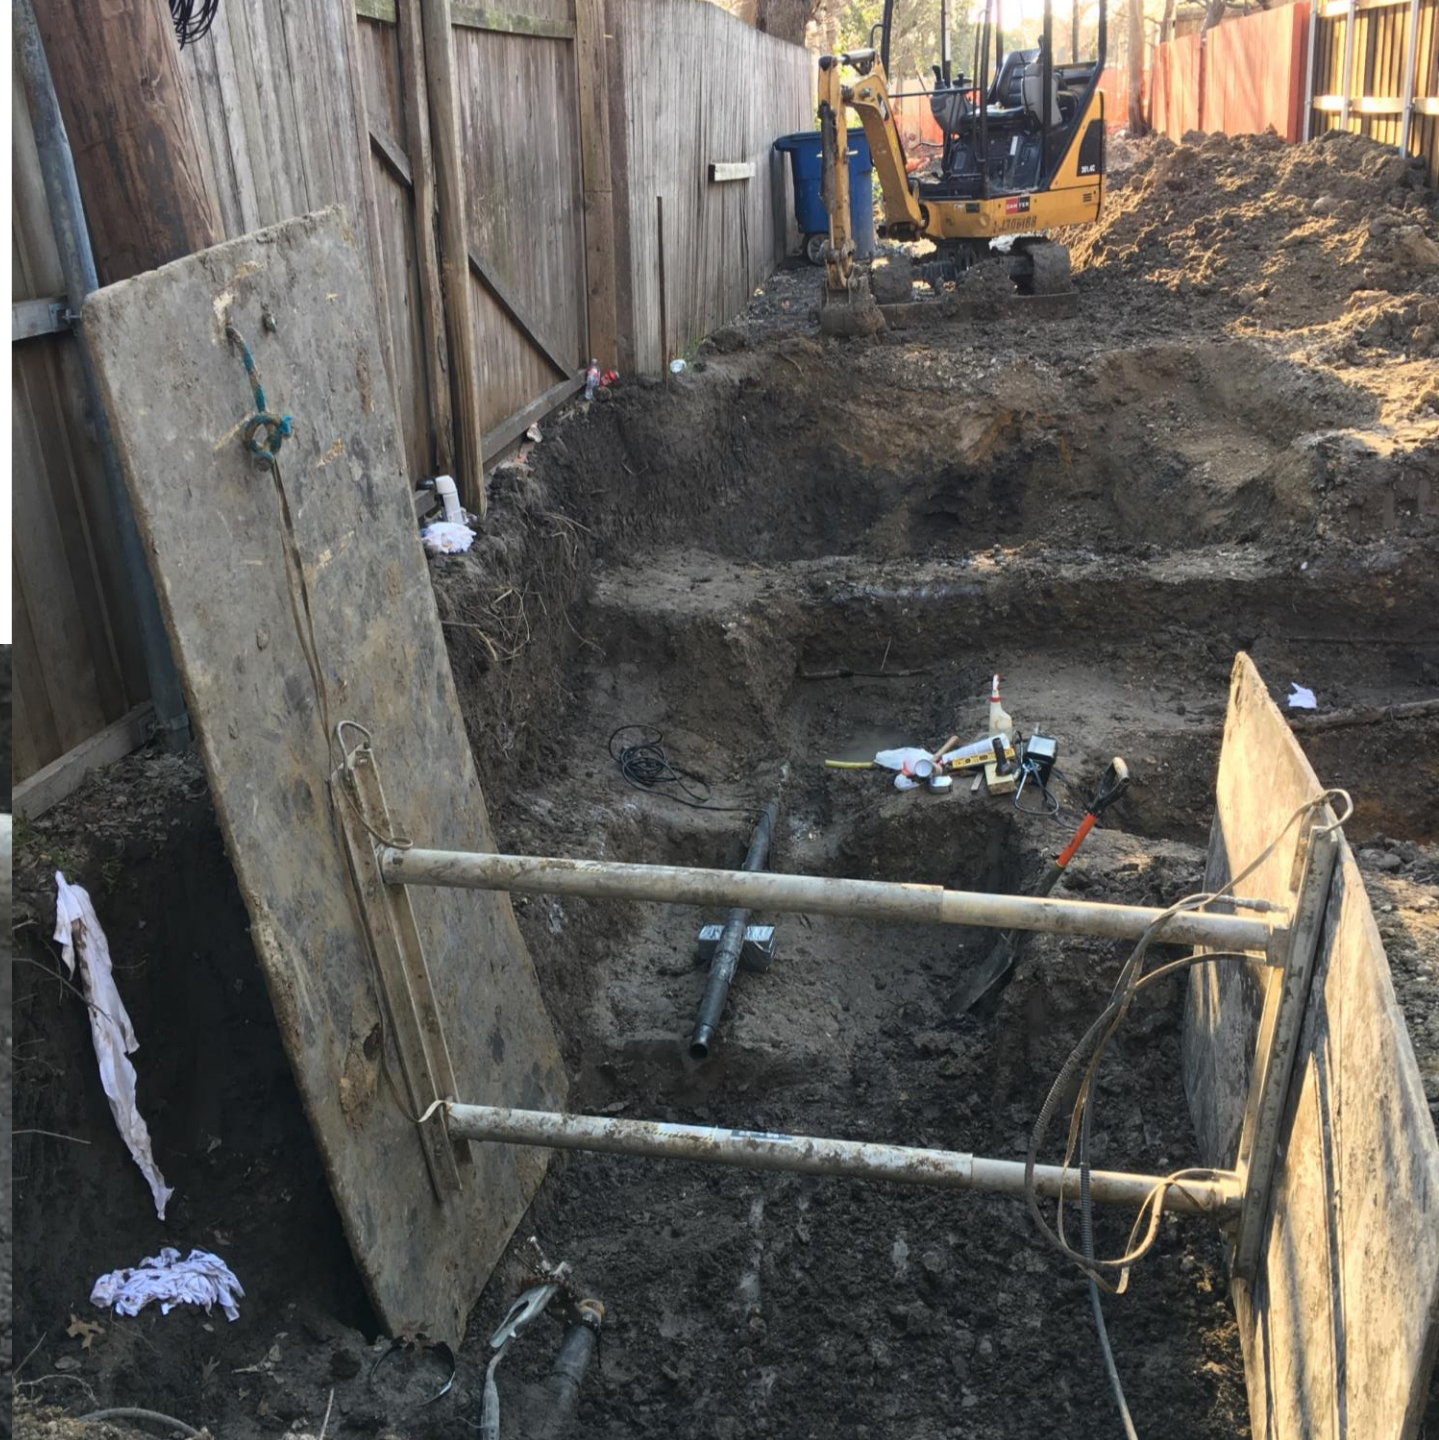
Be safe while working, What is wrong with this picture. A pressure test cap will be welded on for pressure testing in a few minutes. A compression coupling can be seen by support block.
