PSC
of WISCONSIN

2026 Wisconsin Pipeline Safety Seminar

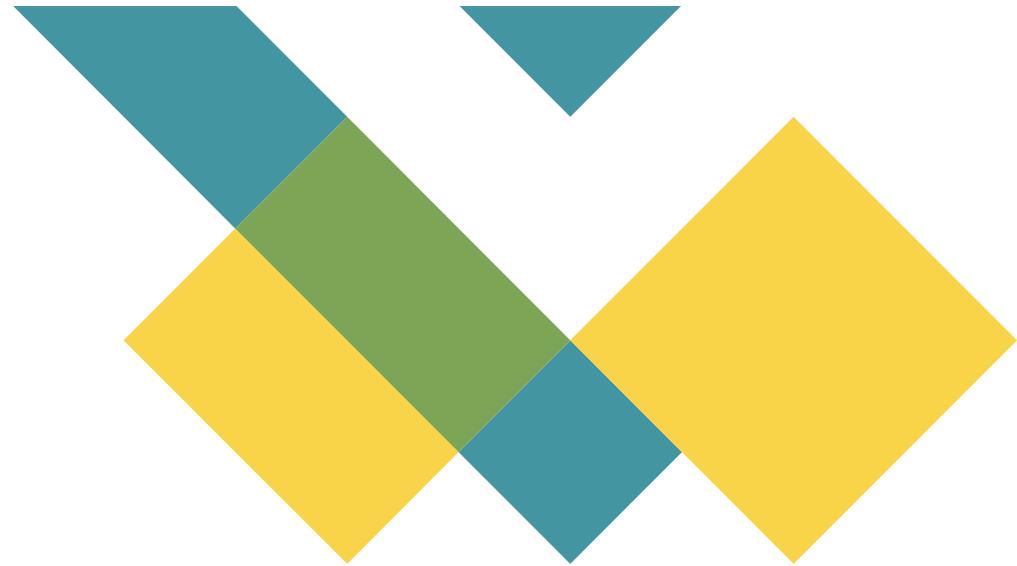
- Purpose
- What is a Cross Bore – a Brief History
- Cross Bore Prevention = Damage Prevention
- Best Practices – Worth the Cost?

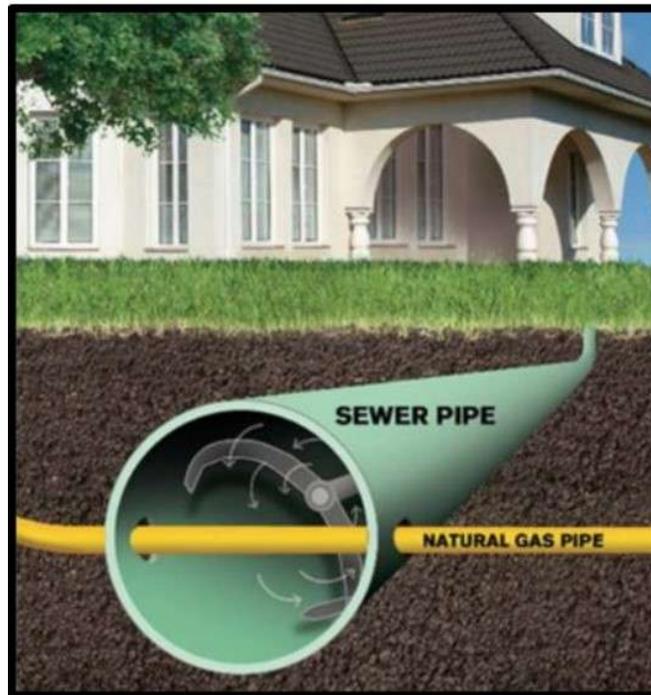
What Construction types cause them?

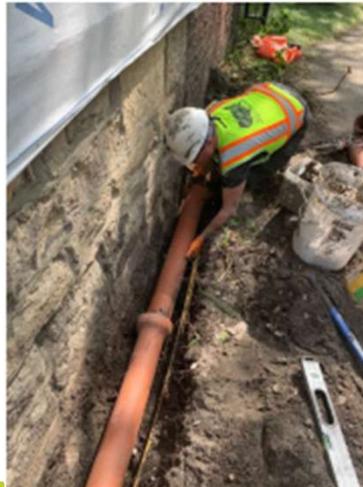
Repair per local codes
