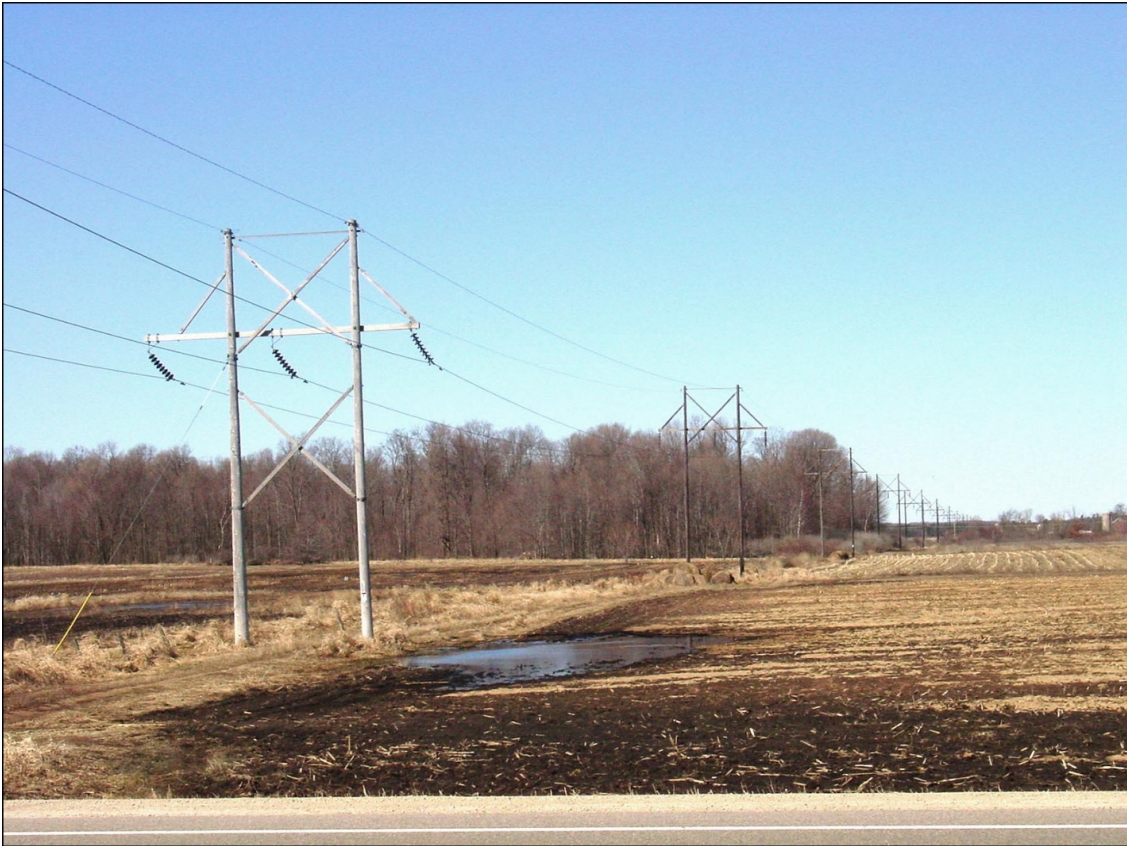
Figure Vol. 2-8 Typical two-pole H-frame structures (Image is for illustration purposes only and are not the actual structures proposed for the Badger-Coulee project.)

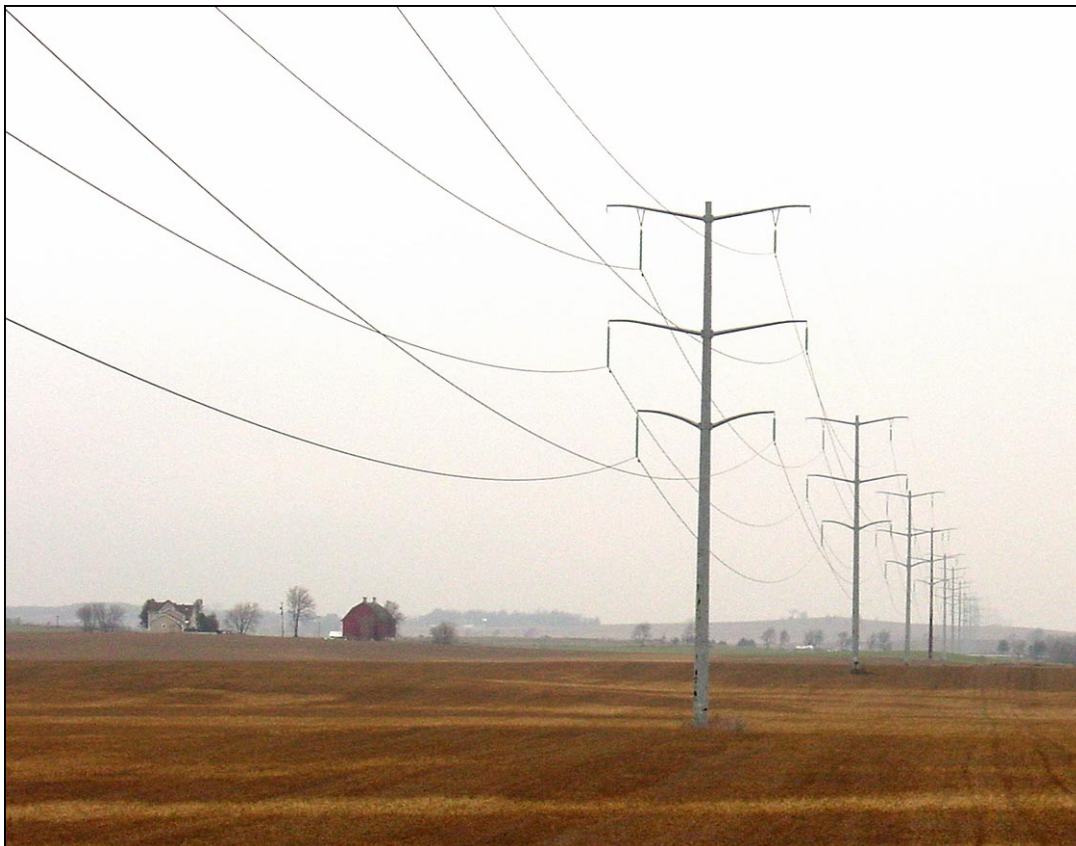
Figure Vol. 2-9 Typical single-pole double circuit structures (Image is for illustration purposes only and are not the actual structures proposed for the Badger-Coulee project.)

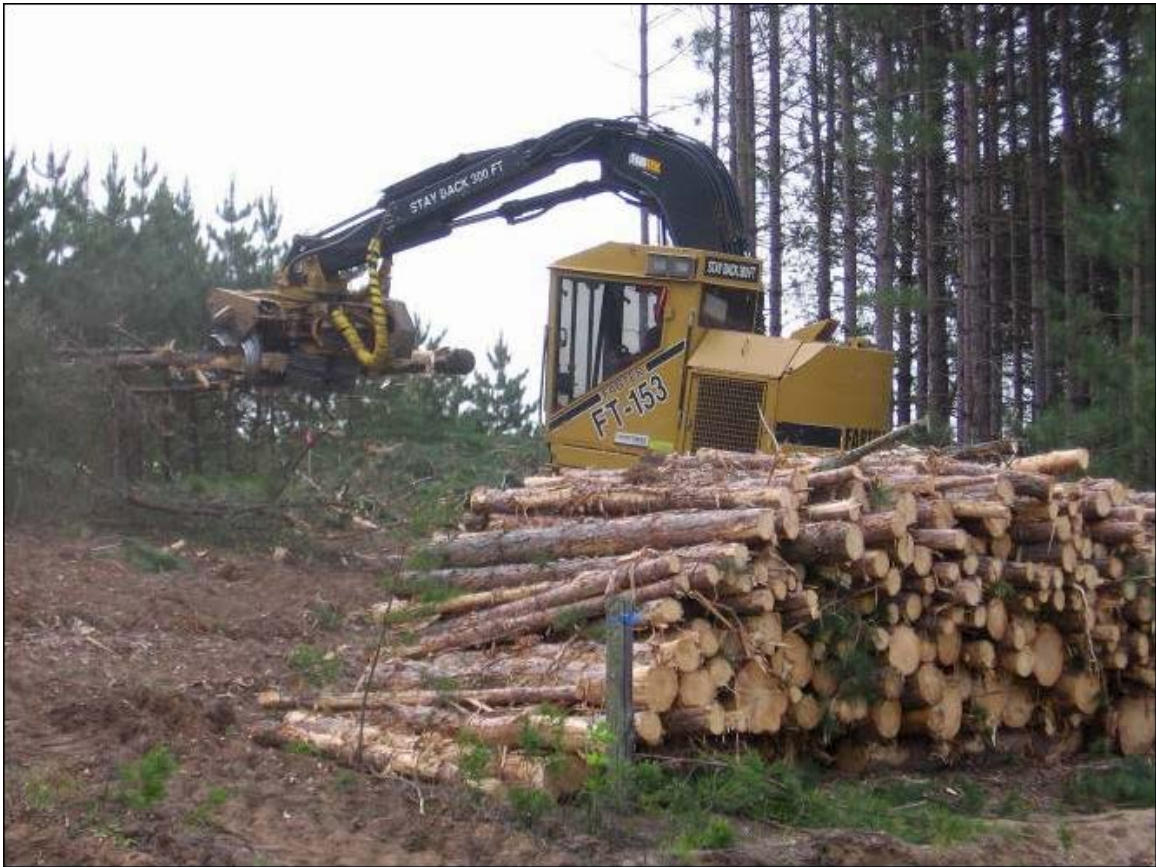
Figure Vol. 2-10 Tree processor used for clearing – capable of cutting a standing tree, de-limbing it, and sawing it into logs

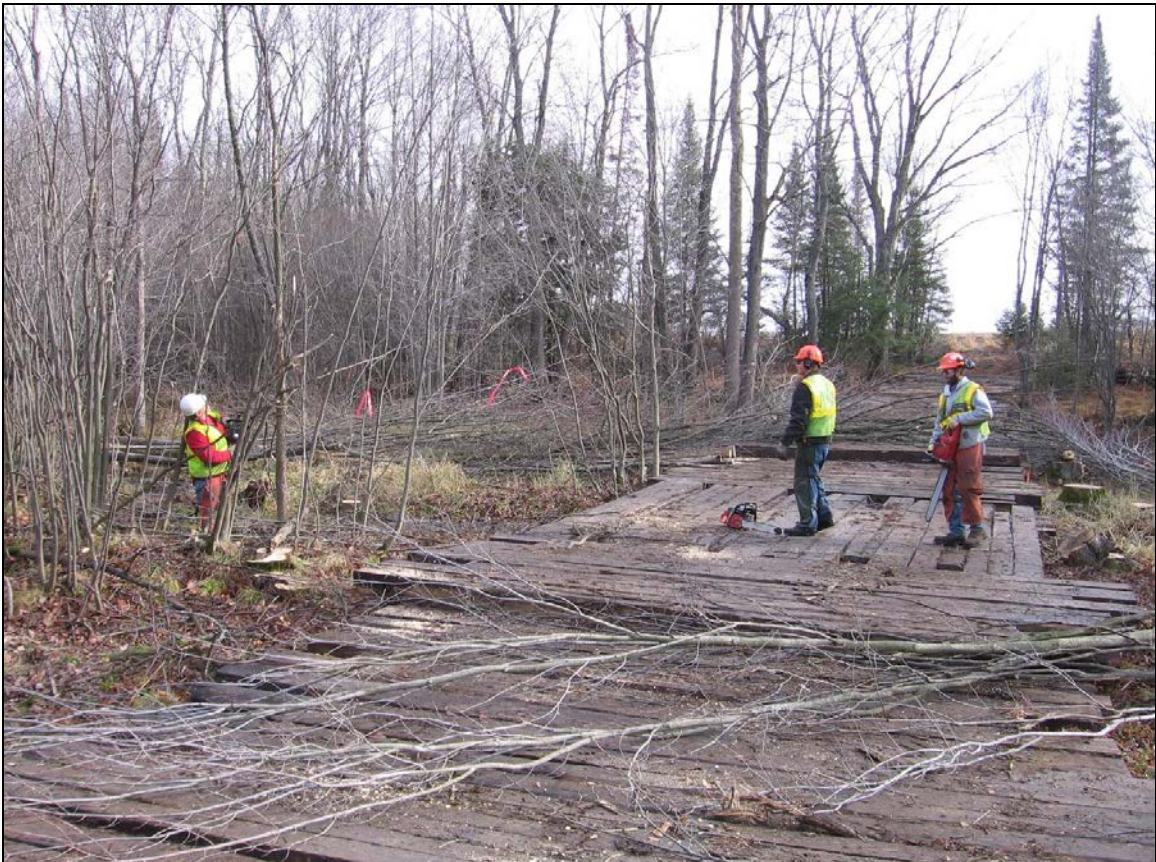
Figure Vol. 2-11 Hand-clearing along a flood channel

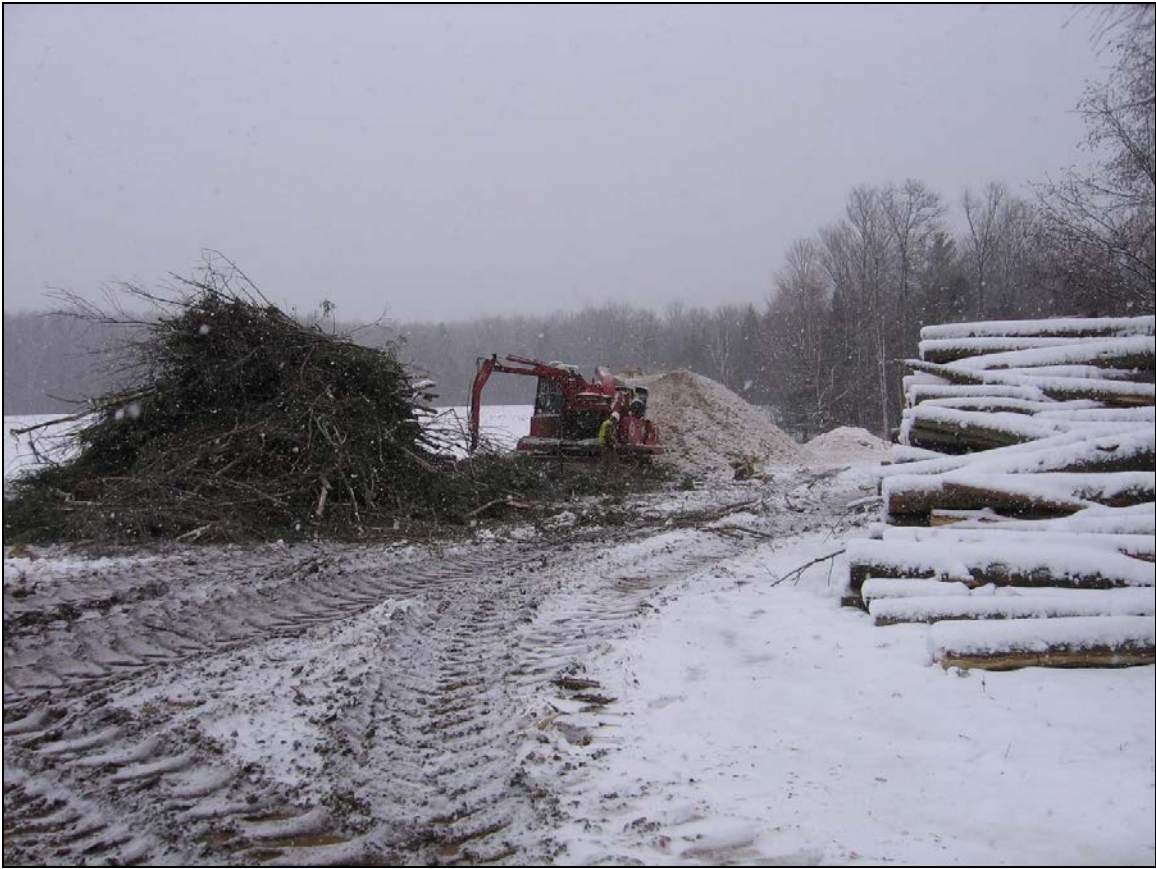
Figure Vol. 2-12 Chipping slash on upland ROW

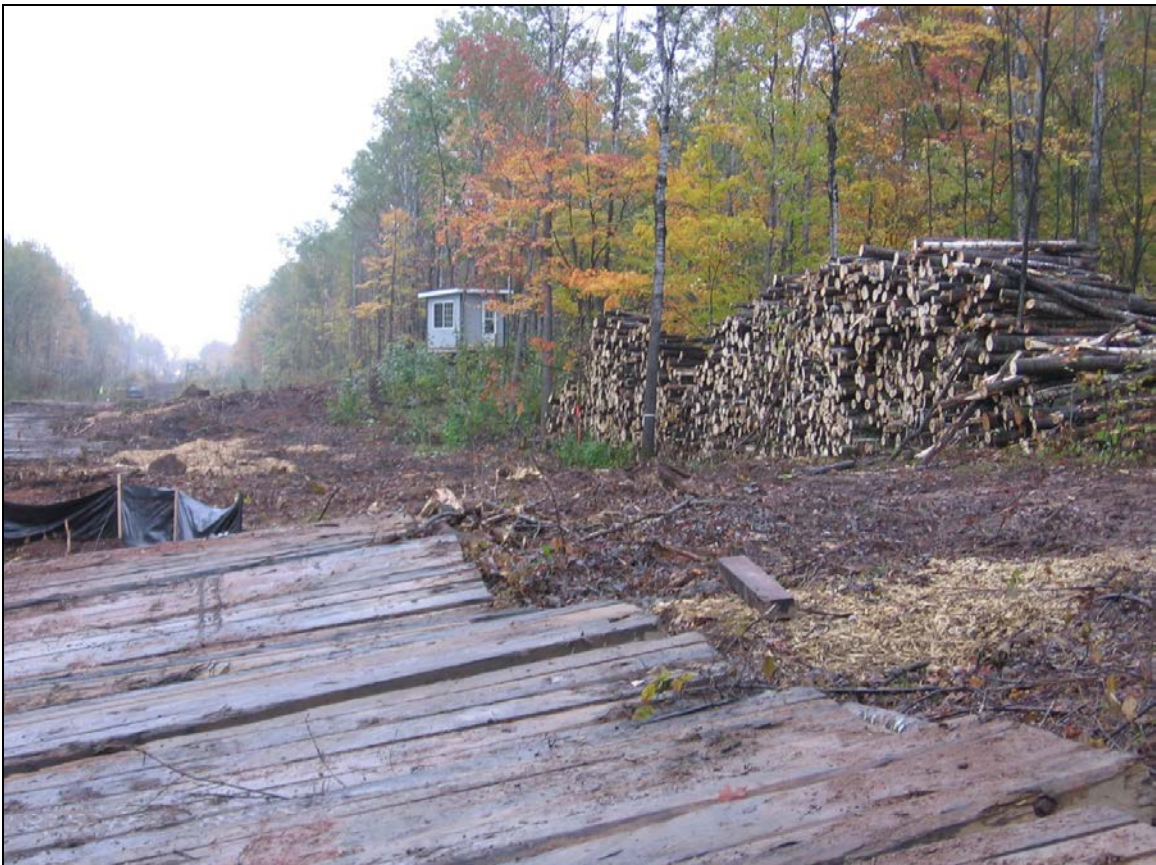
Figure Vol. 2-13 Timber piled on edge of ROW

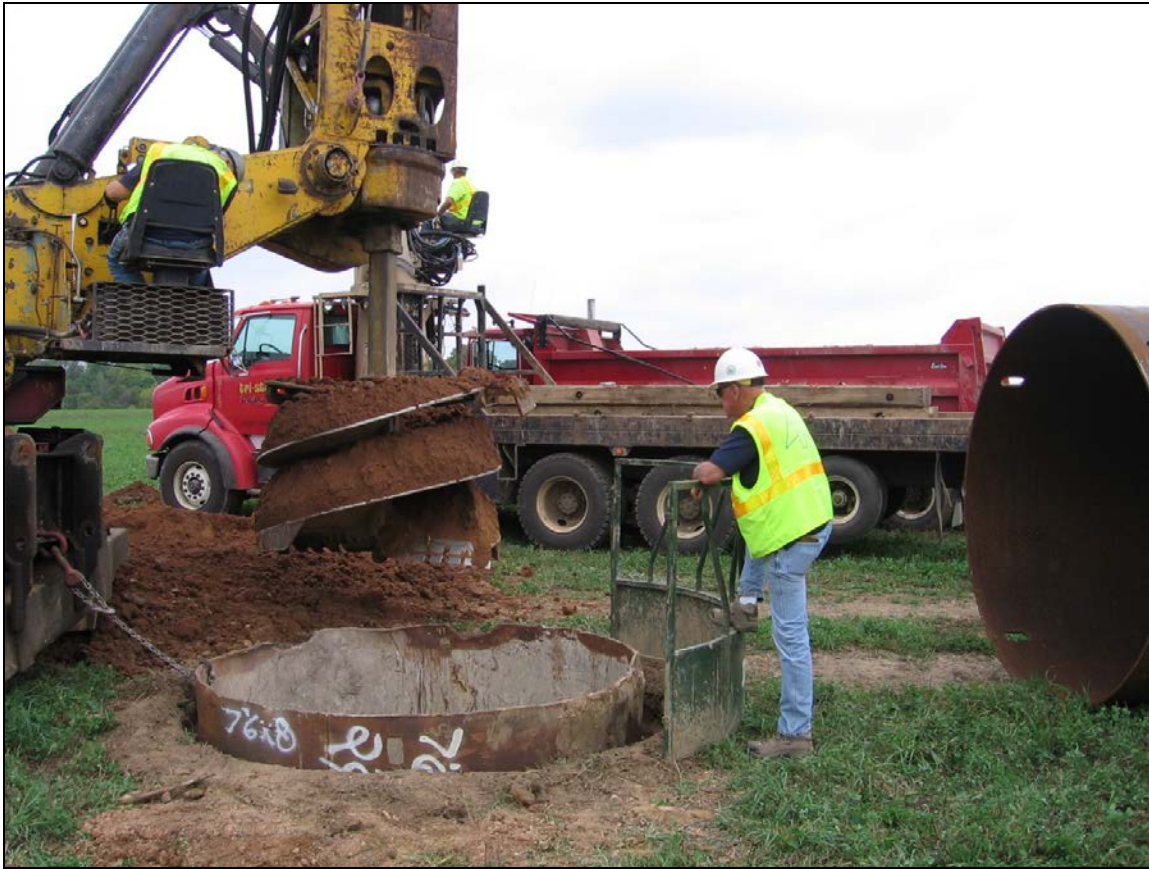
Figure Vol. 2-14 Augering a foundation excavation in dry upland soils

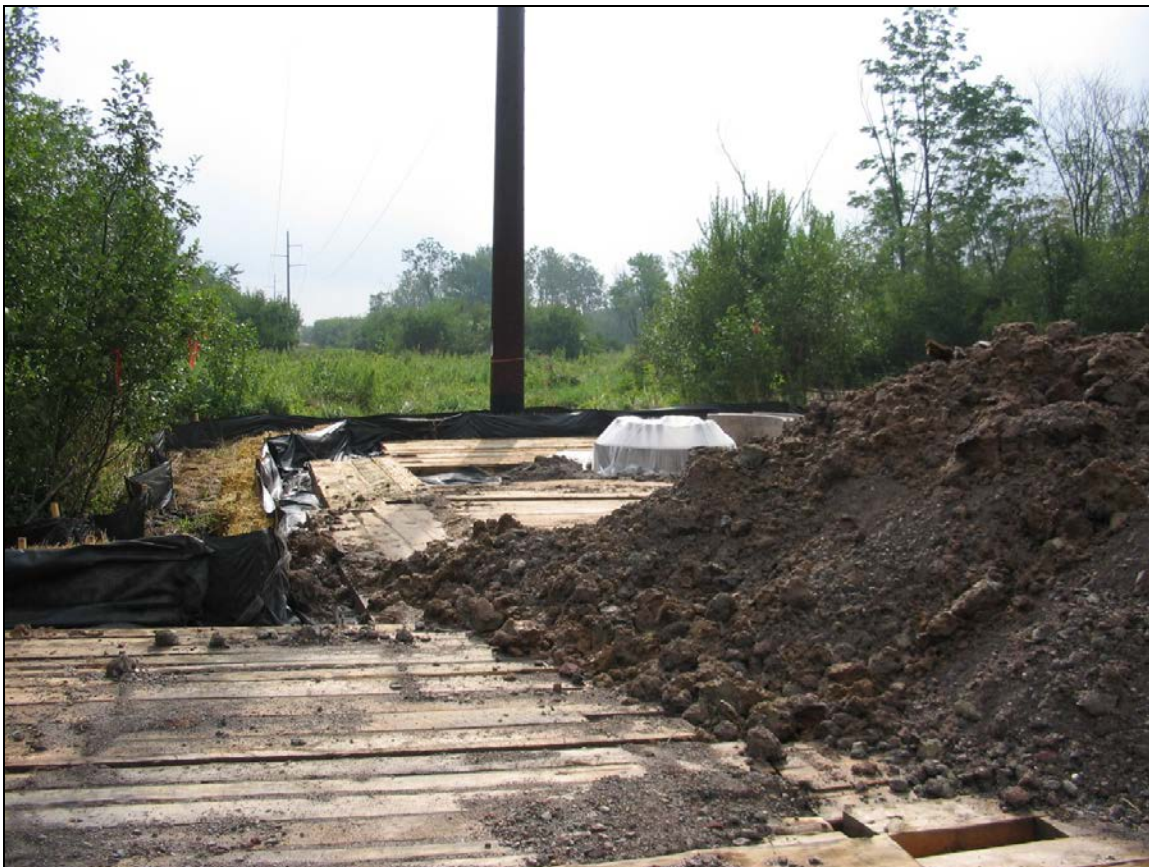
Figure Vol. 2-15 Structure location in wetland – matted work platform, foundation, spoil pile (to be removed), and erosion control

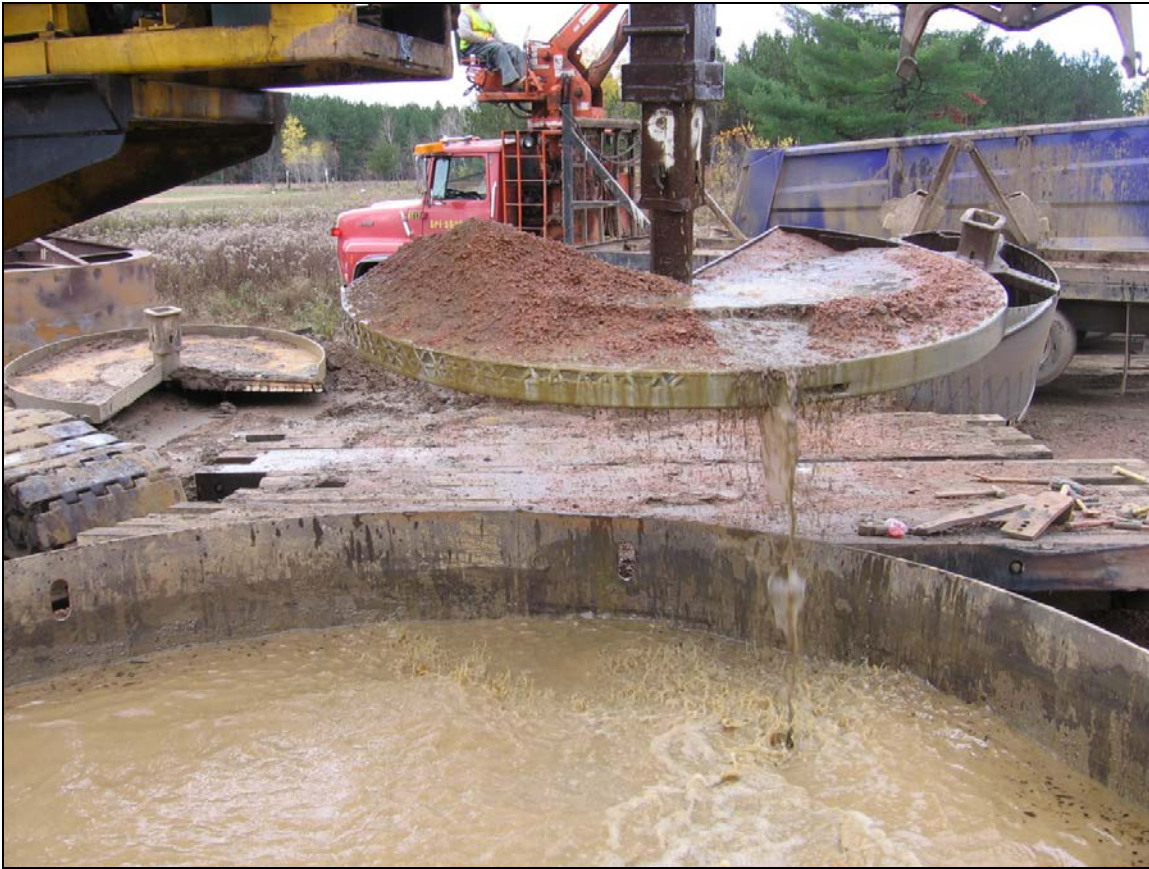
Figure Vol. 2-16 Augering in unconsolidated material (i.e gravel) – flooding of the excavation is necessary to prevent the sides from collapsing

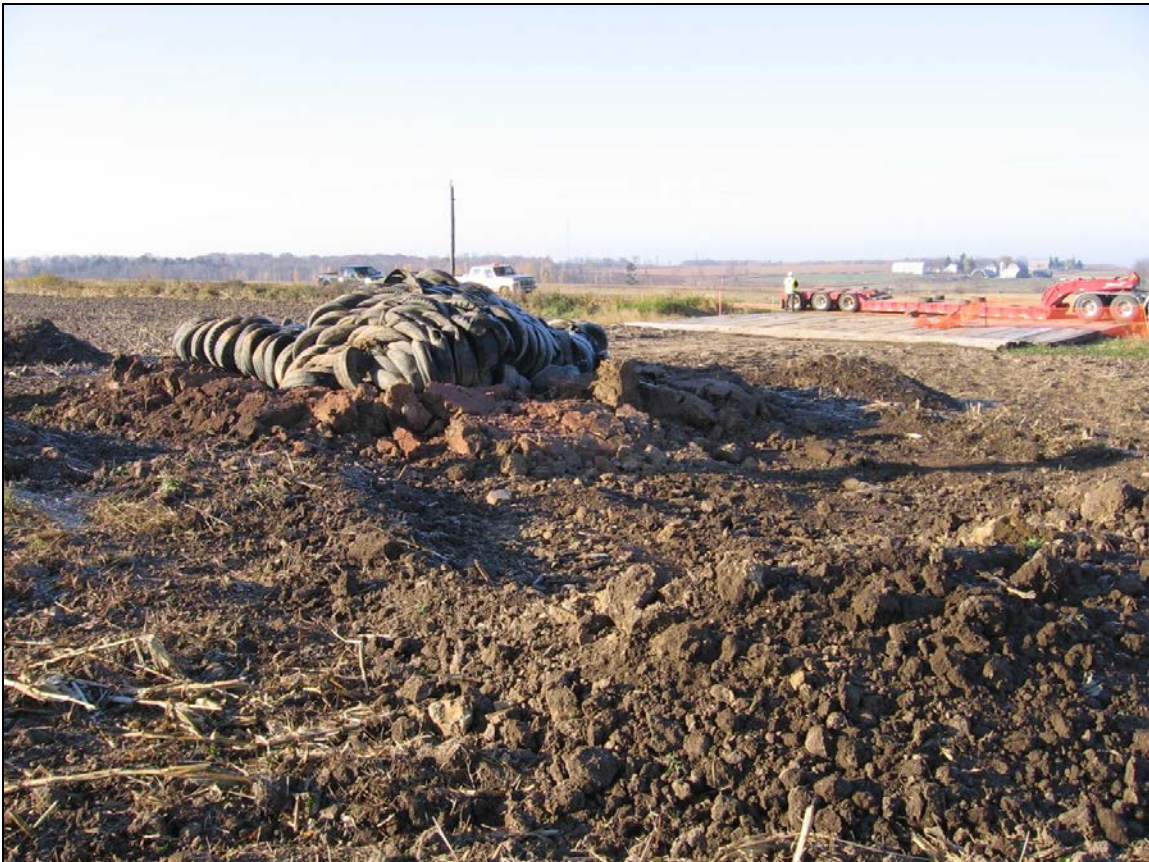
Figure Vol. 2-17 Prepared blast location – topsoil stripped and stockpiled off to side prior to blast and blasting mats in place

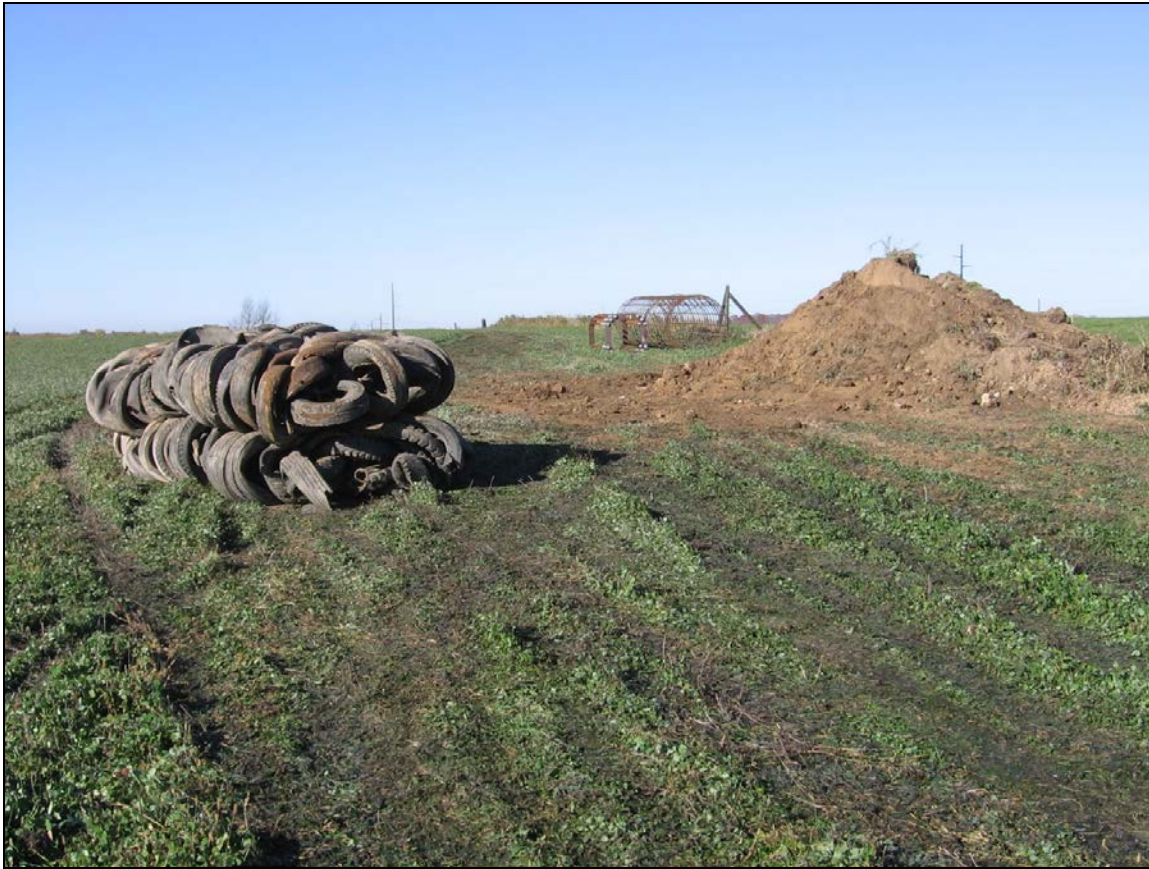
Figure Vol. 2-18 Blasting mats and post-blast soil/rubble pile

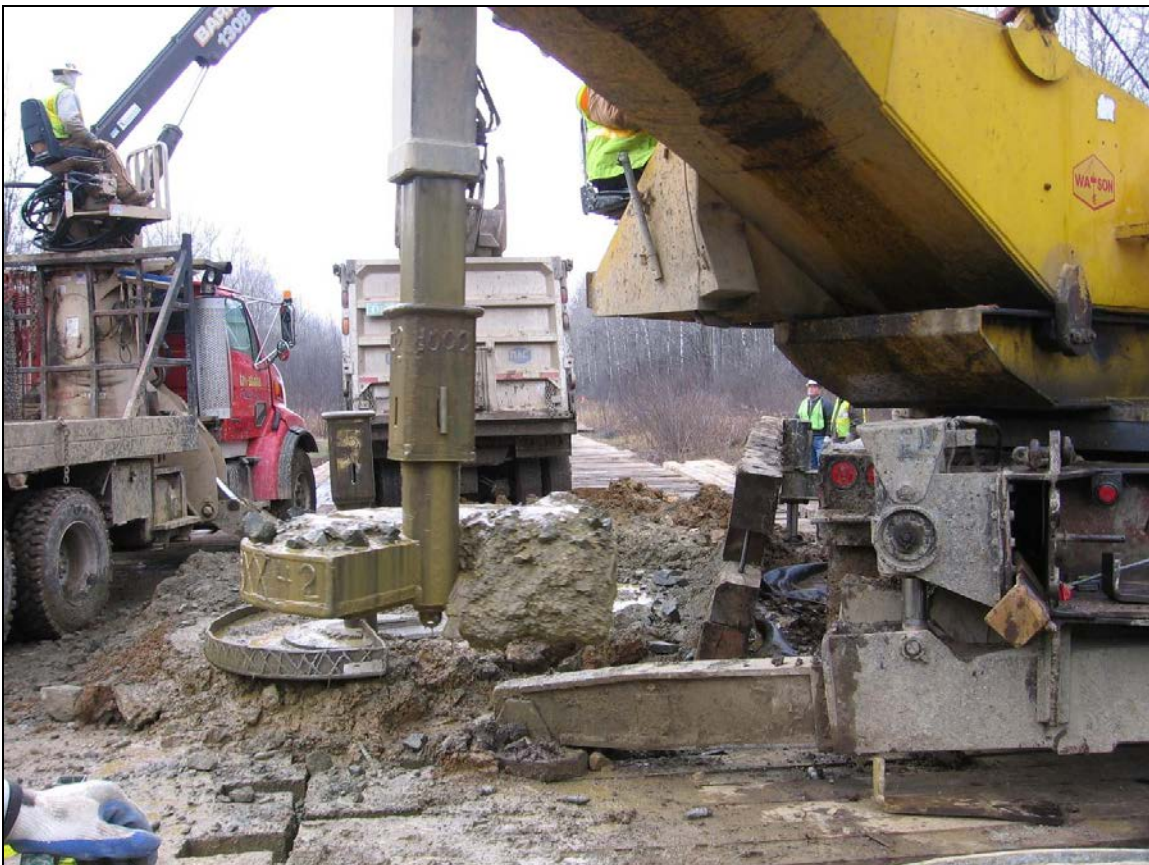
Figure Vol. 2-19 Augering rocky subsoils

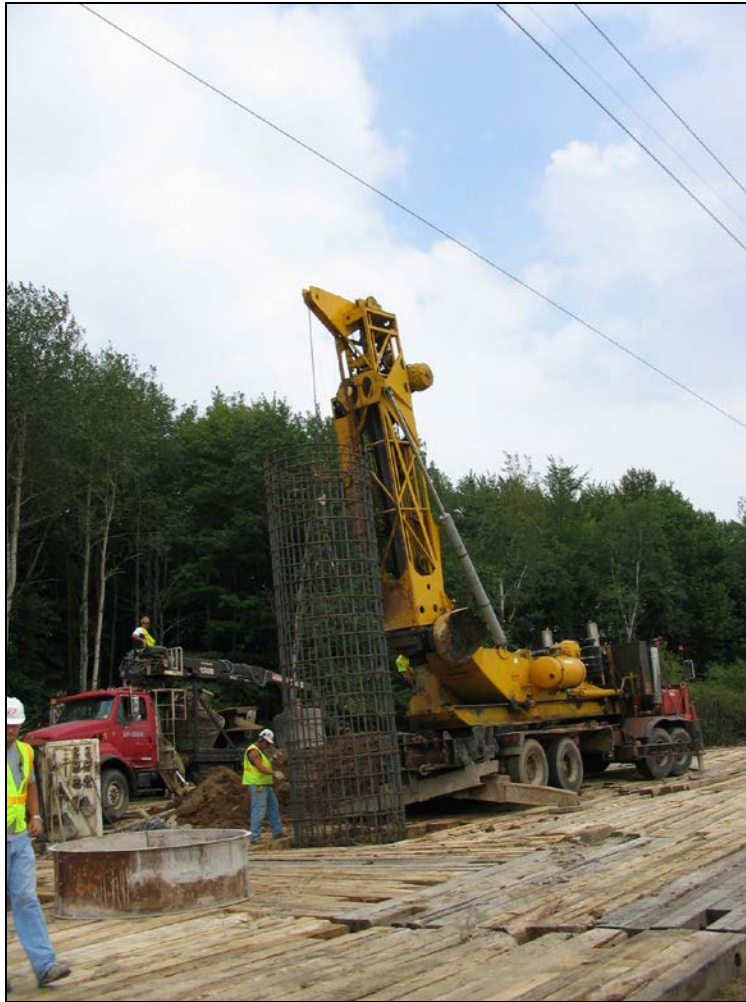
Figure Vol. 2-20 Placing foundation cage inside the excavated hole

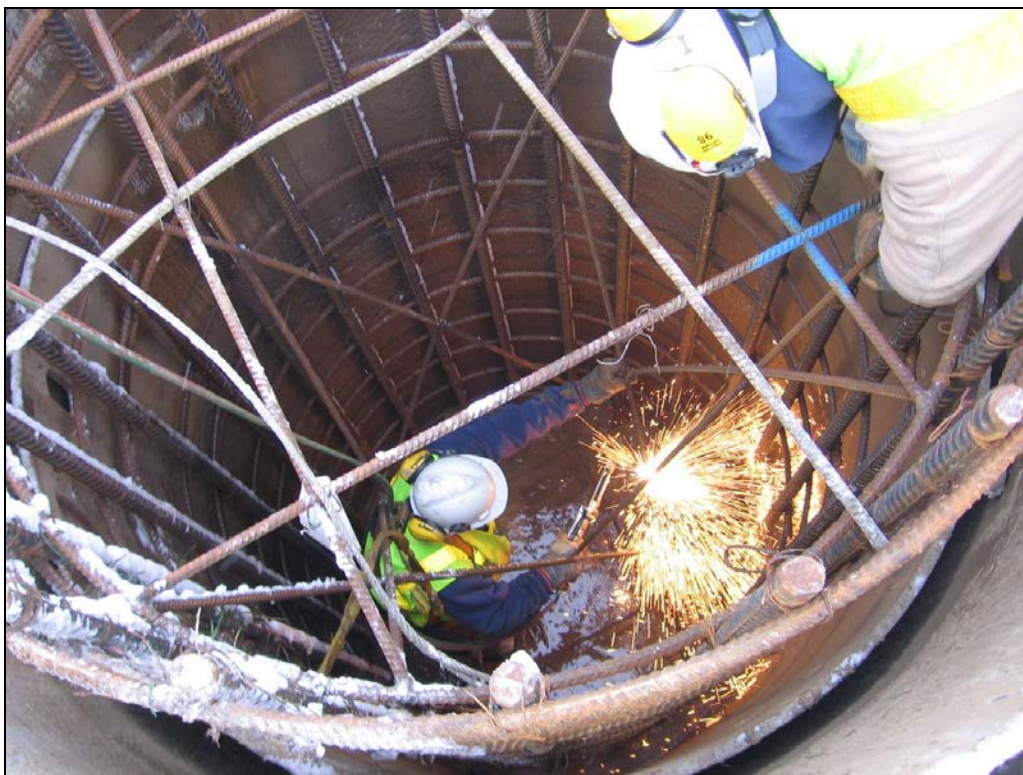
Figure Vol. 2-21 Final rebar work in preparation for concrete pour

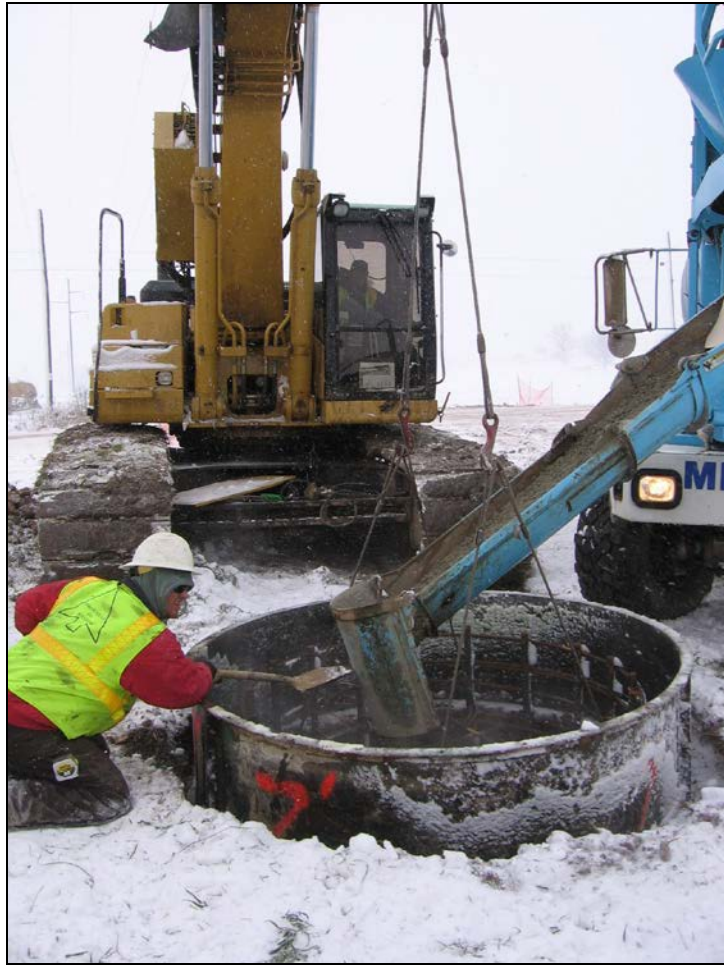
Figure Vol. 2-22 Pouring the concrete foundation

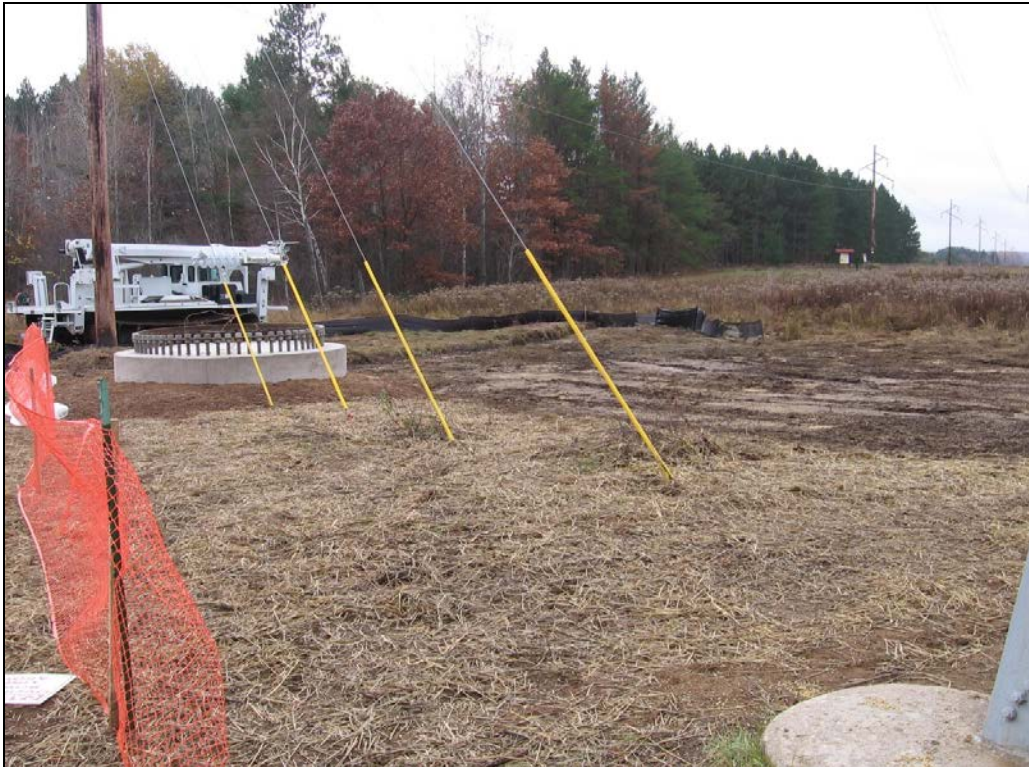
Figure Vol. 2-23 Completed foundation after initial cleanup

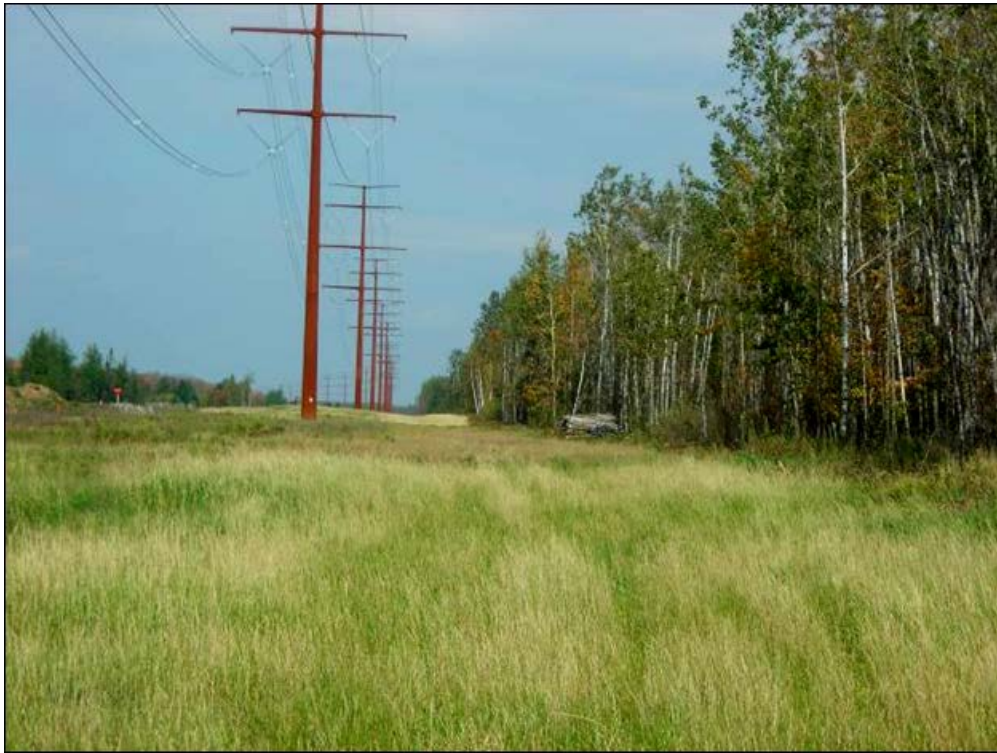
Figure Vol. 2-24 Upland ROW seeded with oats and rye grass for quick soil stabilization while native vegetation re-establishes

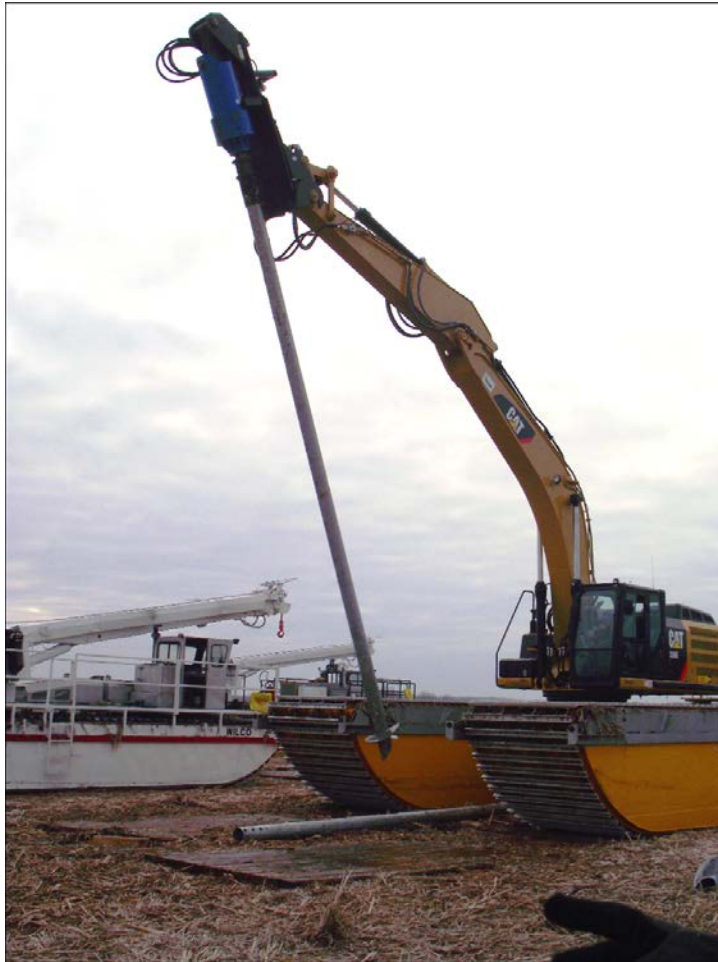
Figure Vol. 2-26 Installation of a helical pier foundation in a wetland with a marsh buggy

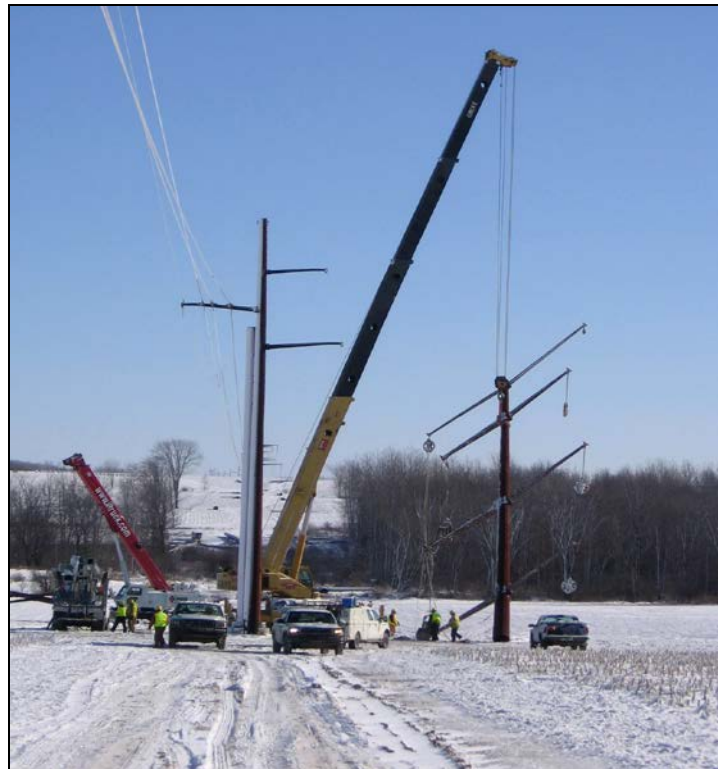
Figure Vol. 2-27 Installing the top section of the tower

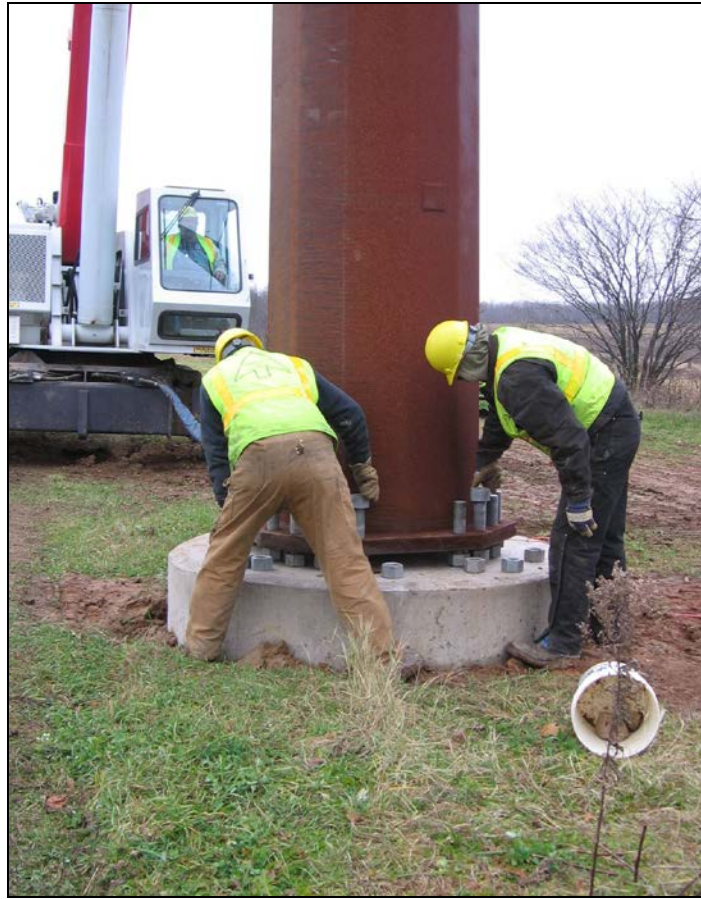
Figure Vol. 2-28 Bolting tower to concrete foundation

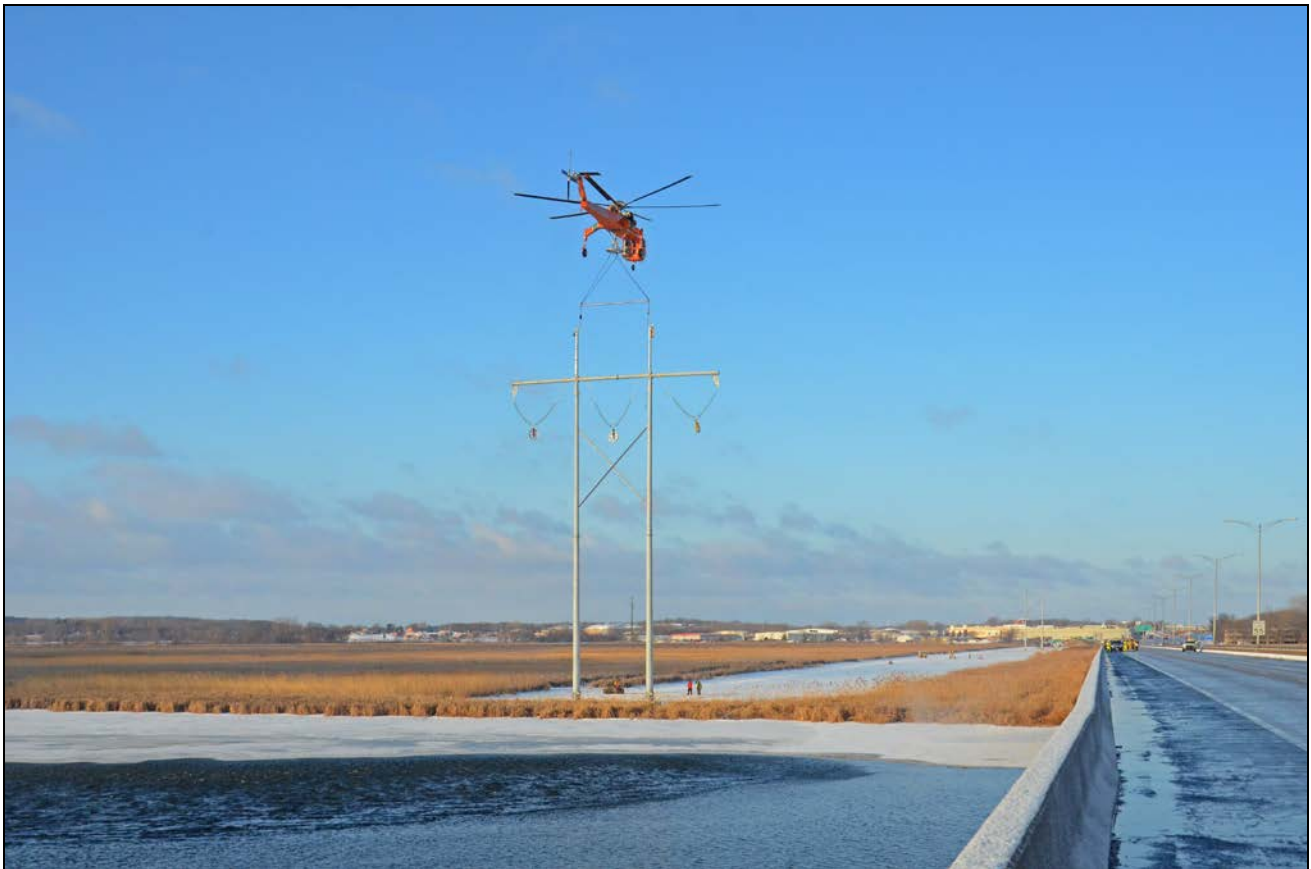
Figure Vol. 2-29 Helicopter setting tower on foundation

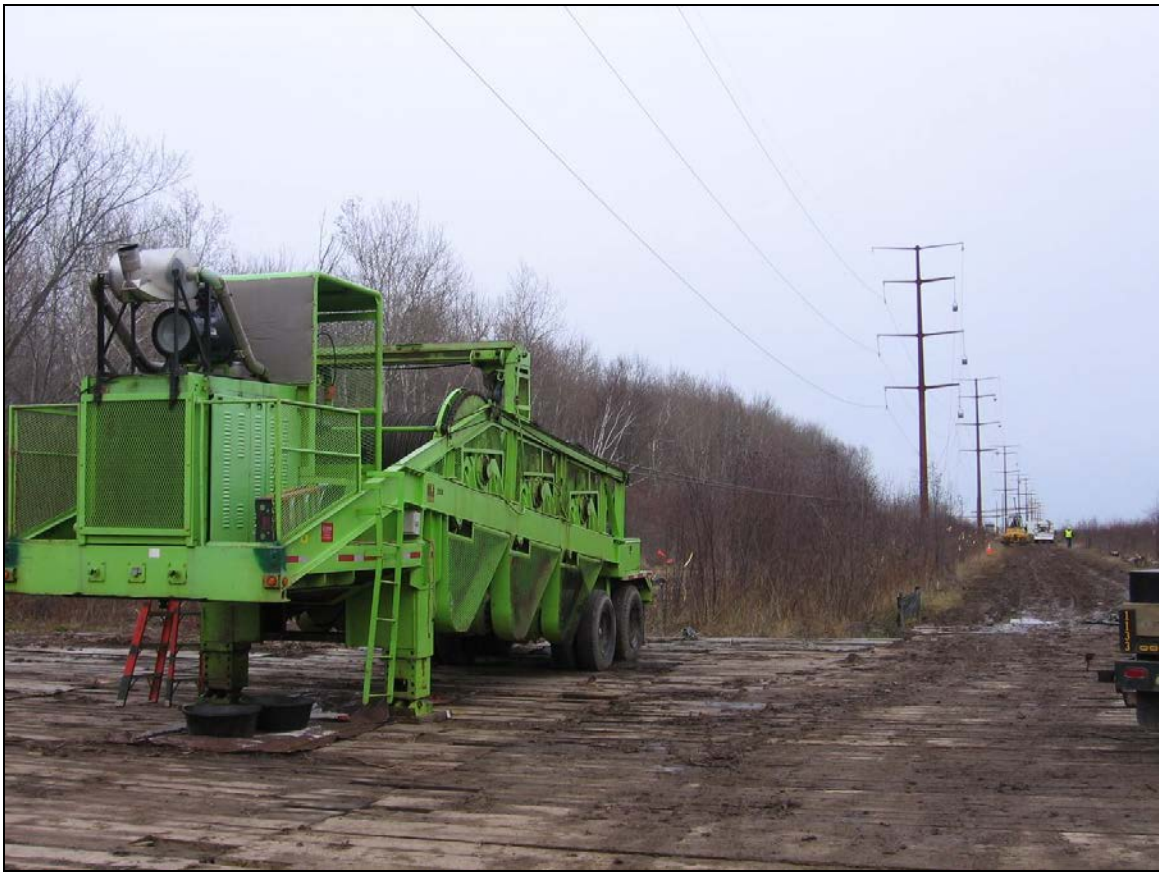
Figure Vol. 2-30 Pulling cable through structure arms

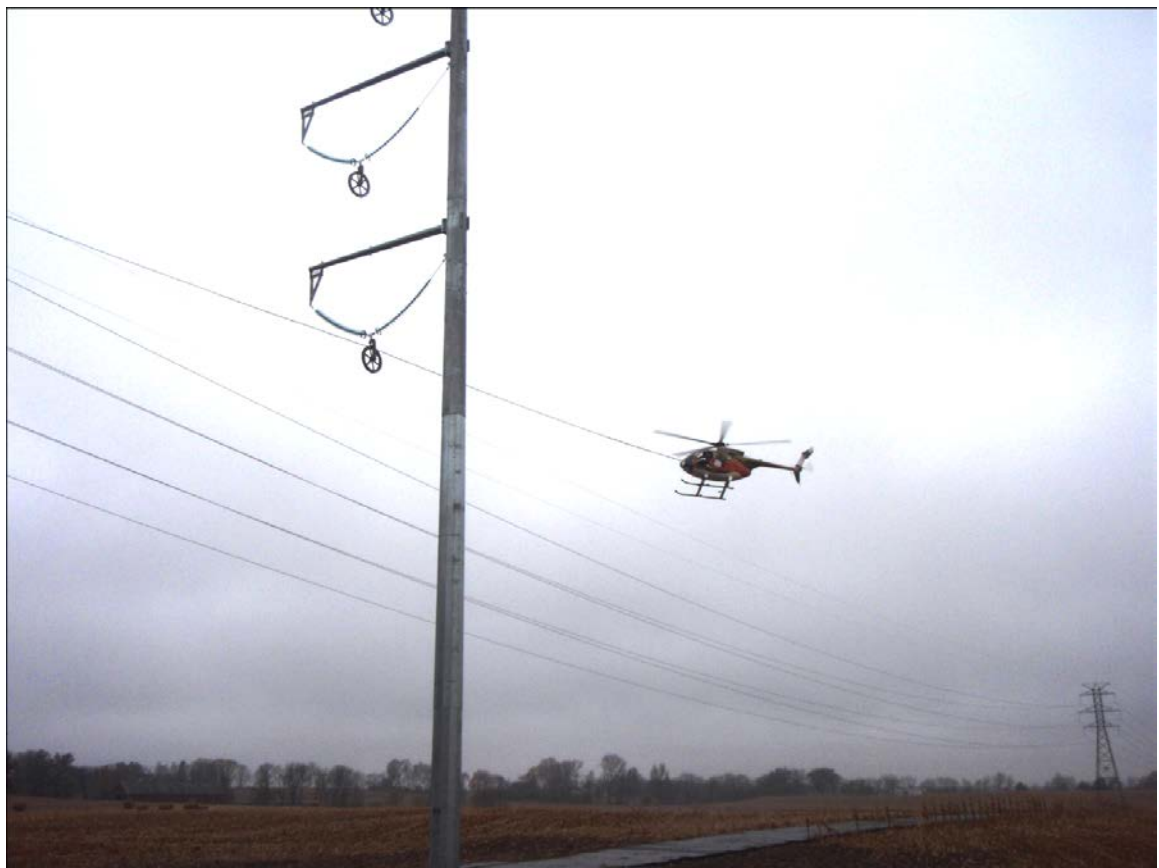
Figure Vol. 2-31 Wire stringing with a helicopter

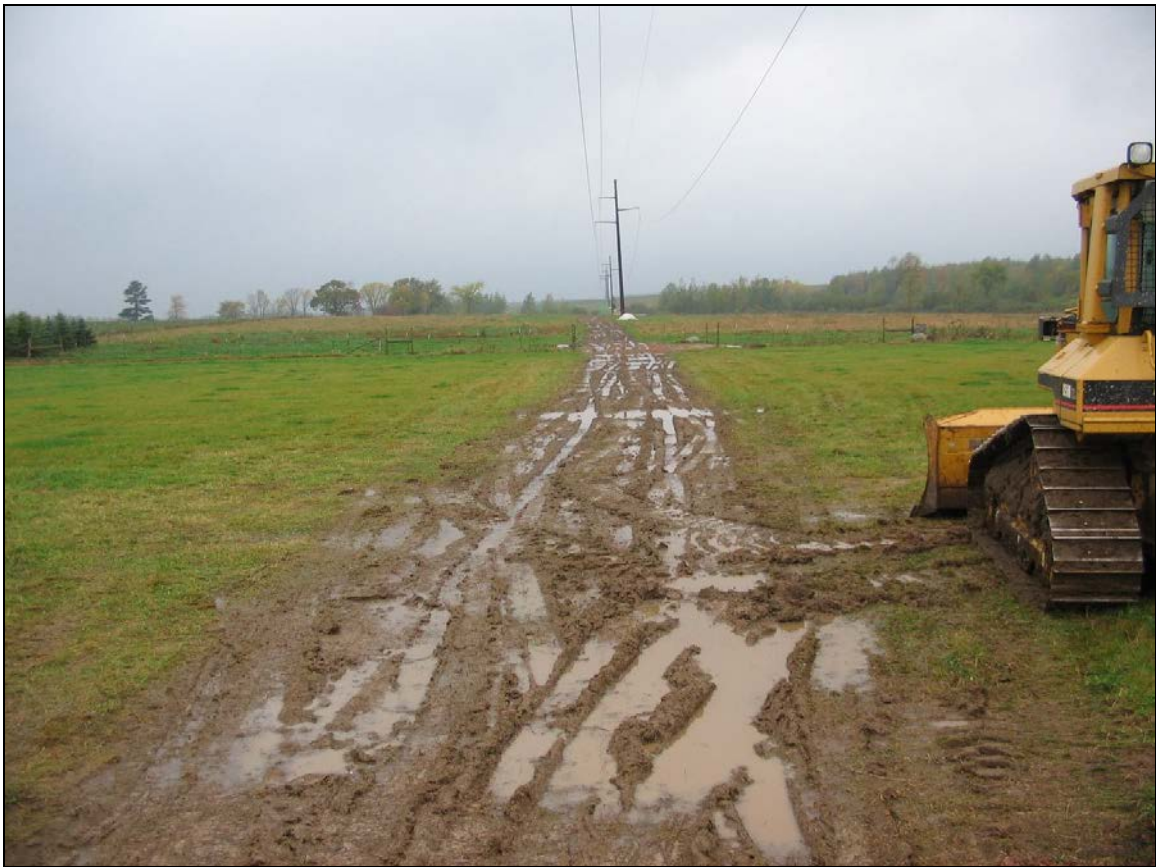
Figure Vol. 2-32 Minor soil rutting in pasture land

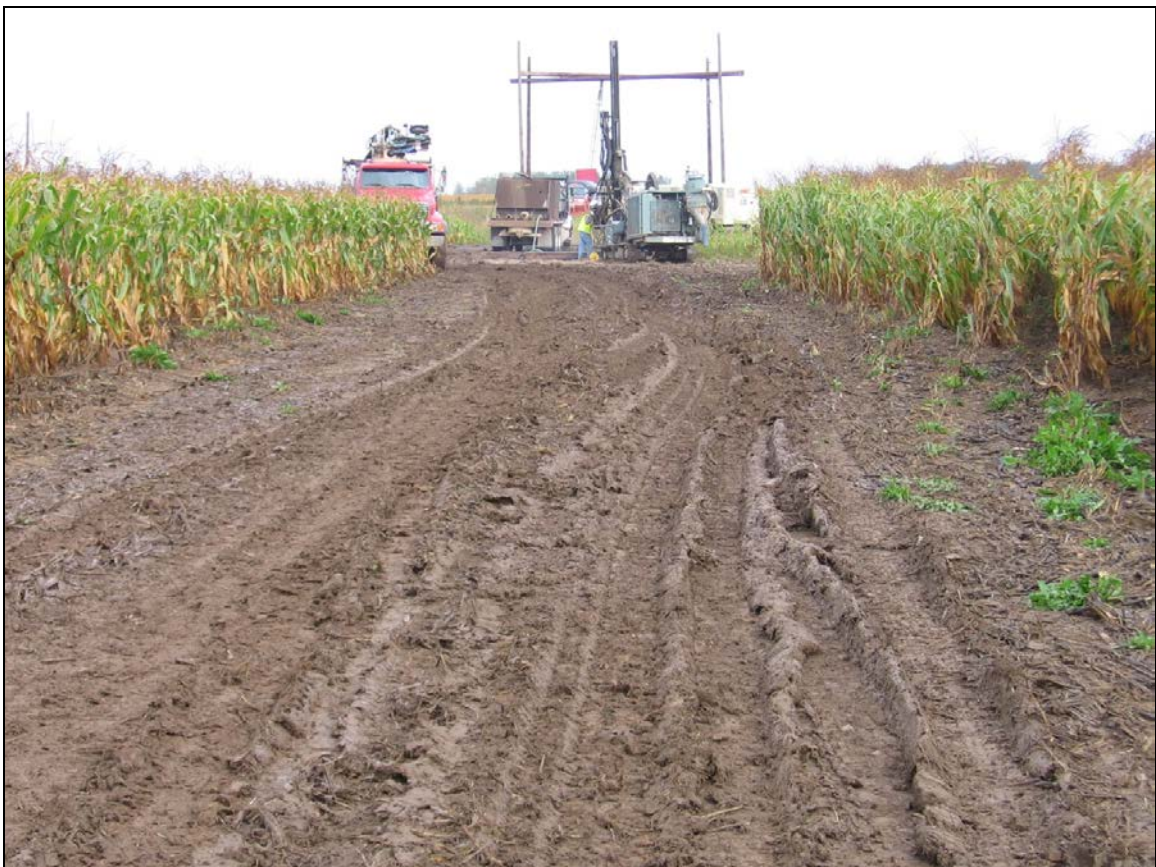
Figure Vol. 2-33 Rutting of topsoil in cropland – no soil mixing
