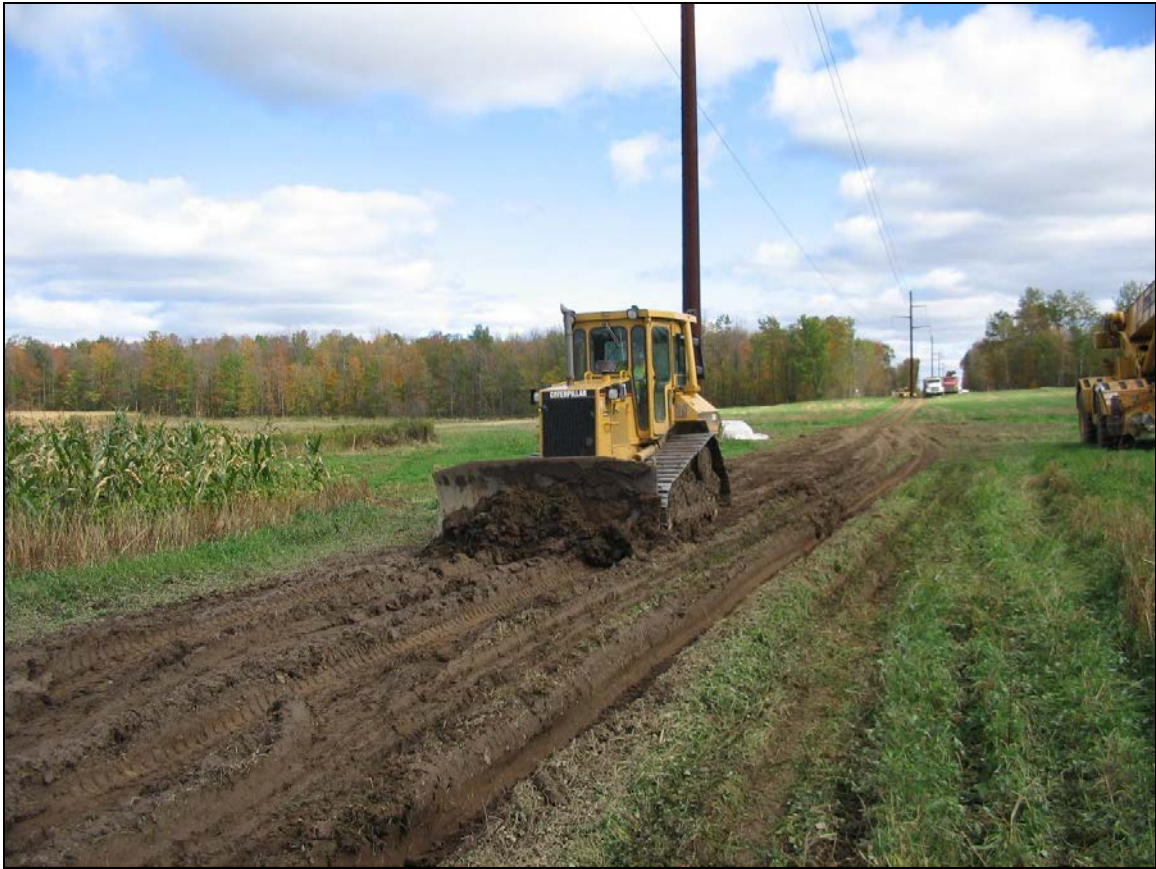
Figure Vol. 2-34 Ruts being smoothed with blade

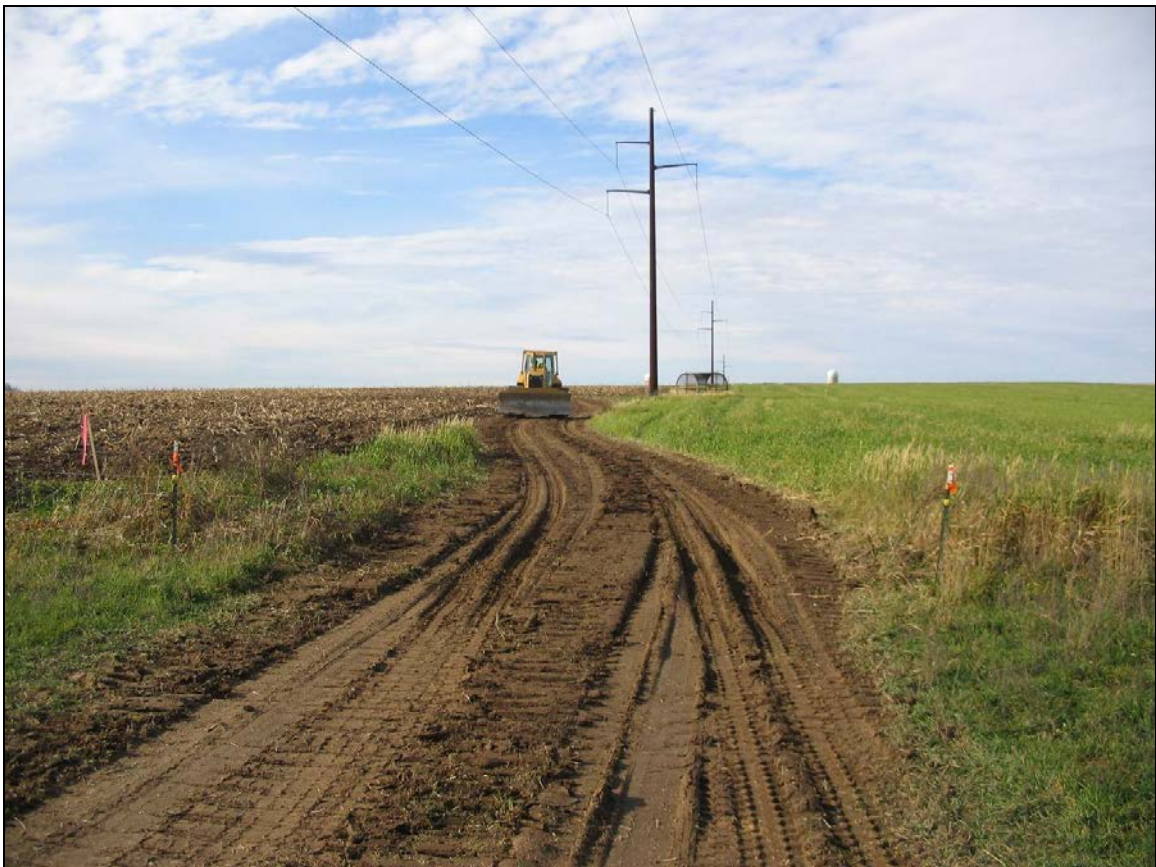
Figure Vol. 2-35 Smoothing out ruts by backblading with a dozer

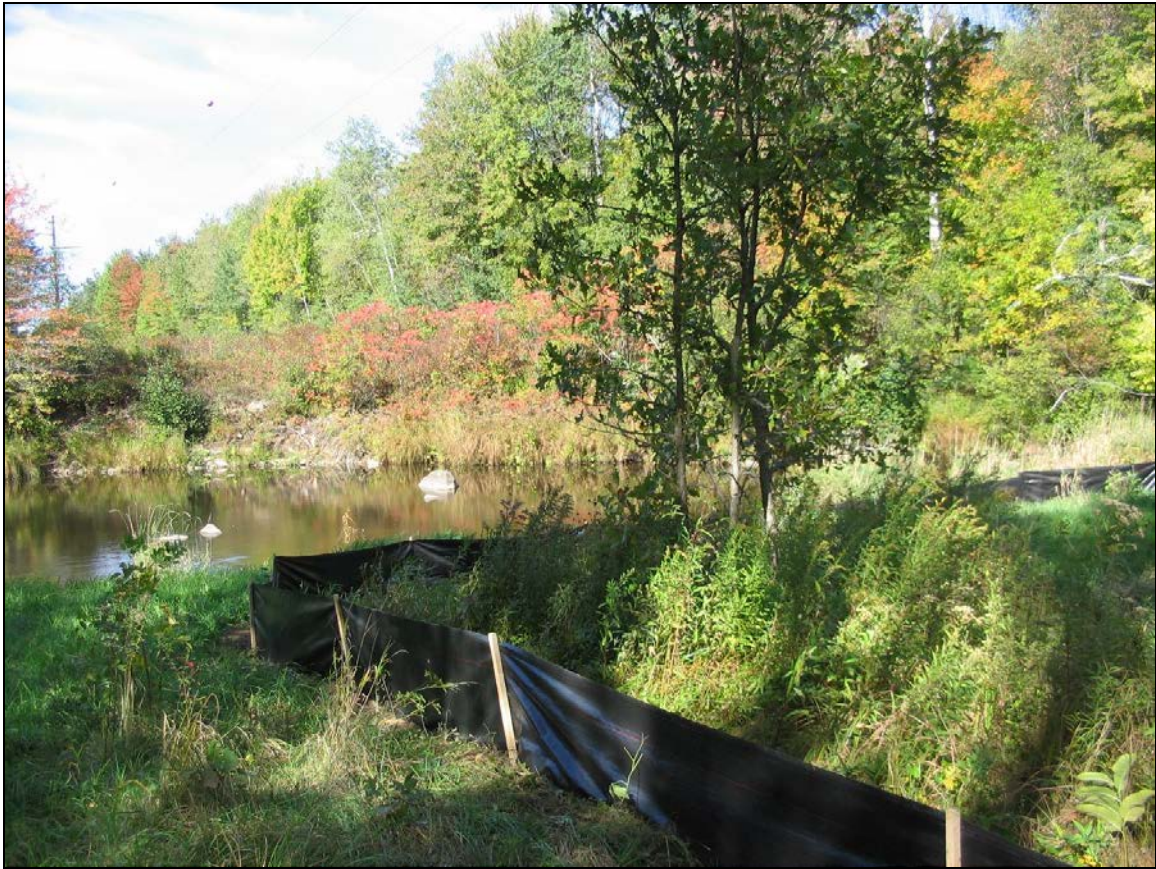
Figure Vol. 2-36 Turtle exclusion fence

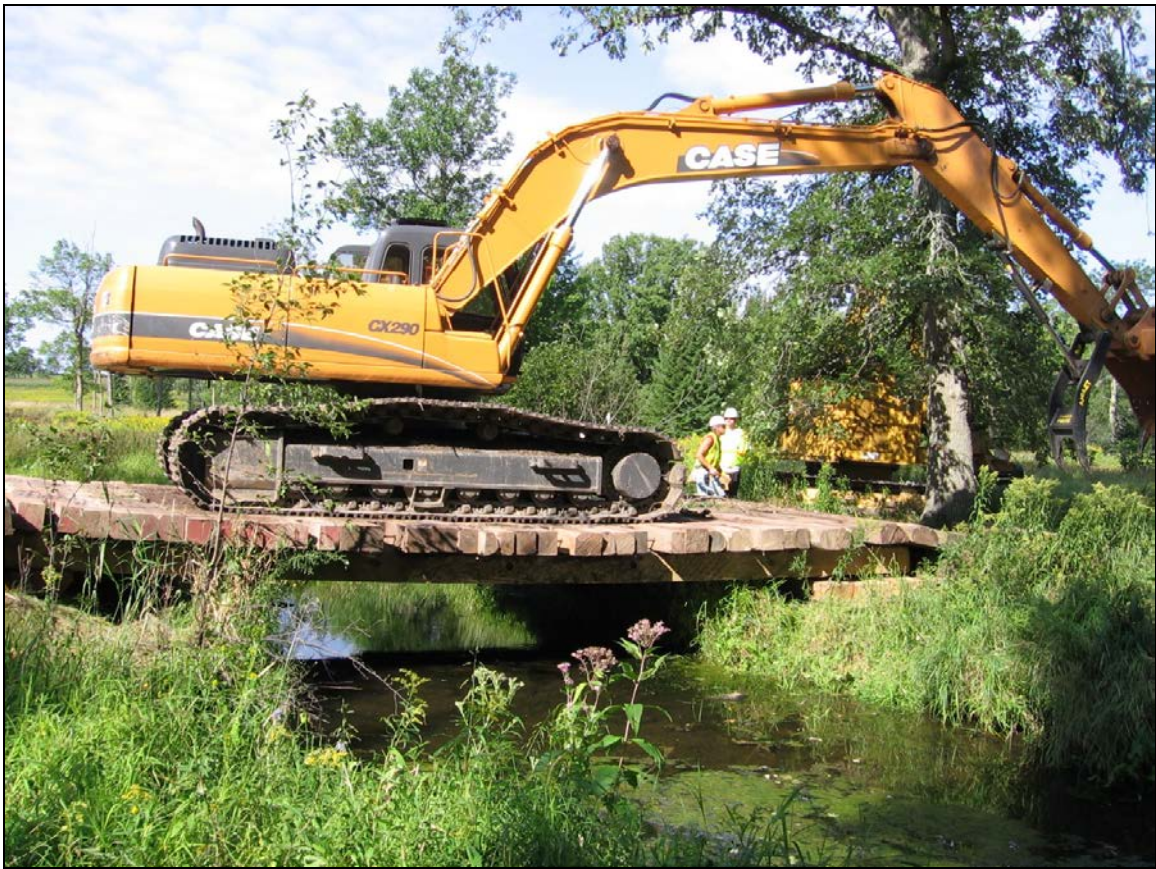
Figure Vol. 2-38 Timber mat equipment bridge at stream crossing

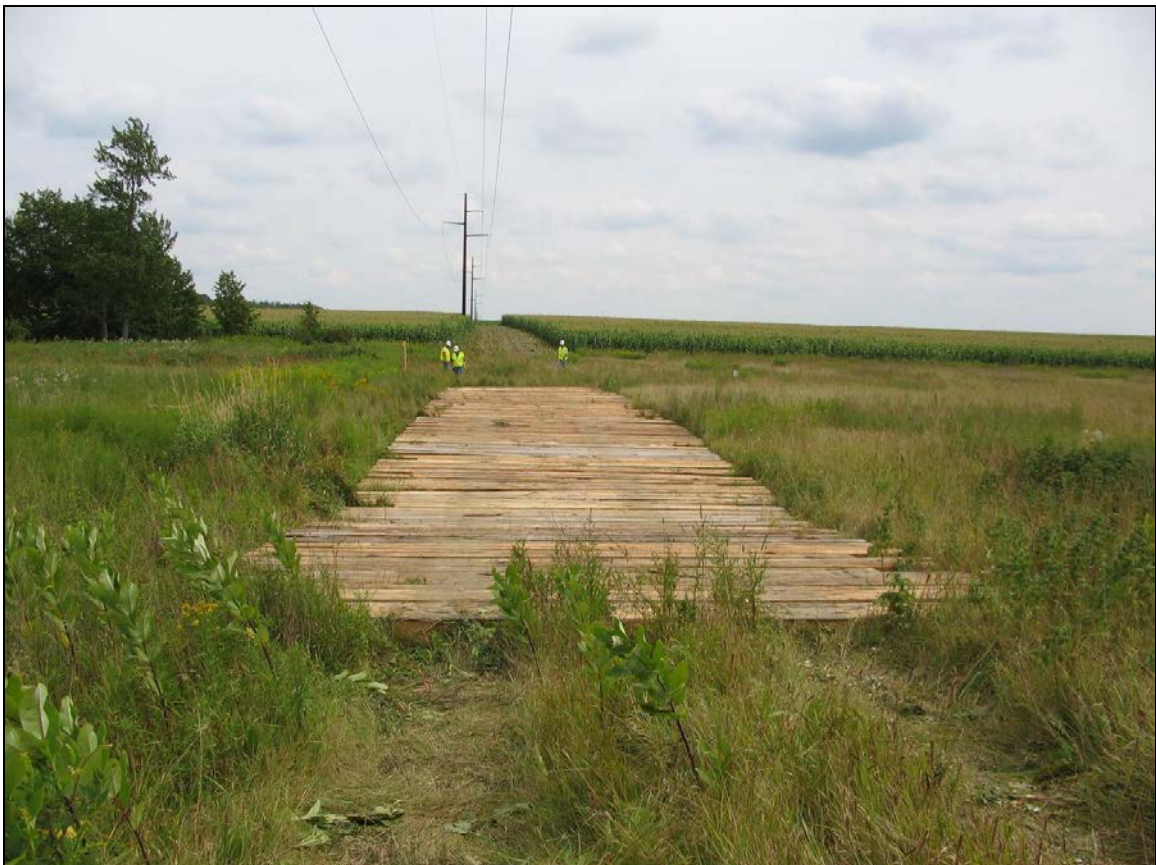
Figure Vol. 2-39 Mats in wet meadow

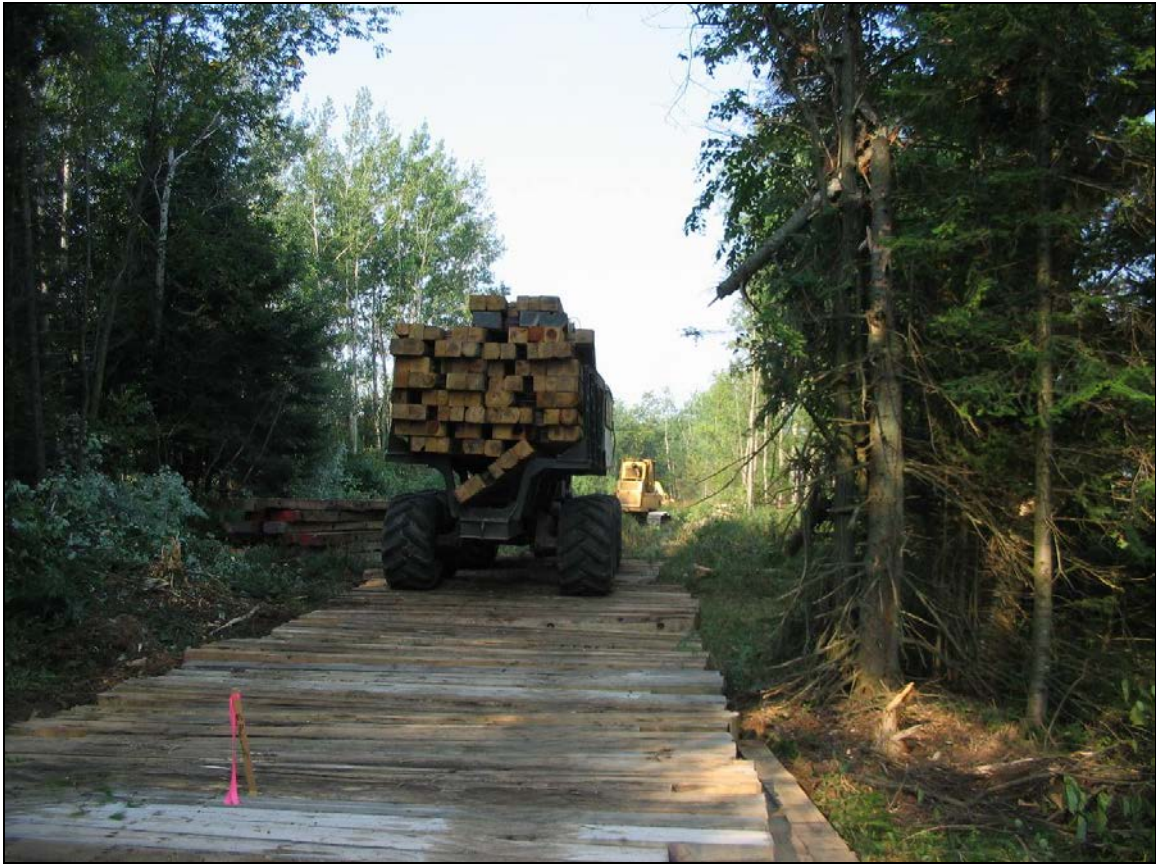
Figure Vol. 2-40 Timber mats being placed in wooded wetland
