Wisconsin Incidents 1986-Present

Wisconsin Pipeline Safety Seminar

February 9th, 2024

Public Service Commission of Wisconsin

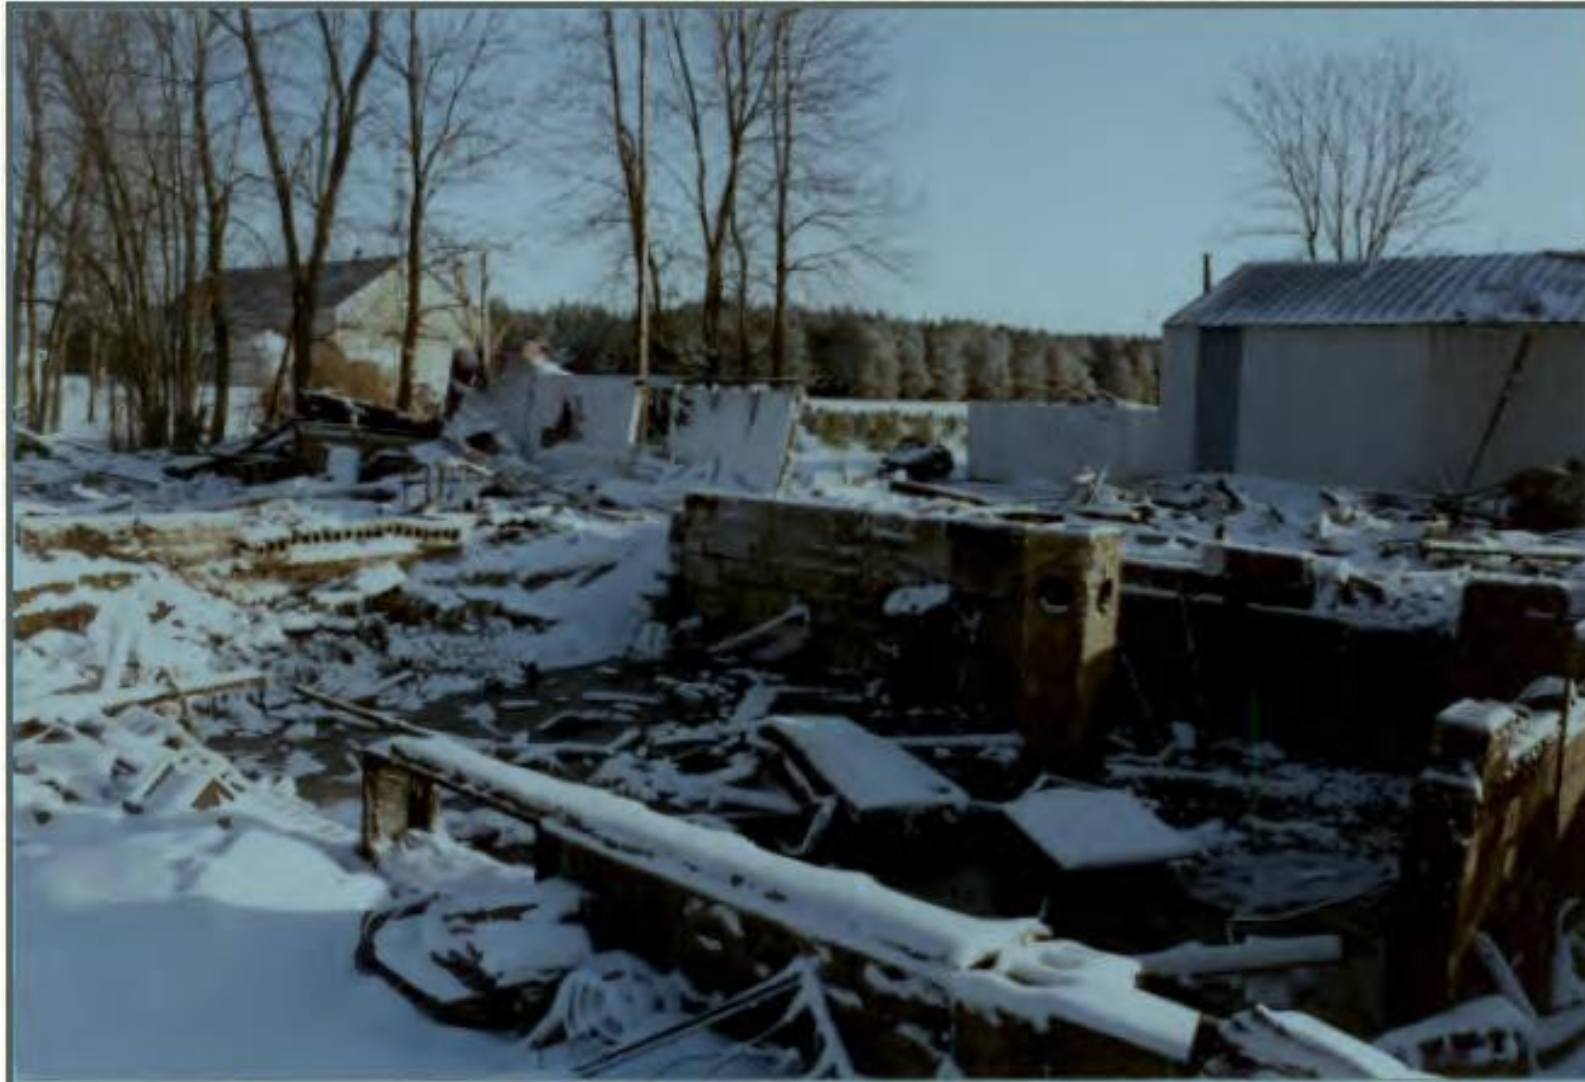
Harrison Excavation Damage

- Telecommunications company contractor
- Boring alongside 2" PE (50psi) main
- Crew called utility after smelling gas
- Utility crew arrived and explosion occurred shortly after

- No Fatalities
- Damage exceeded \$150,000
- Boring head accidentally veered into pipe, ripping through a 5 ft length
- 30" frost cap made the service to the home the path of least resistance
- Main was properly remarked the morning of the incident

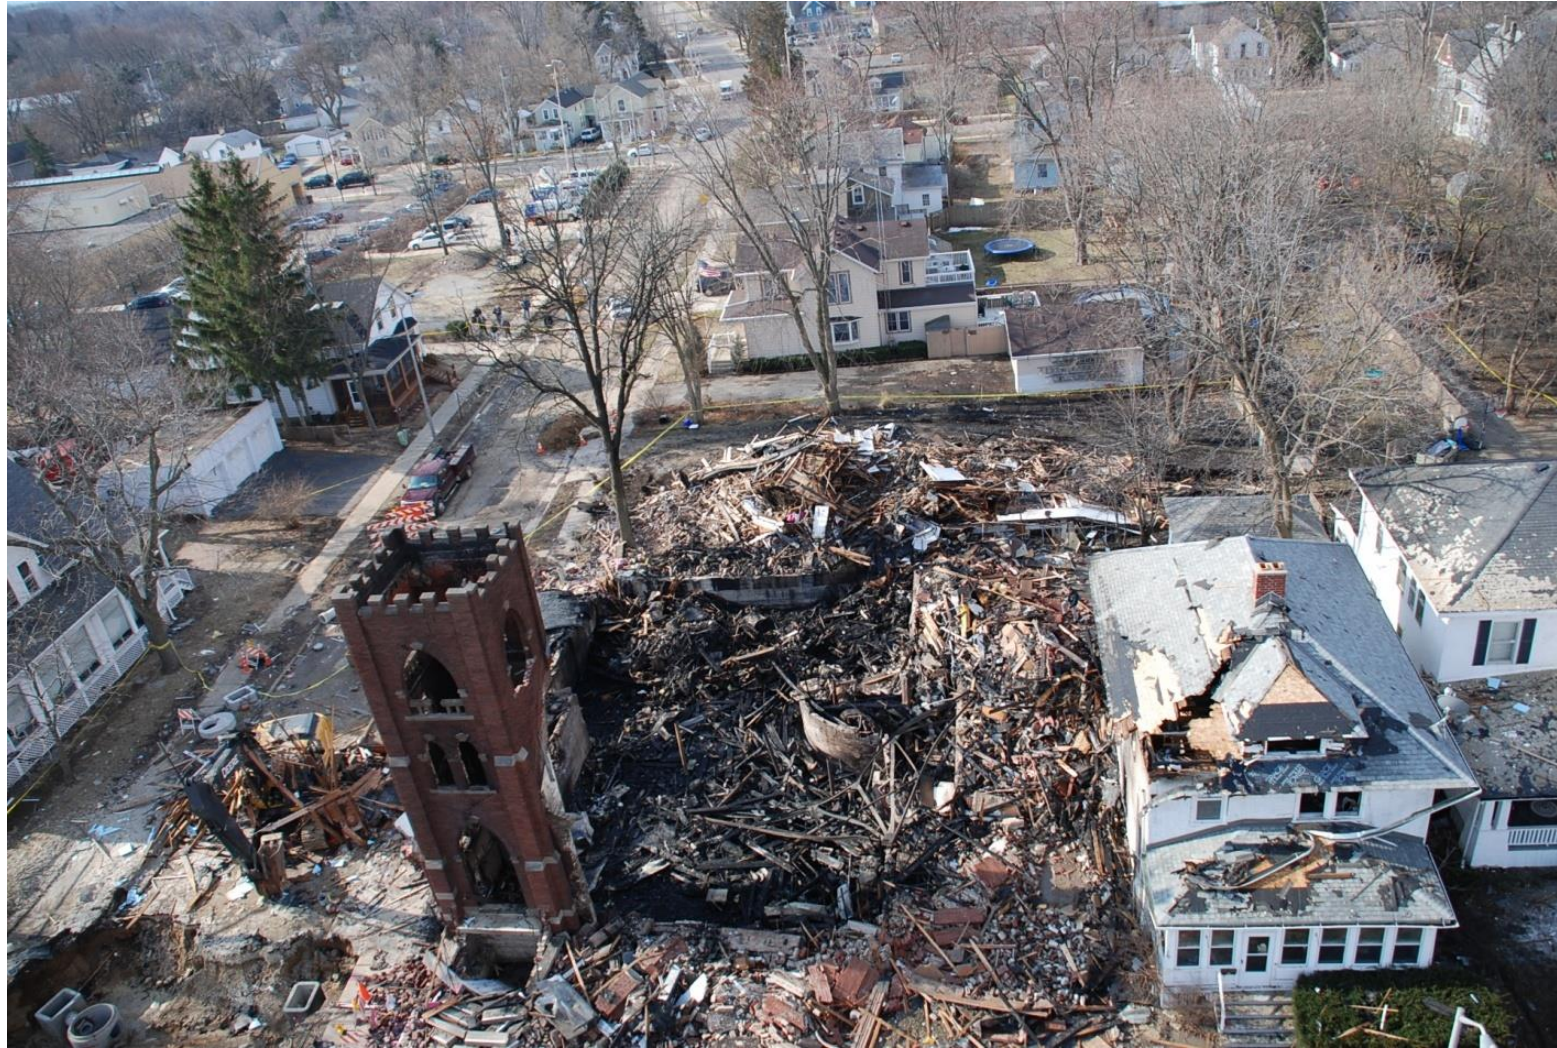
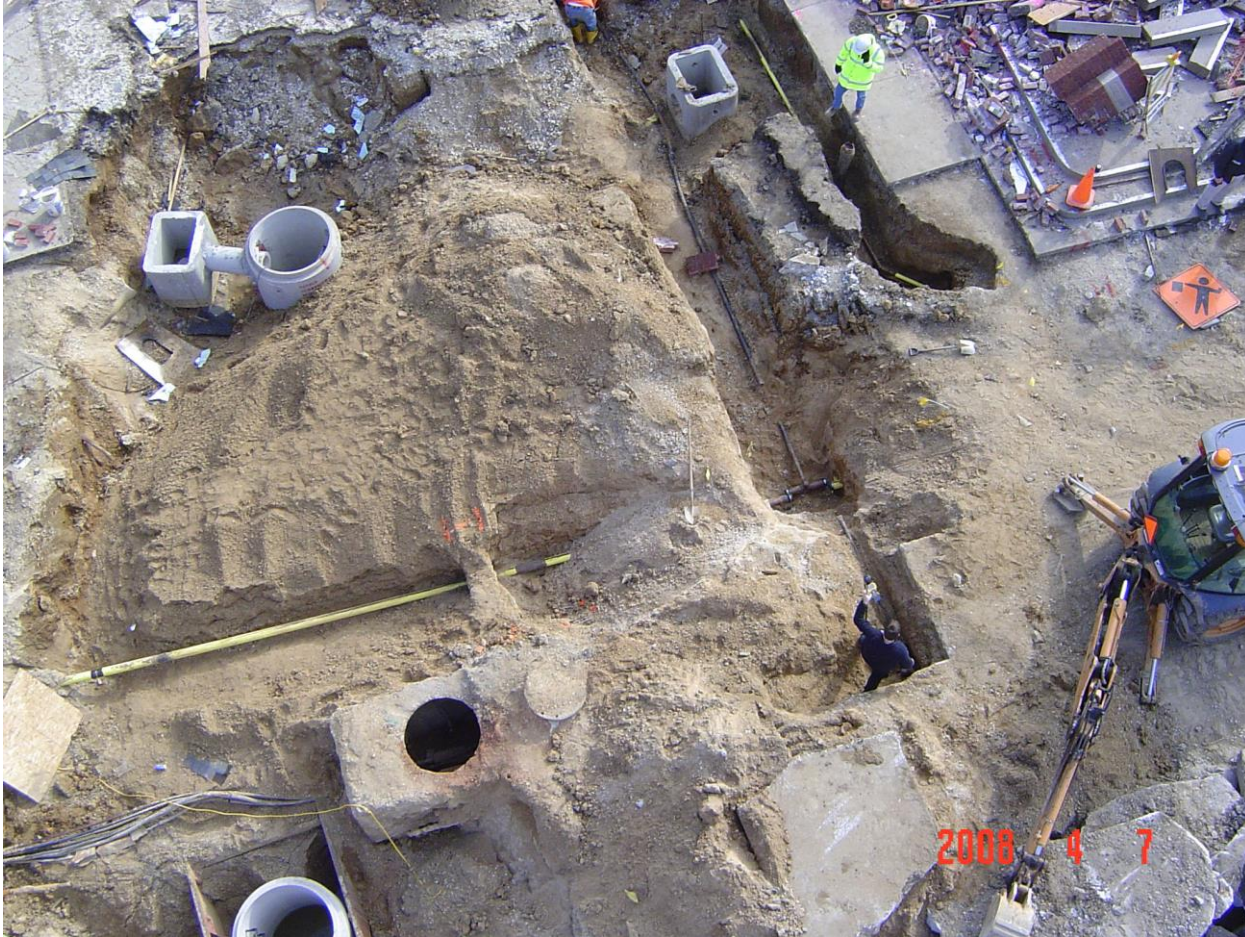
Oconomowoc Excavation Damage

- Sewer contractor installing concrete catch basin and sewer piping
- Contractor exposed three separate mains in the road:
 - Marked 2" coated steel (yellow)
 - Marked 4" coated steel (yellow)
 - Unmarked 2" coated steel (black)
- Contractor assumed 2" black pipe was retired as they had cut out similar looking retired pipe earlier in the job
- While installing a catch basin, contractor used excavator to displace unmarked 2" black pipe and provide clearance
- Contractor contacted utility, reporting a gas leak
- Shortly after utility arrival, the nearby church exploded

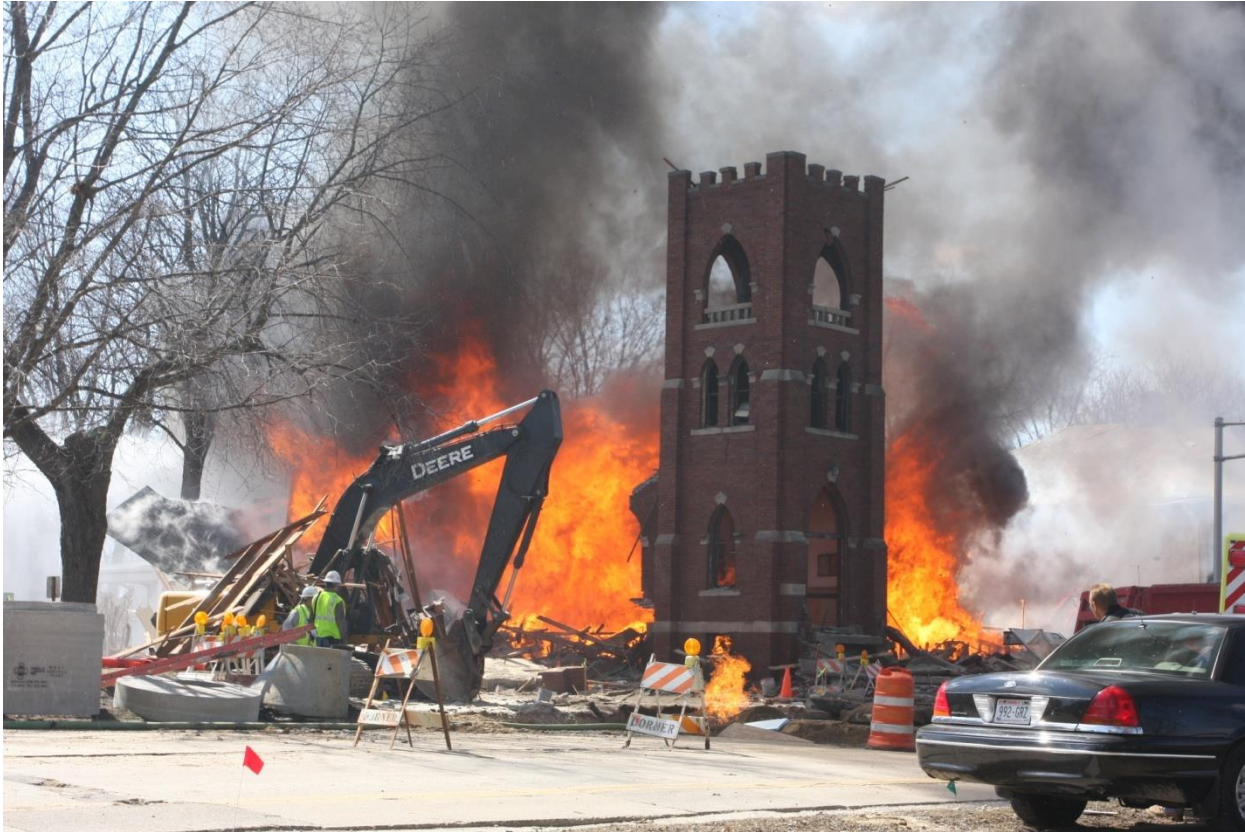
1 hospitalization, over \$1 million of property loss

1. Failure to maintain maps and records in accordance with Wis. Admin. Code § 134.16.
2. Failure to maintain maps or records in accordance with 49 CFR § 192.491(a).
3. Failure to provide construction records, maps and operating history in accordance with 49 CFR § 192.605(b)(3).
4. Failure to properly locate facilities in accordance with 49 CFR § 192.614(c)(5).

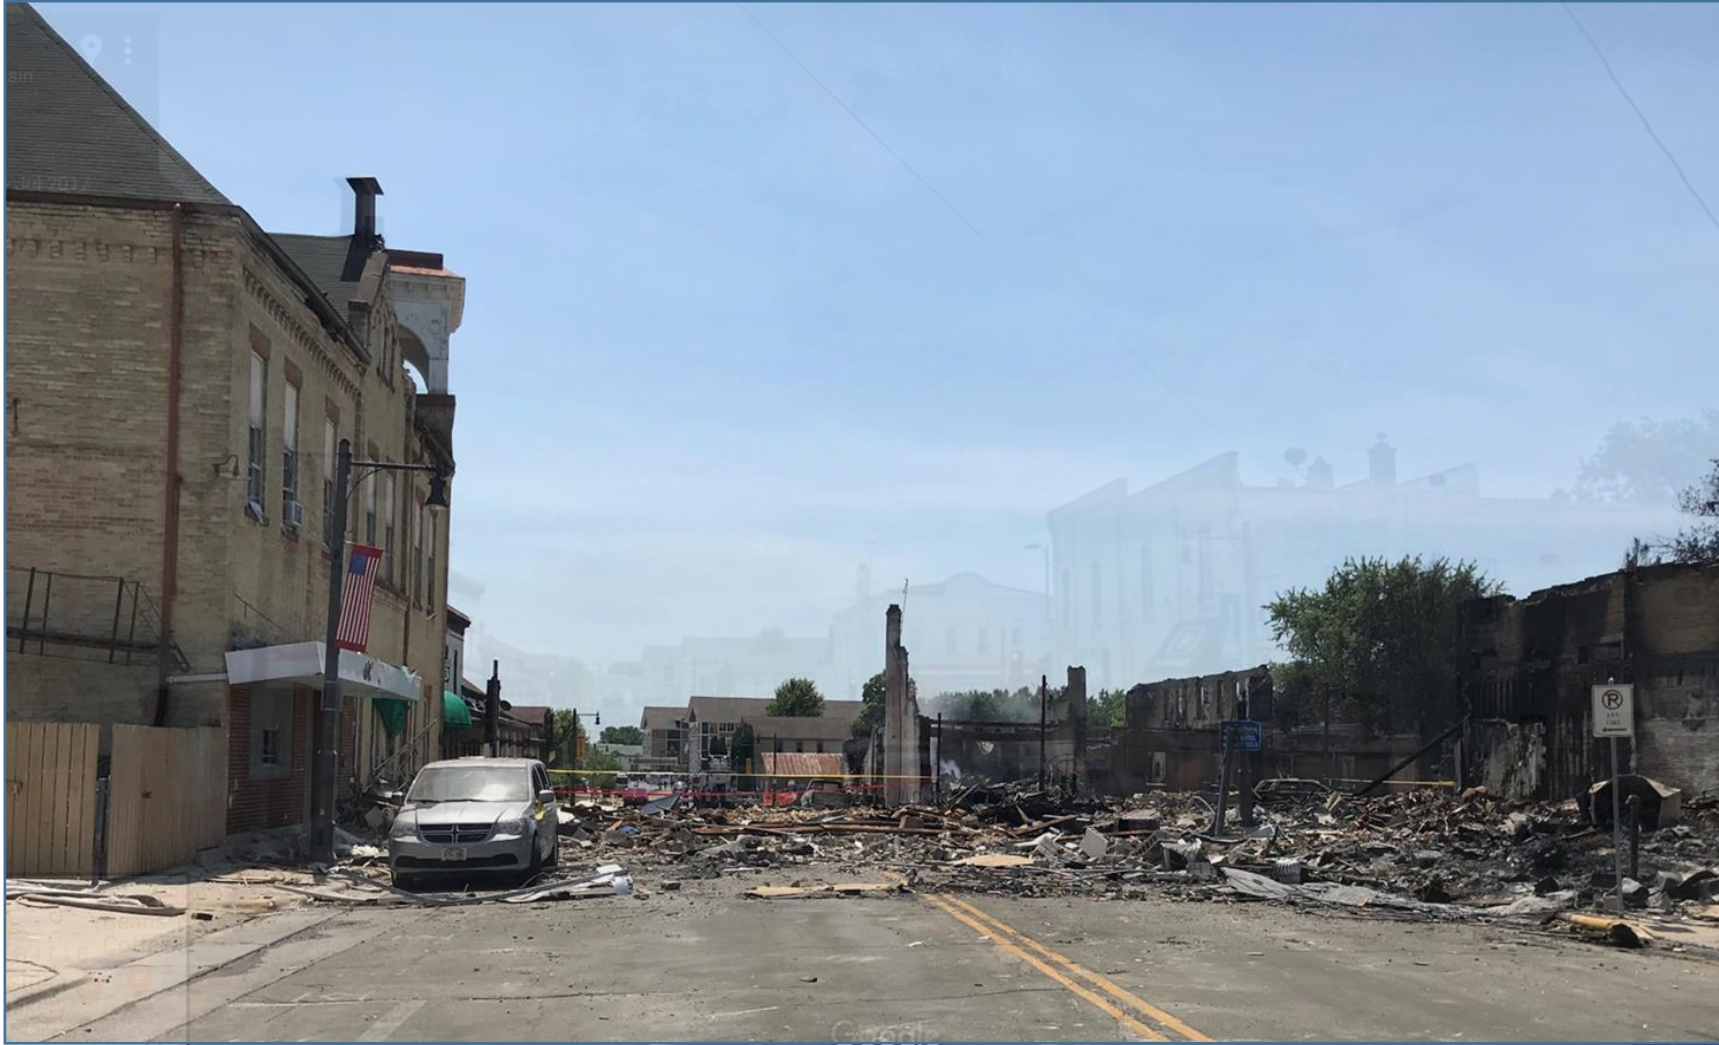
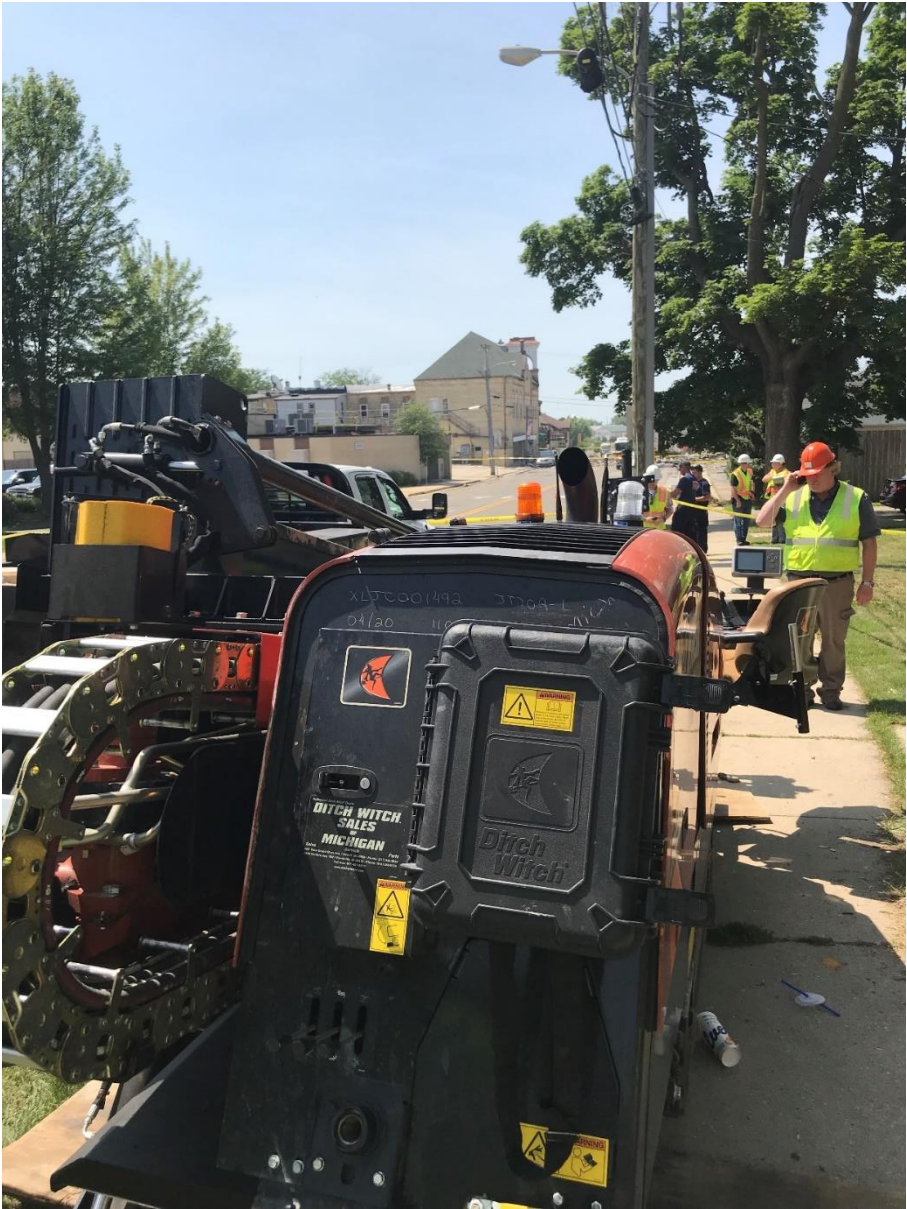
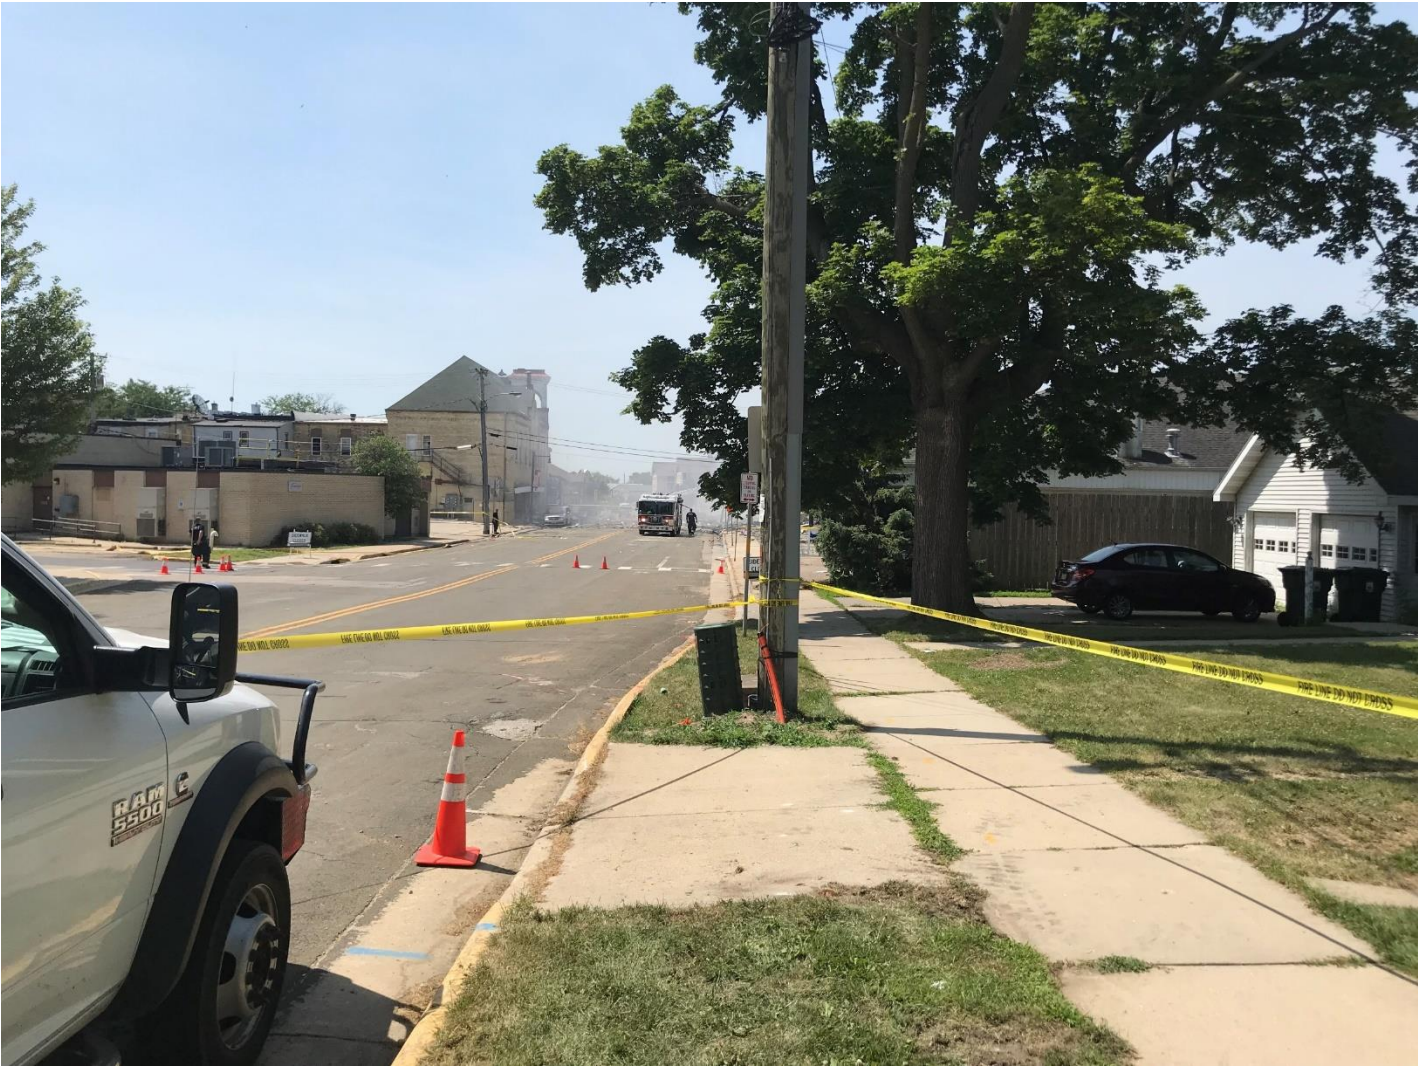
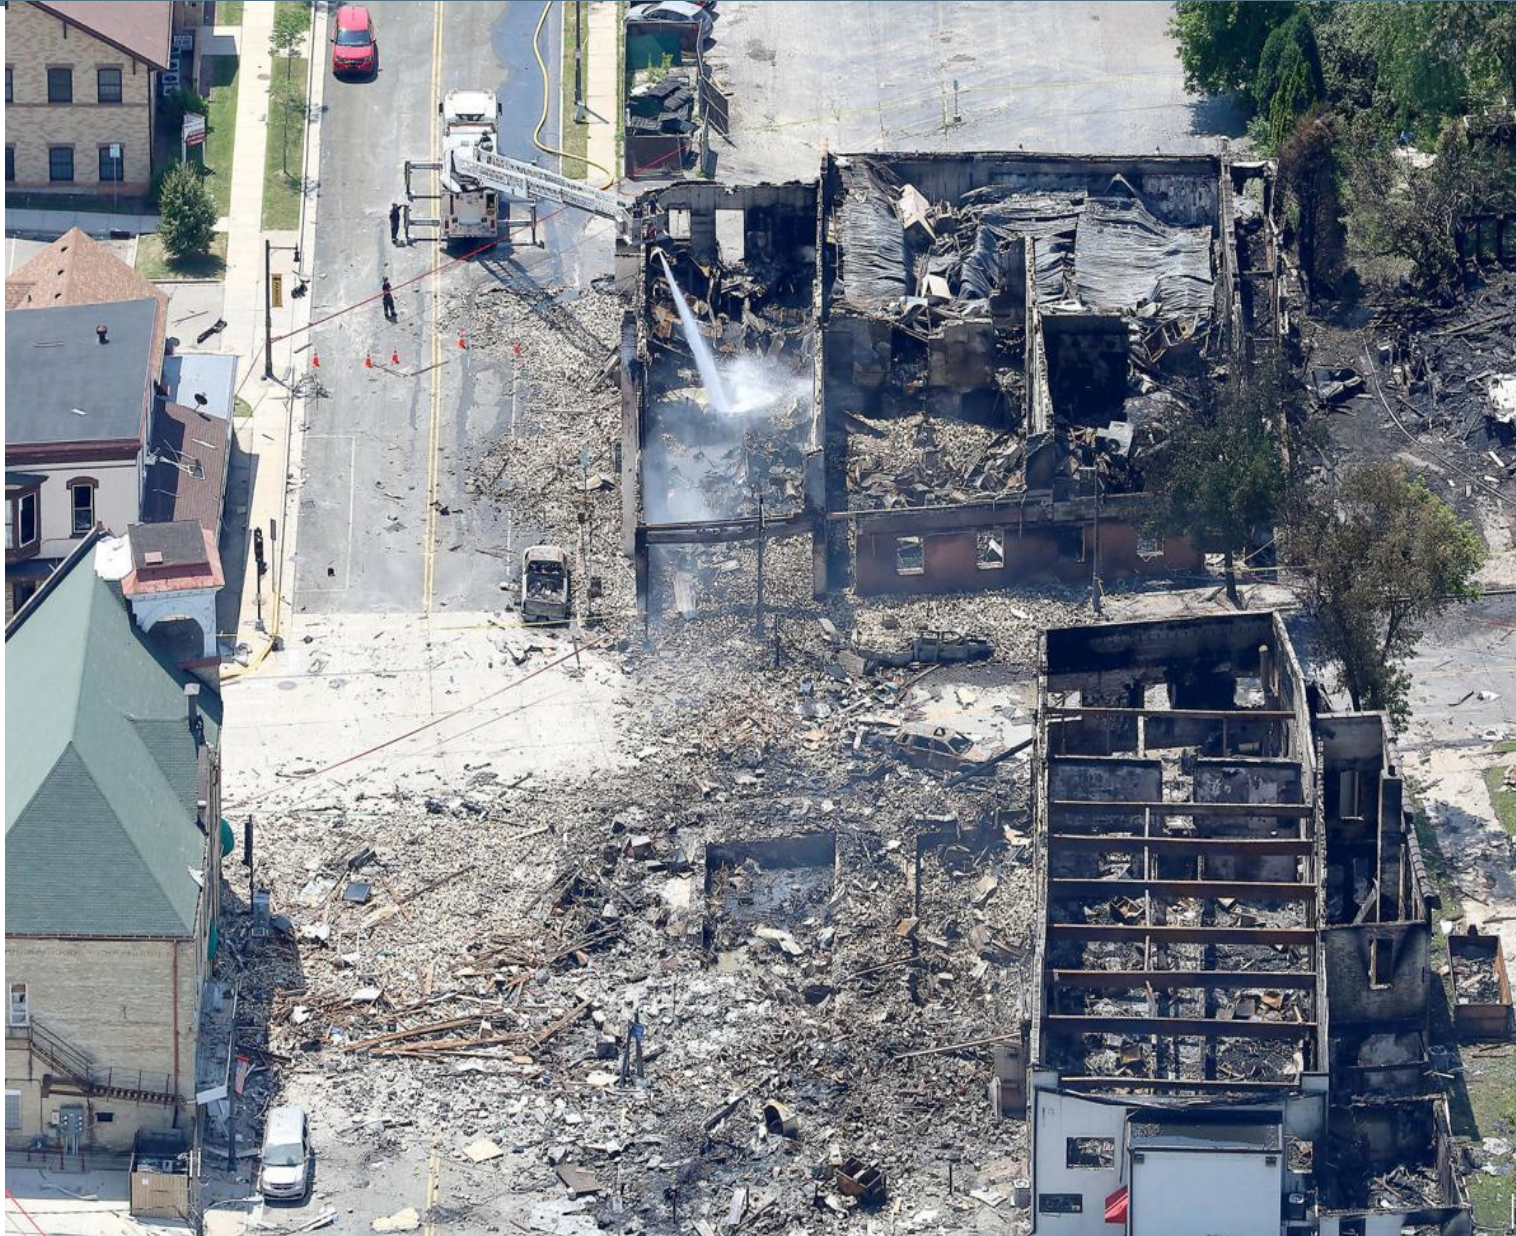
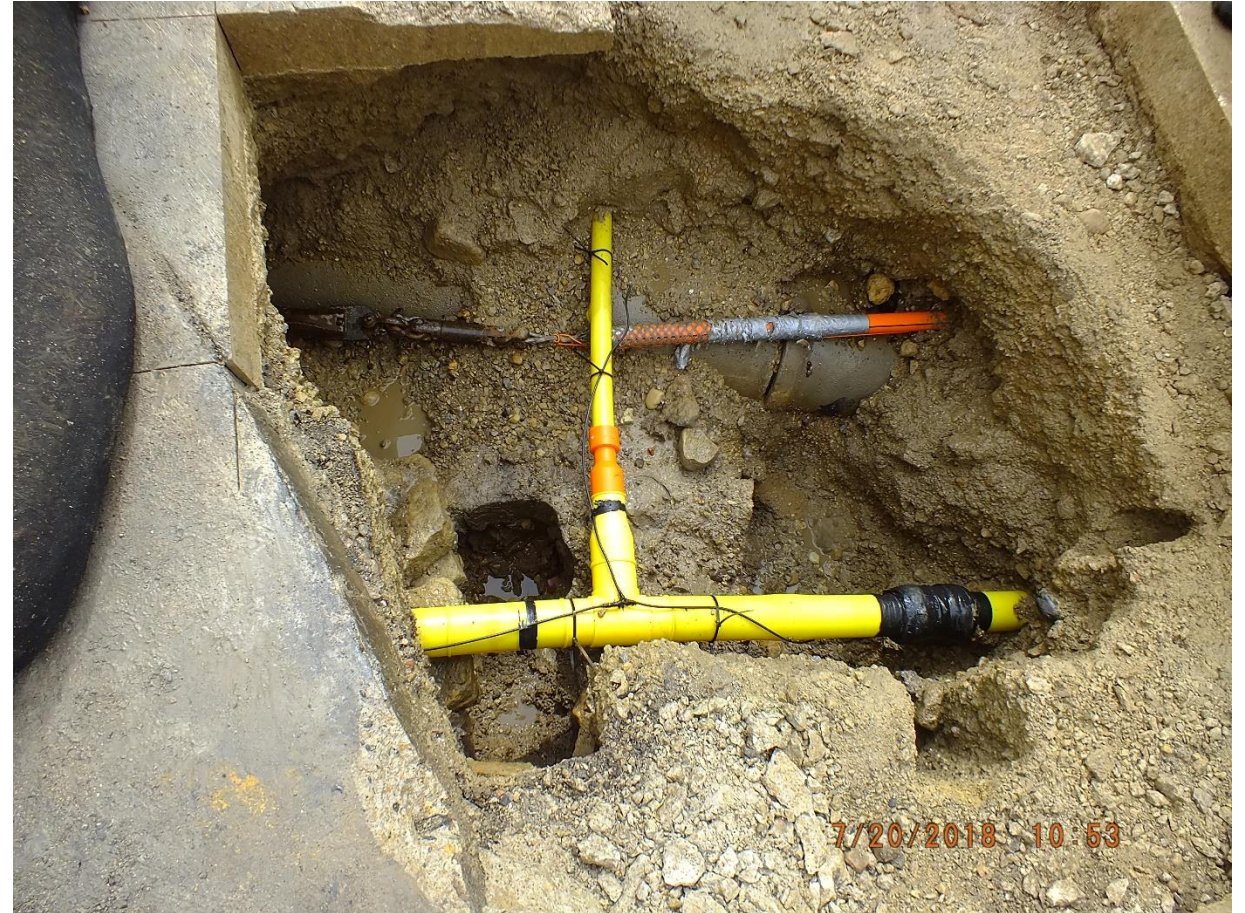
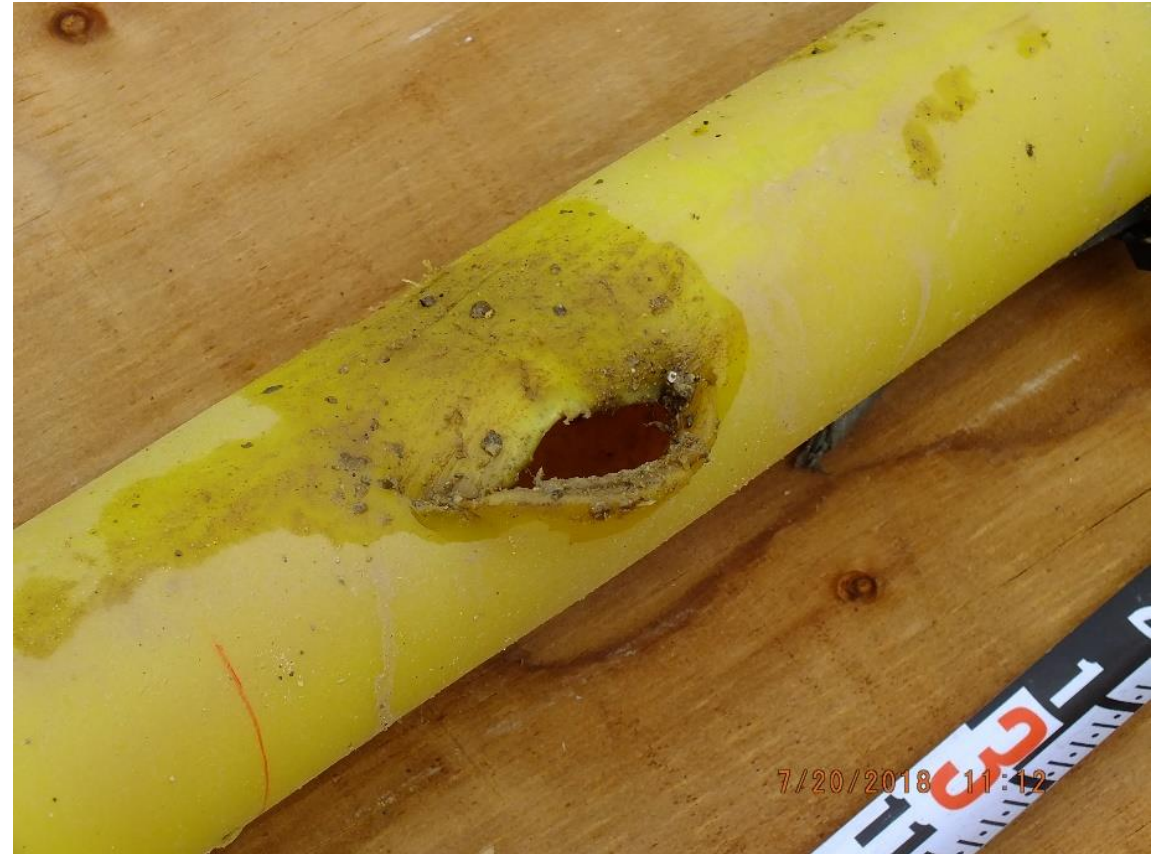
Sun Prairie Excavation Damage

- Telecommunications subcontractor boring
- Struck 2” PE while pulling back
- Subcontractor contacted utility
- Shortly after utility arrival, building next to struck pipe exploded

- 1 Firefighter fatally injured
- 1 Utility employee seriously injured
- Over \$1 million of property loss
- Original subcontractor declined to perform HDD
- Contractor “piggy-backed” on other’s locate request
- Damaged main was not located
- Complaint filed by locator
- PSC Docket 9300-PLI-100
- Excavator was assessed maximum civil penalty of \$25,000

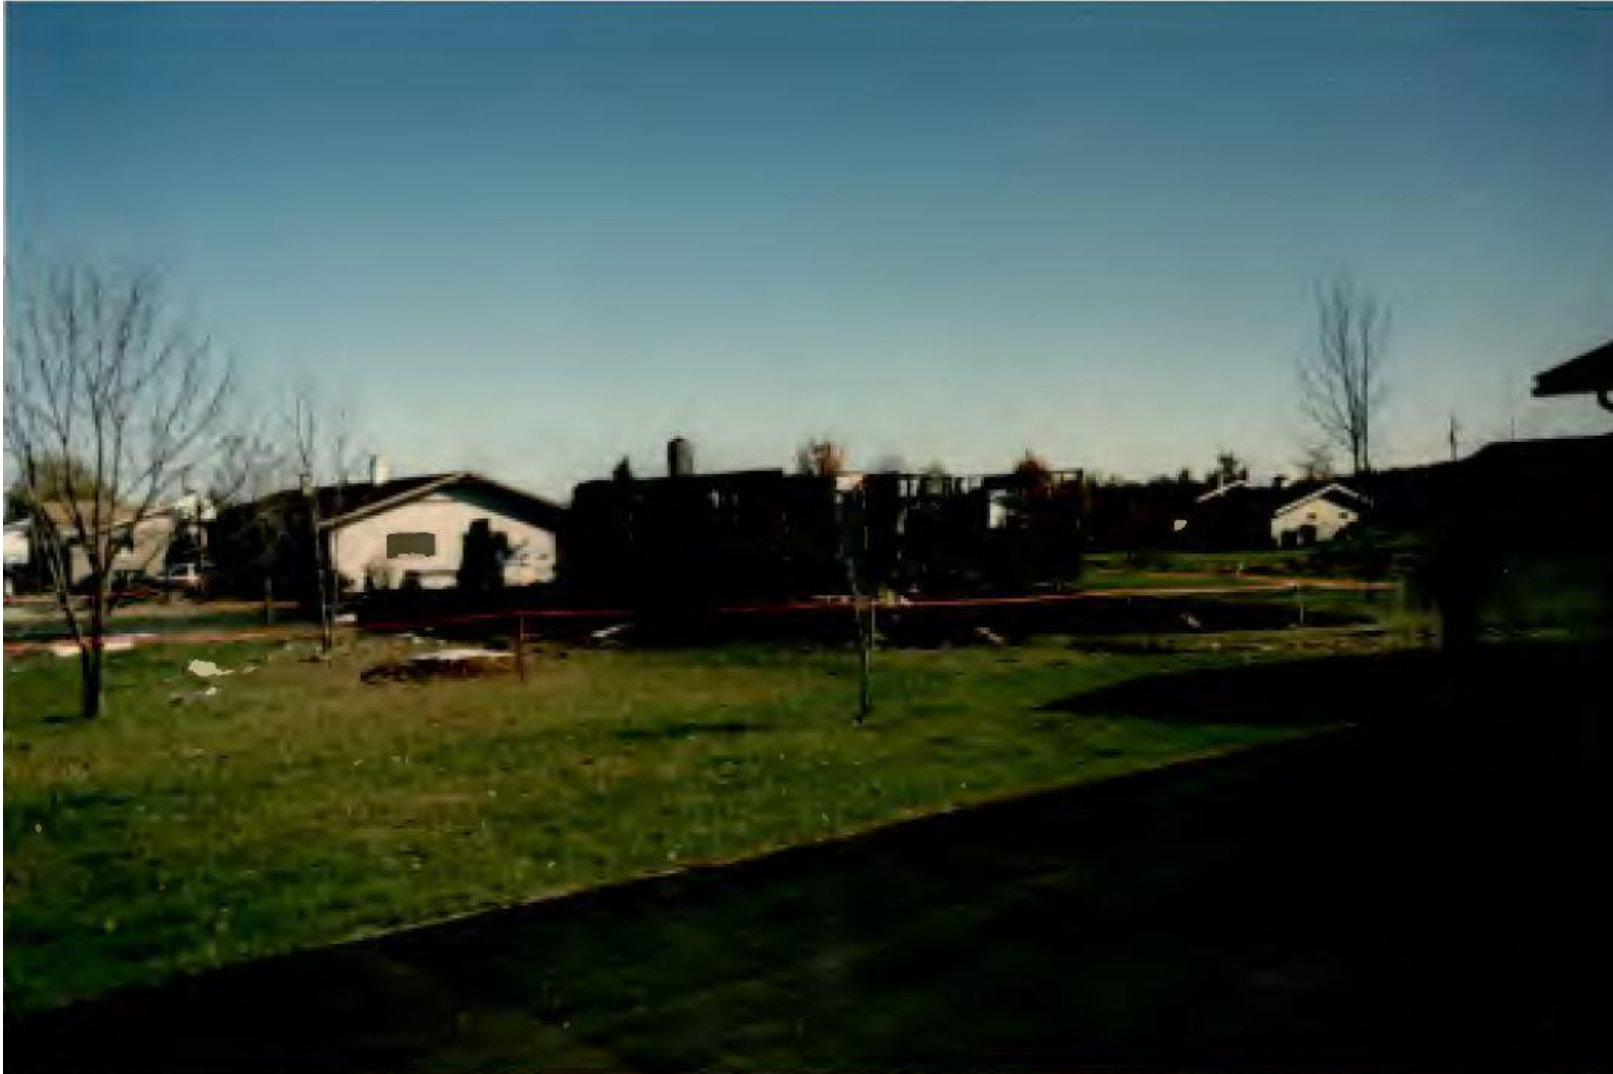
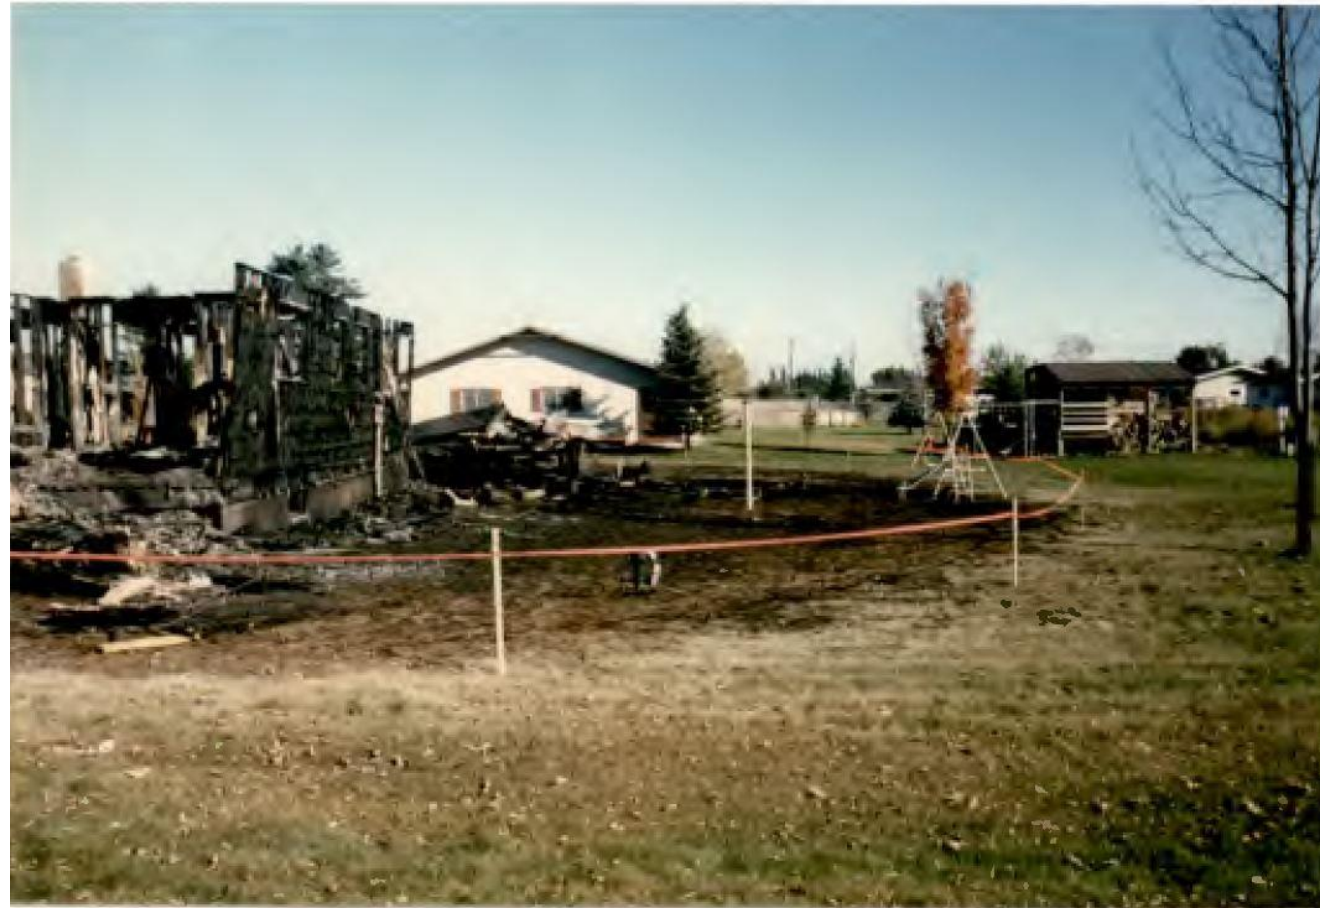
Rib Mountain Pipe Failure

- Thursday 10/16/86 an explosion occurred in a single-family home in Rib Mountain, WI at 5:07pm
- Homeowner returned home from work to an odd odor
- Ignition of gas occurred after the owner decided to light a candle to eliminate the smell
- Fire Department was on the scene 10 minutes later and the utility was notified by 5:27pm of the explosion
- 1 fatality and 1 injury
