Wisconsin Incidents 1986-Present

Wisconsin Pipeline Safety Seminar

February 9th, 2024

Public Service Commission of Wisconsin

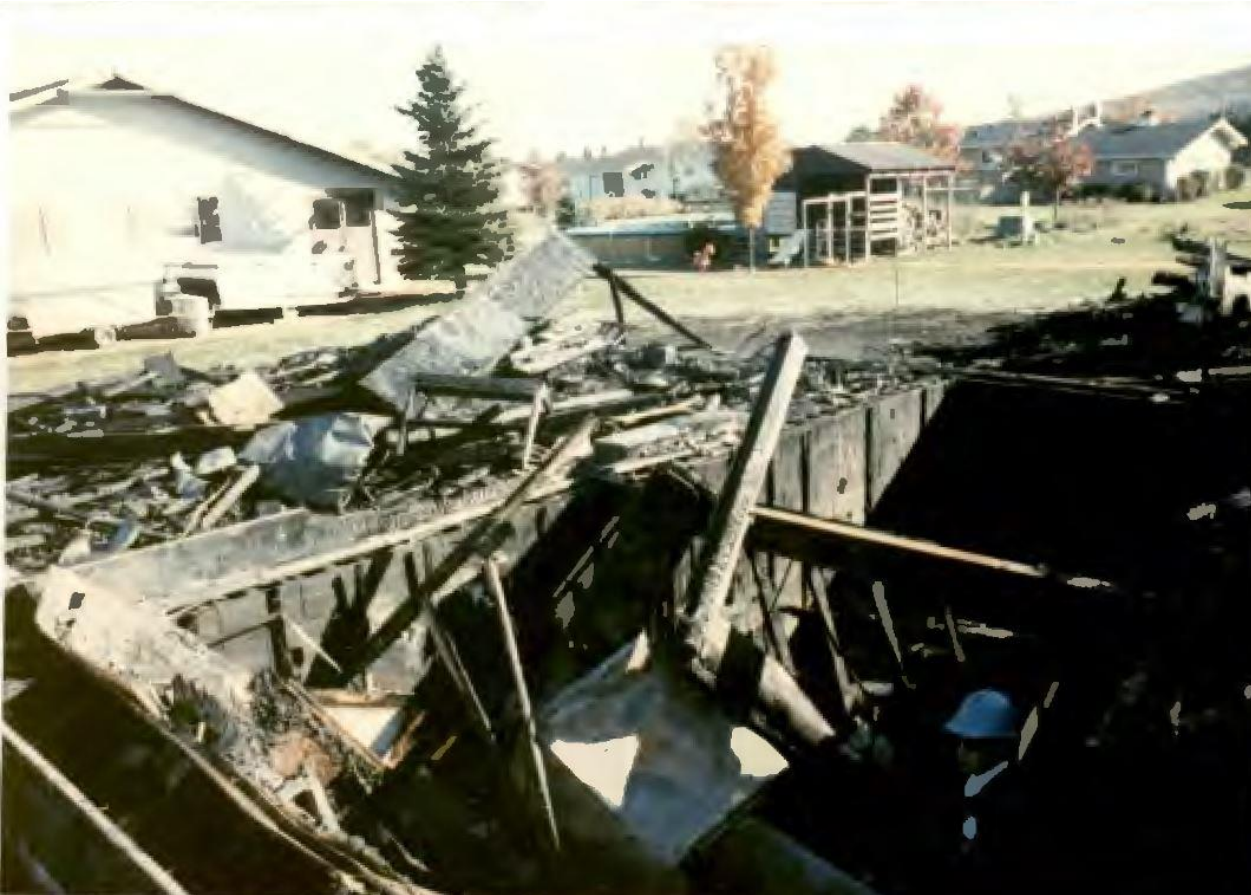
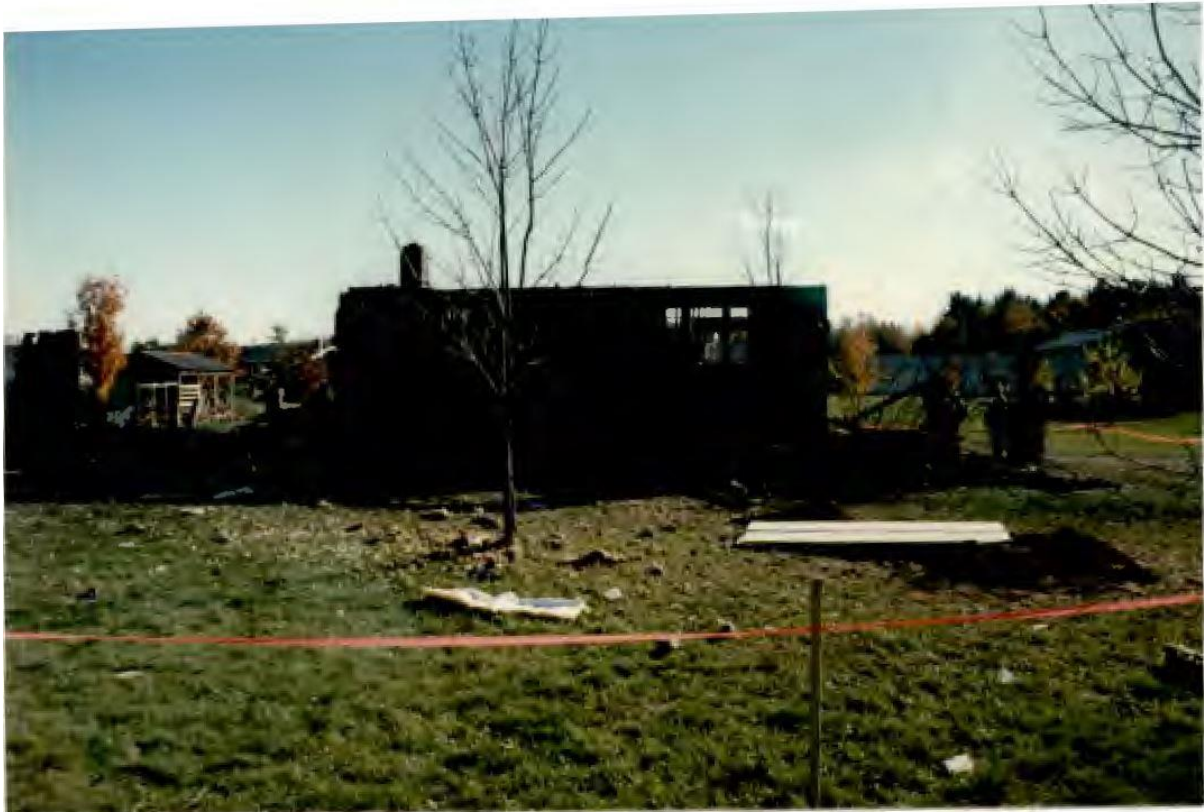
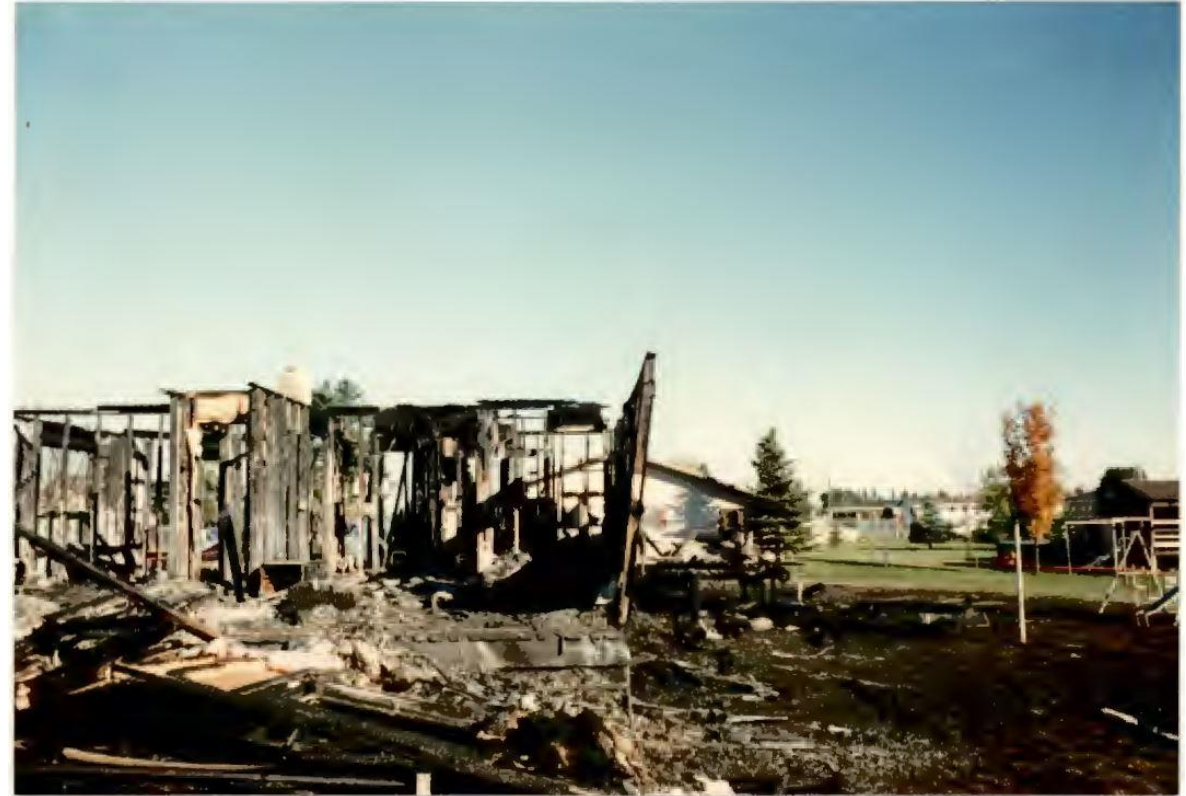
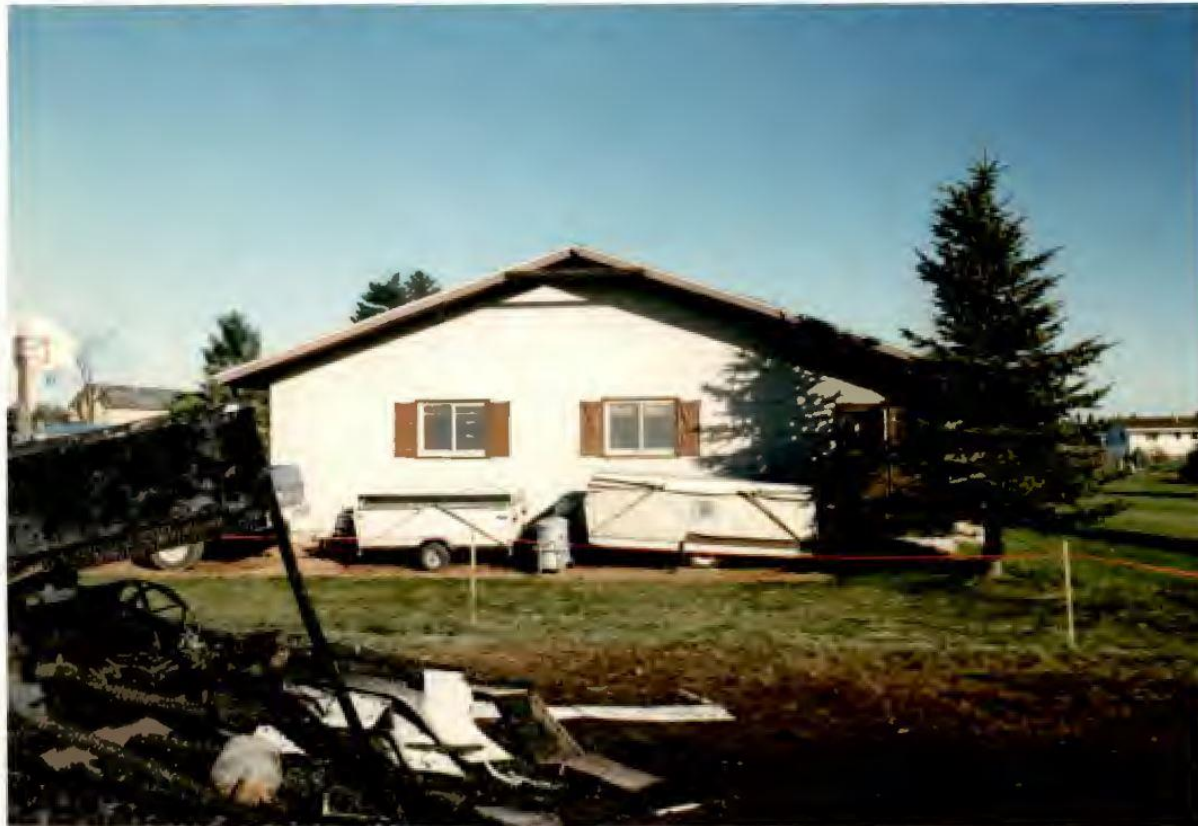
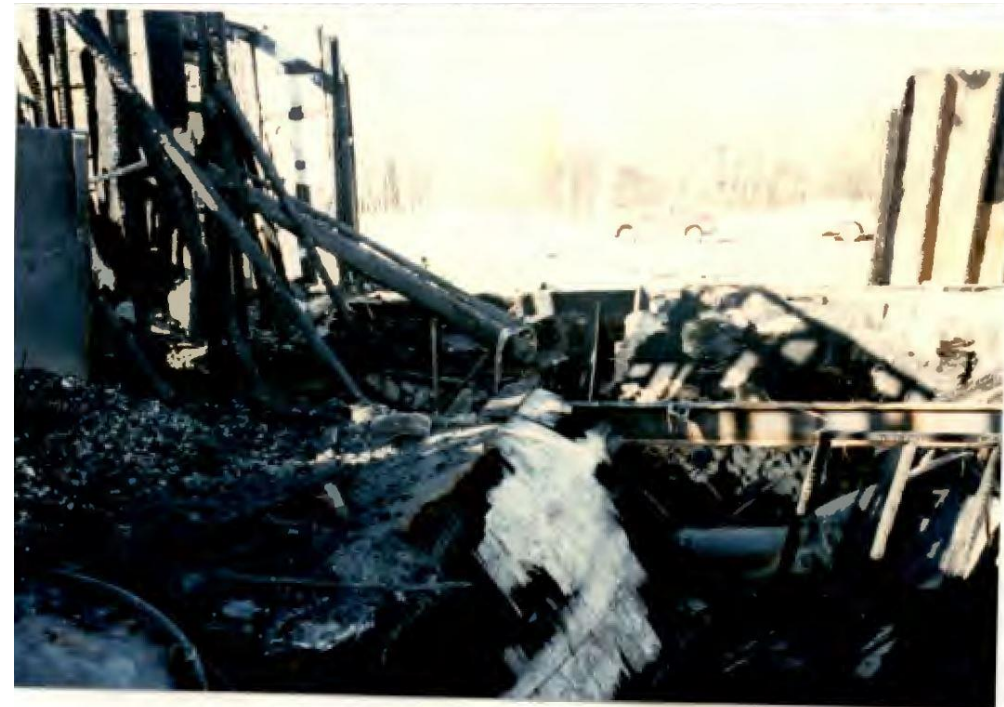
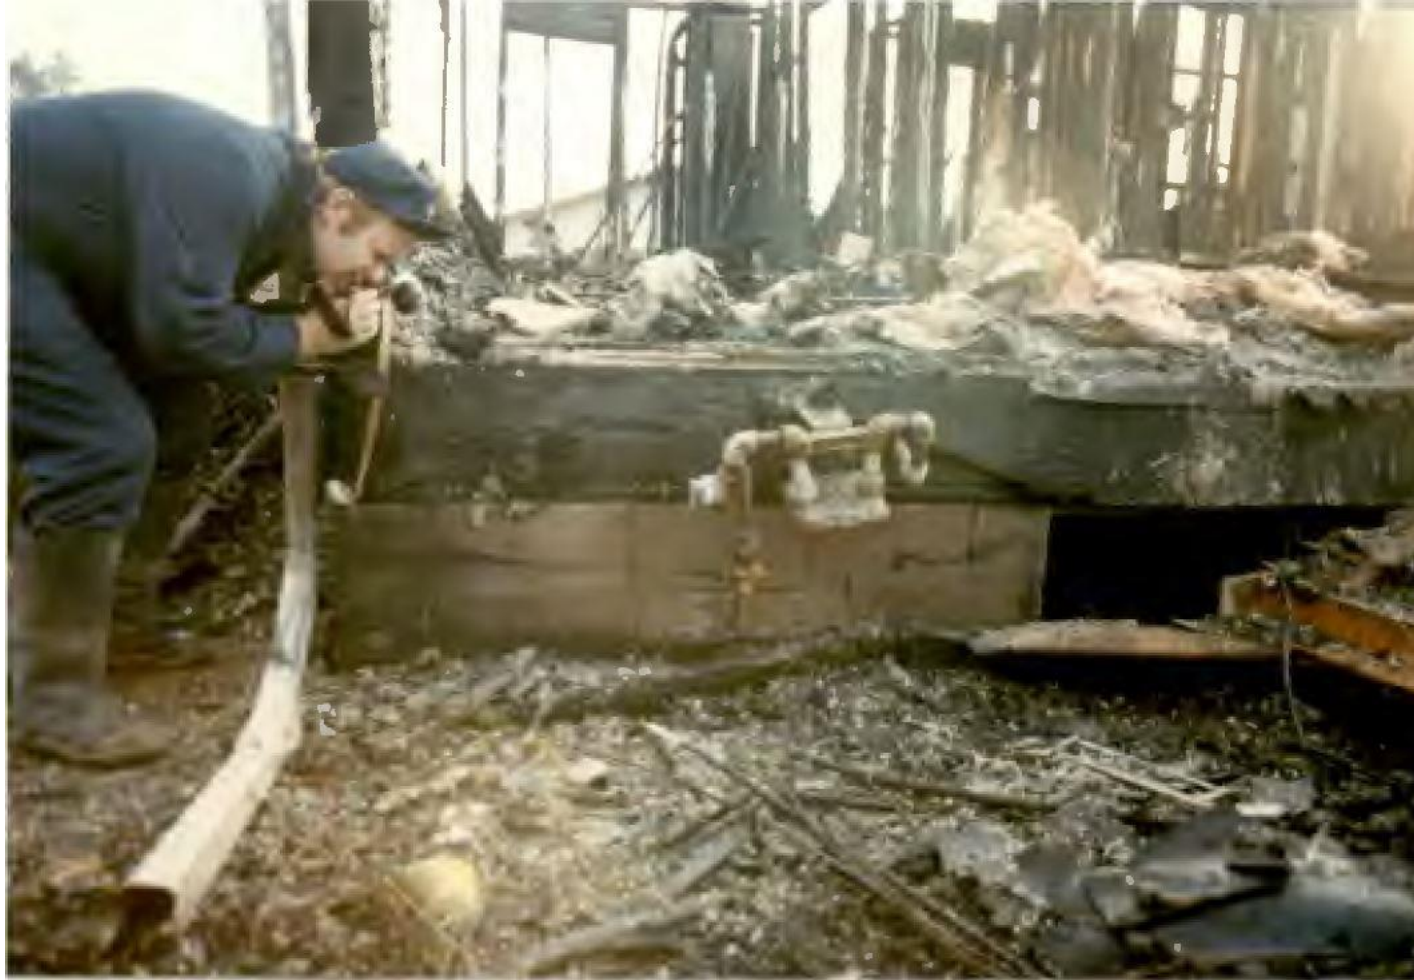
- Investigation discovered that the gas leak originated from the steel service riser to the home
- A compression fitting had been welded onto the end of the half inch service line
- This compression fitting was found to be oversized and never intended for use with plastic
- Pressure test of the house piping found no leaks

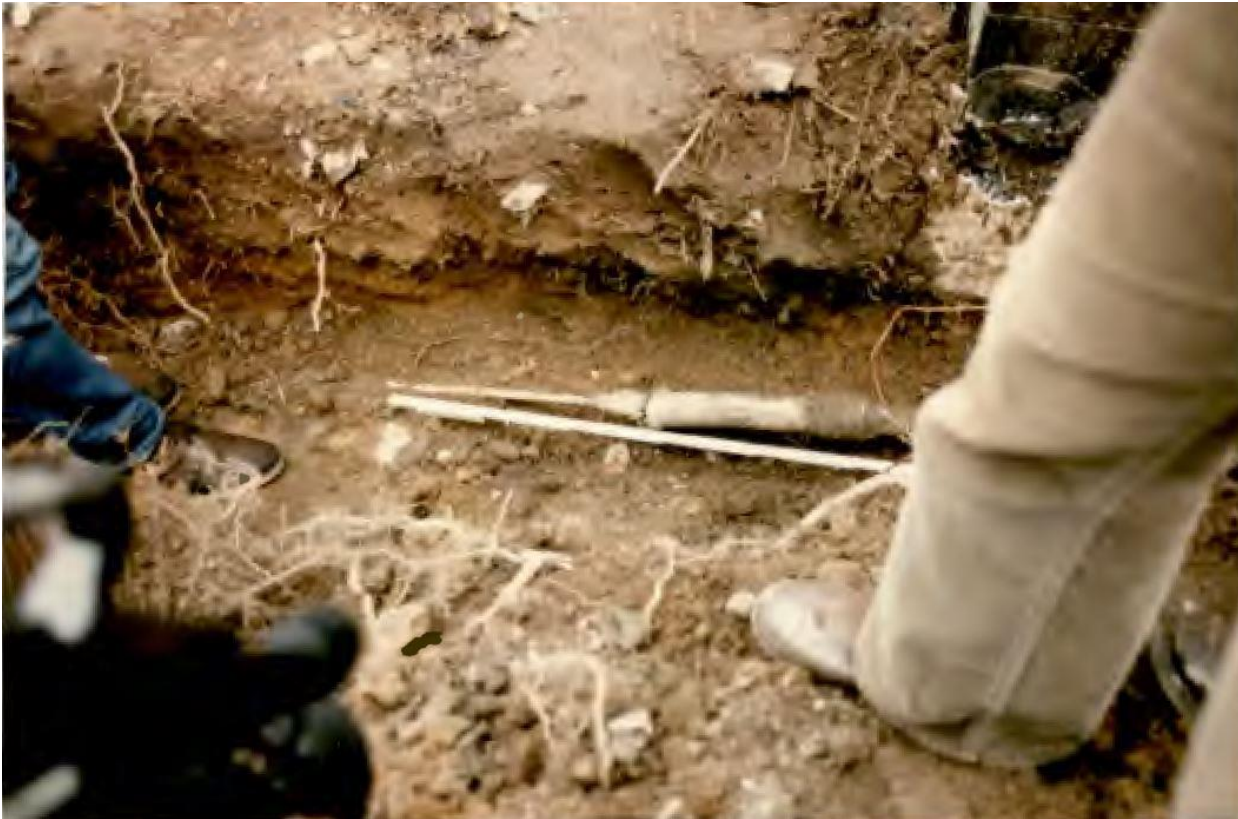
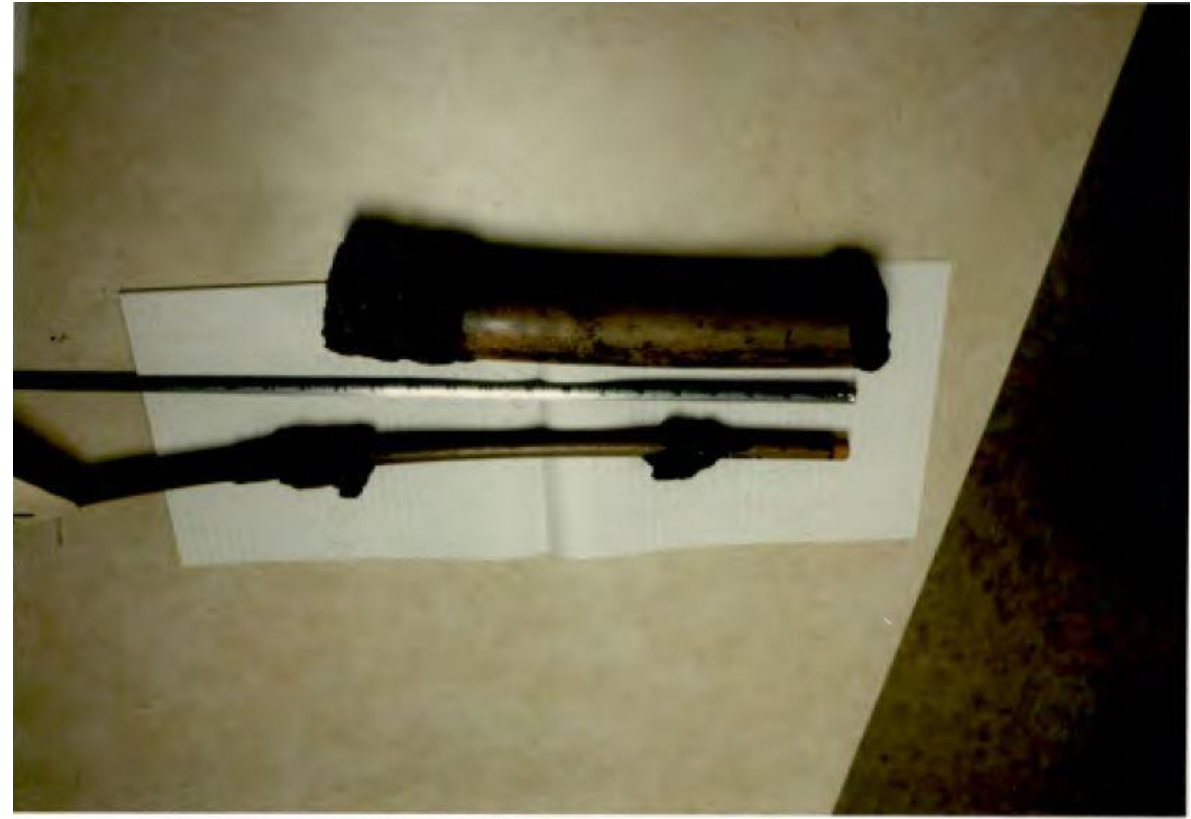
- Leak occurred when the service partially pulled out of the compression fitting
- Utility had no record of the failed fitting and said, “Like nothing we have ordered before.”
- Only 0.5in of service was left in the fitting, typical depth was 3in

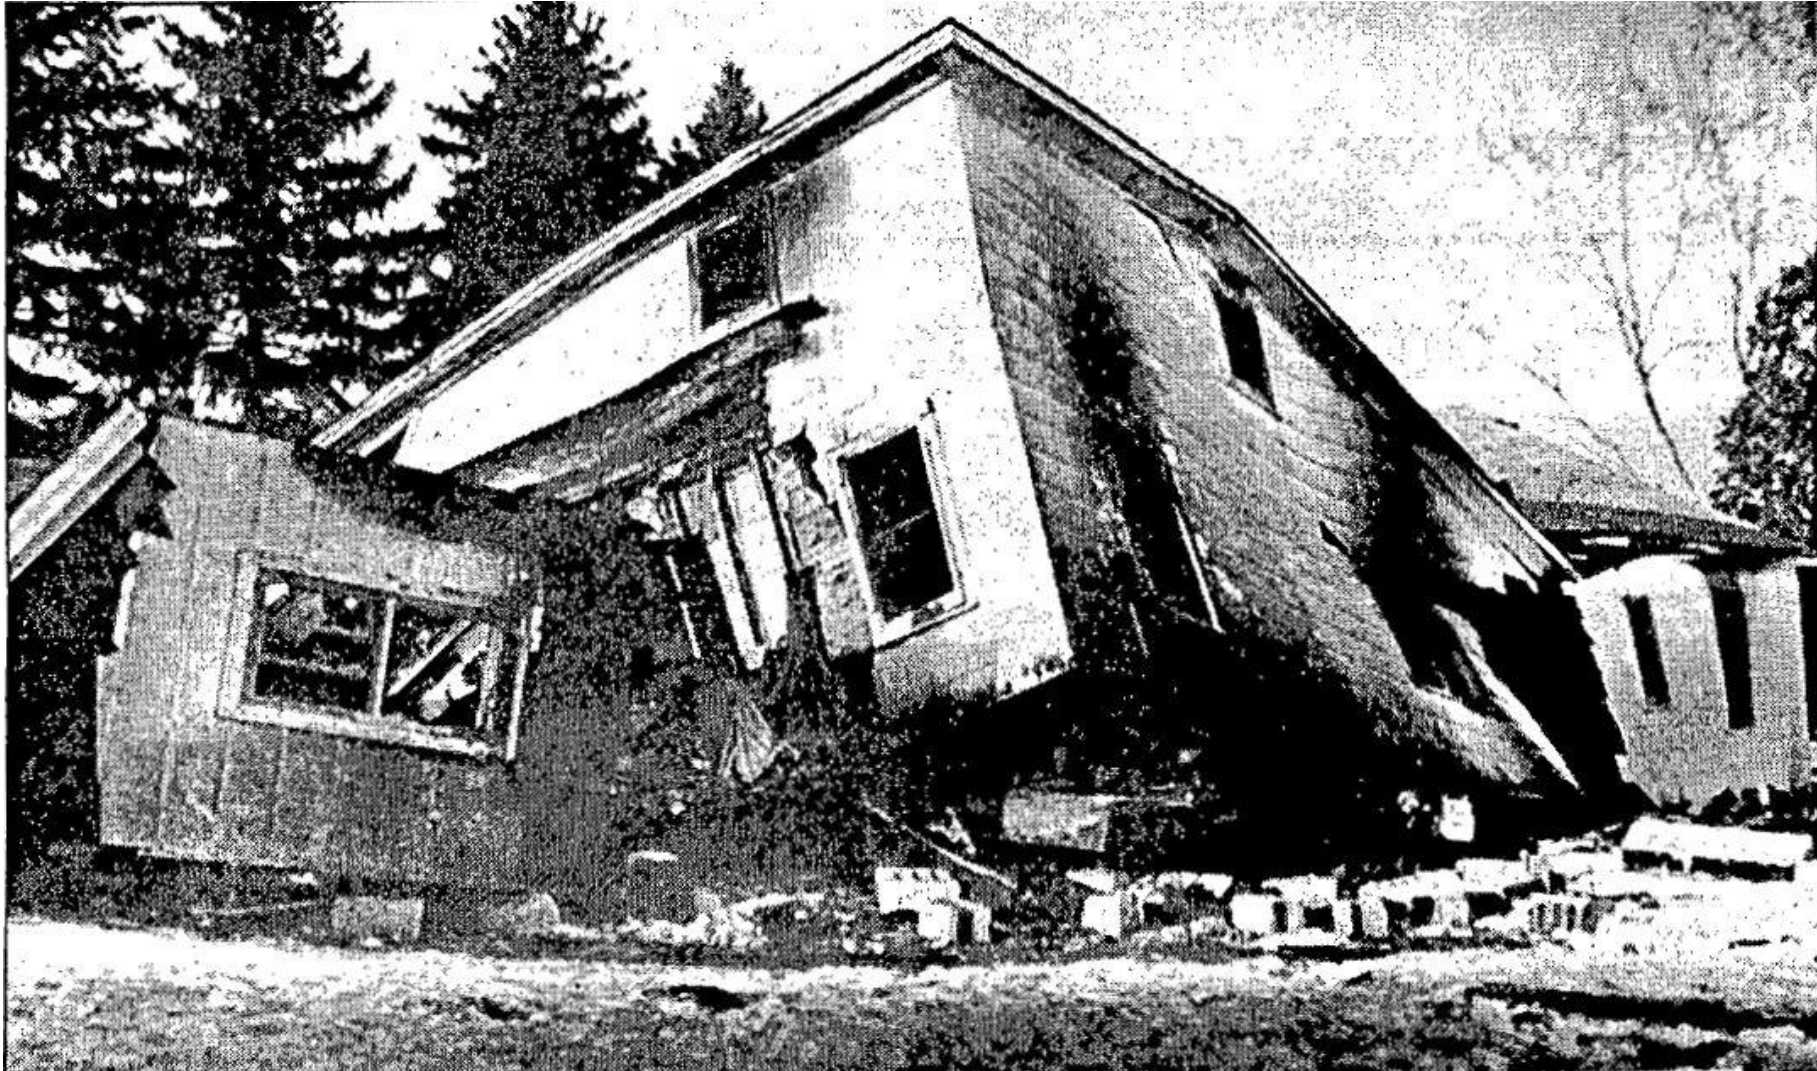
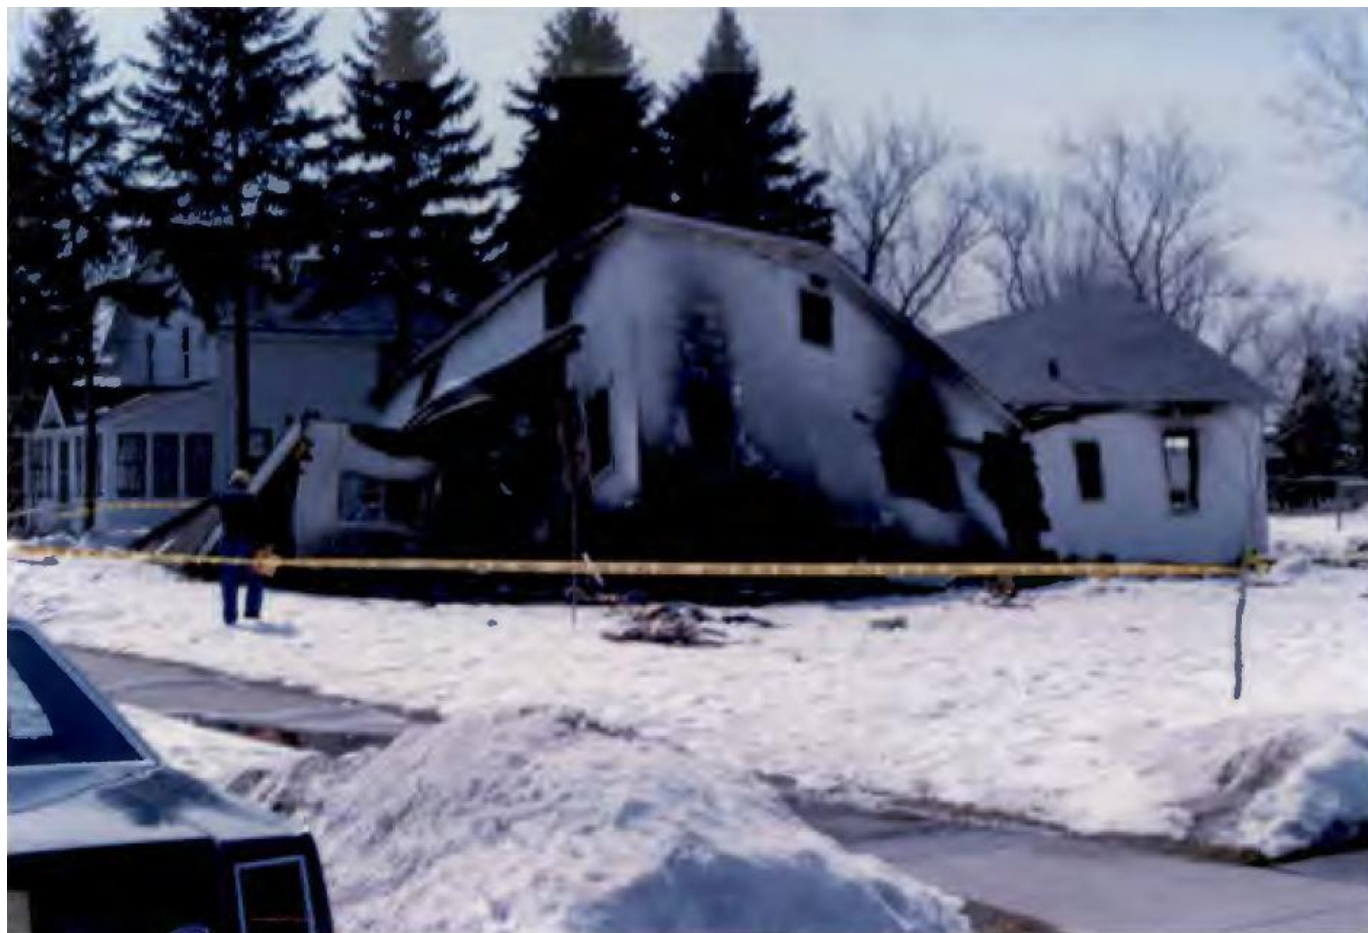
Nekoosa Pipe Failure

- At 8:35pm on March 22nd an explosion and fire occurred at a single-family home in Nekoosa
- The scene was made safe by 11:00pm
- By 2:00am March 23rd the utility had discovered the service line would not hold 10psi
- 1 fatality and 2 injuries

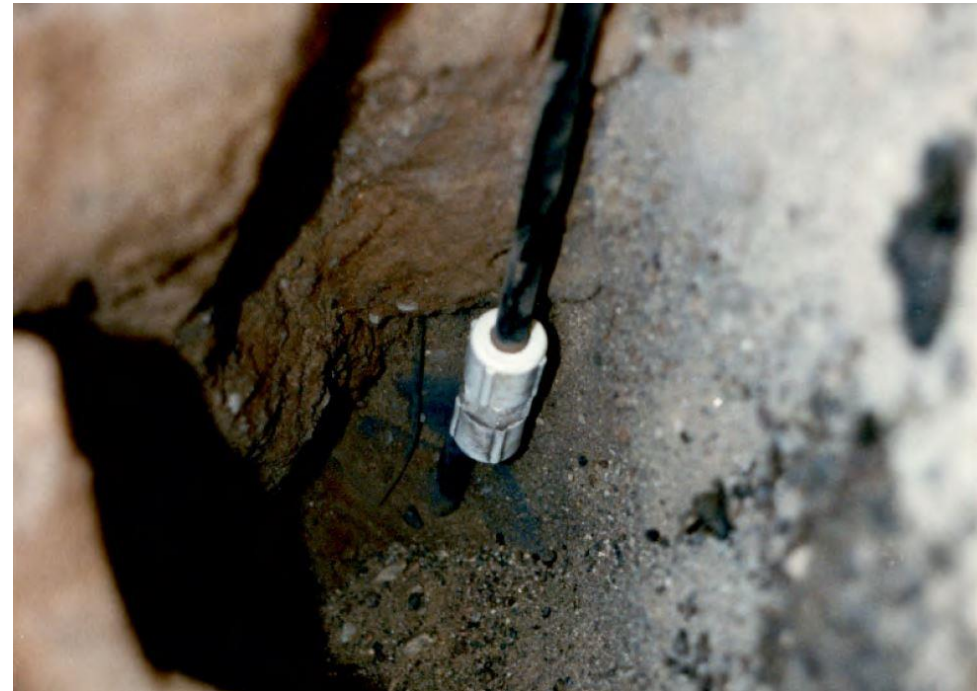
- Portion of service pipe attached via coupling was removed
- Nuts on coupling not fully engaged
- Removed piping/coupling sent to laboratory for further analysis.

- Excellent communication to public officials
- Completed a main and service leak survey of the town
- Repaired any leaks found during the survey
- Reported daily updates on leak survey findings
- Sent letters to customers with a connector style fitting on their service line

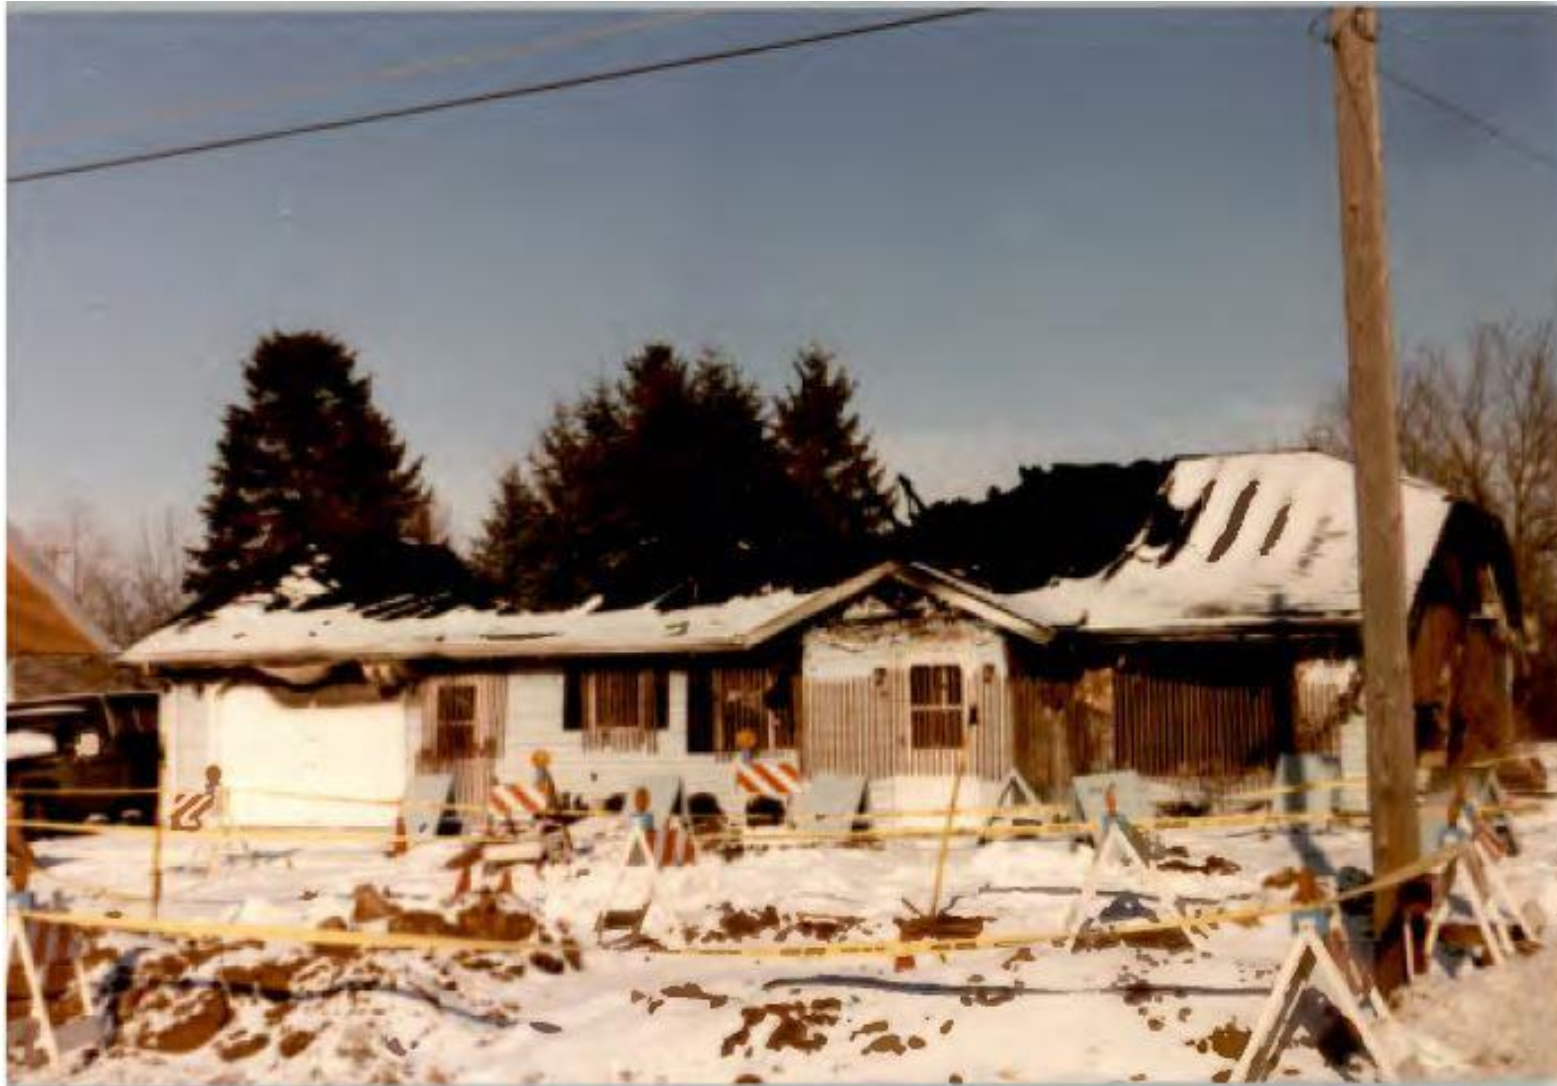
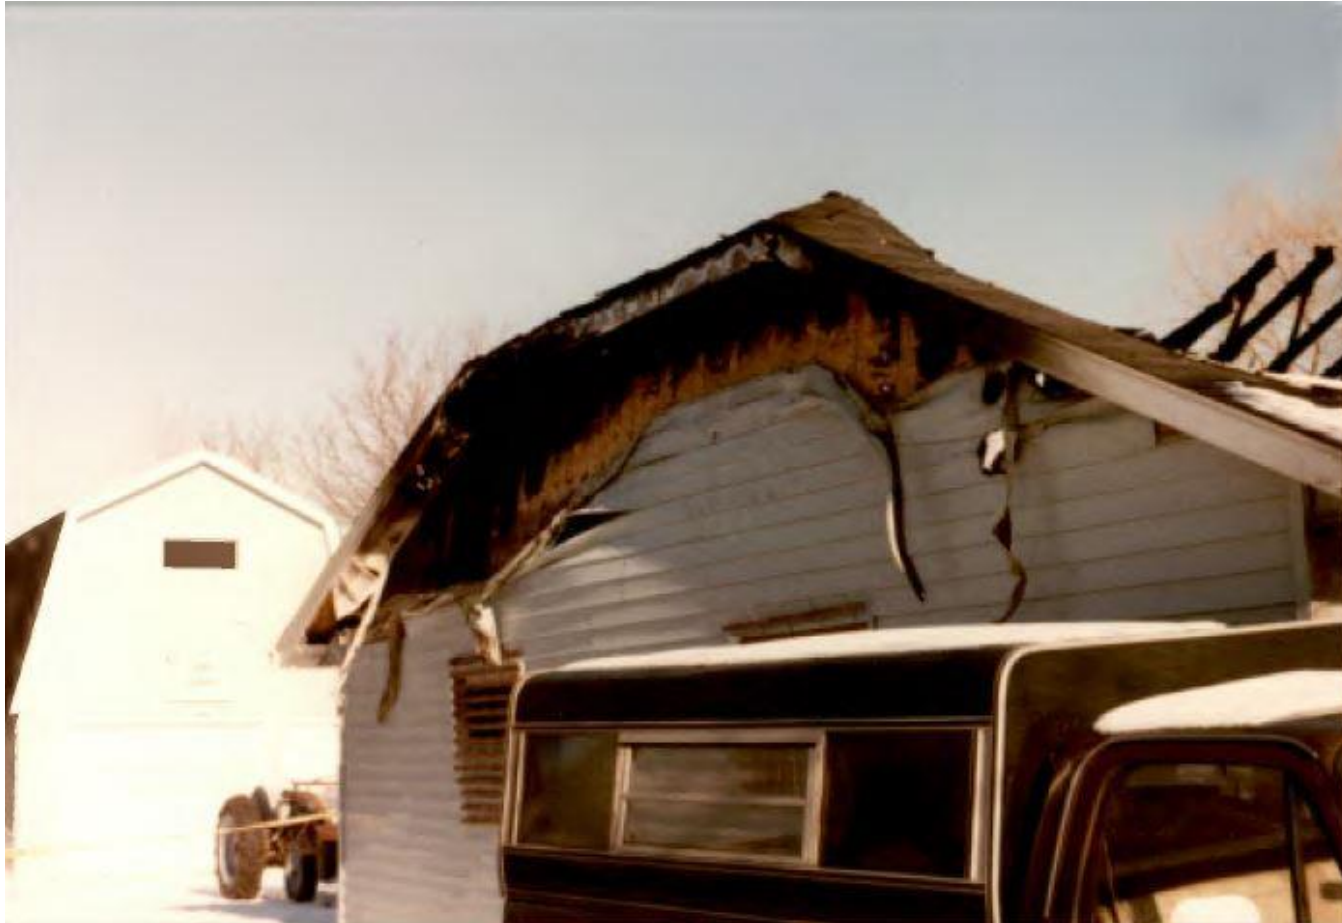
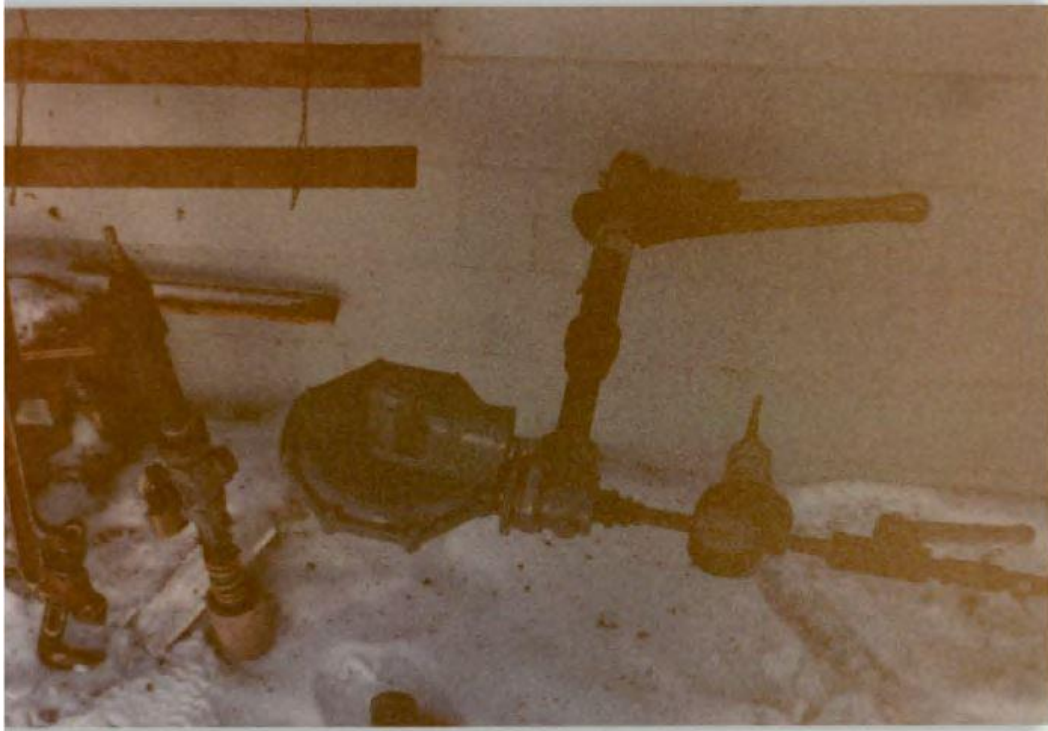
Two Rivers Pipe Failure

- Explosion occurred at a single-family home at approximately 9:00am
- Regulator had been replaced 3 times within the days prior to the explosion
- Pressure problems with gas appliances within the home
- 3 injuries, including 2 utility employees

- Explosion occurred when utility employee lit a match to start gas range
- No leaks found within the home prior to ignition

- Bar-holes found high concentrations of gas in soil
- 2in main in street had a circumferential crack

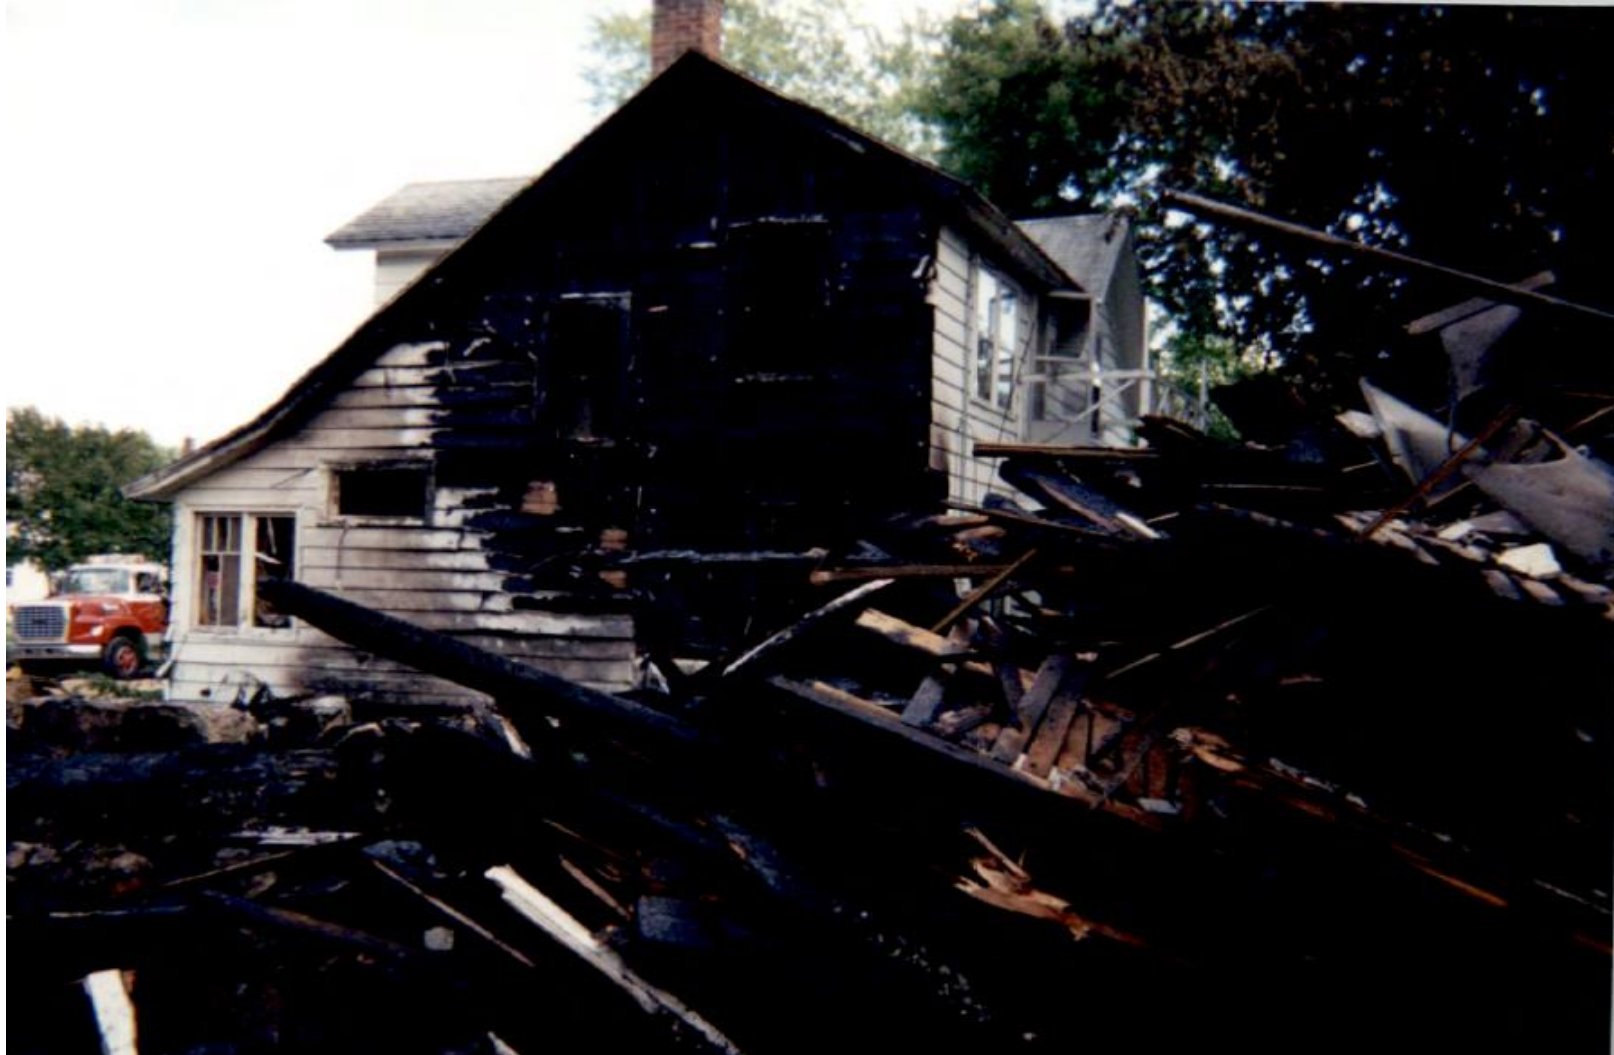
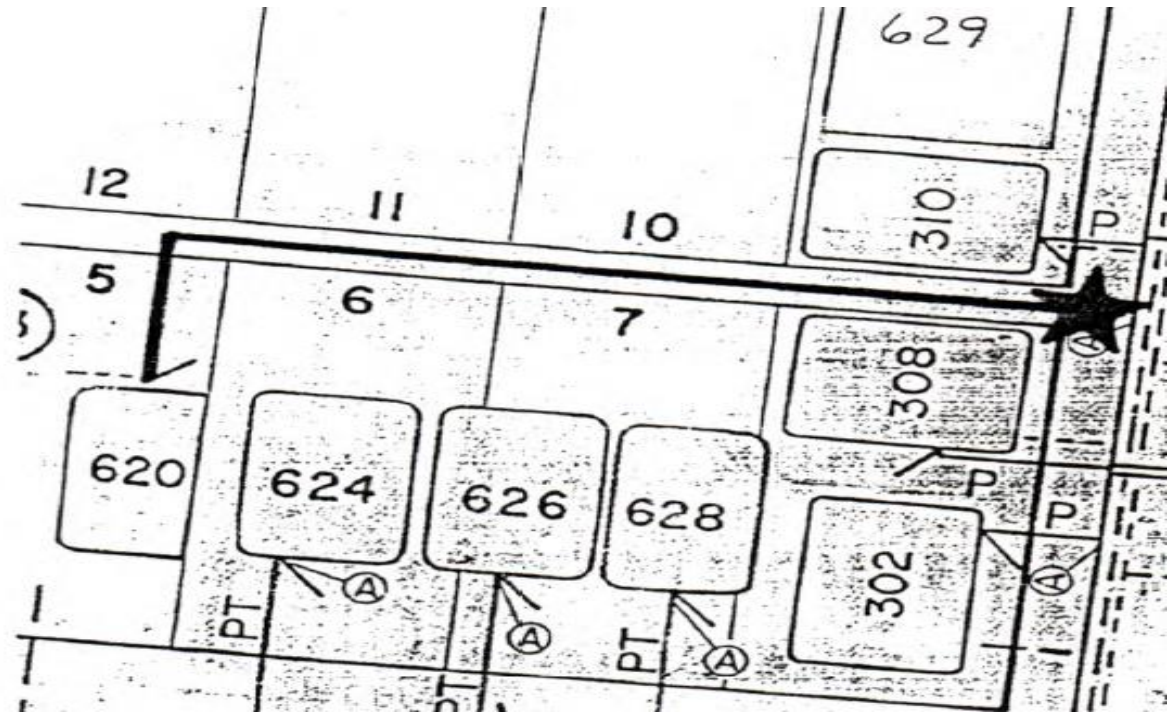
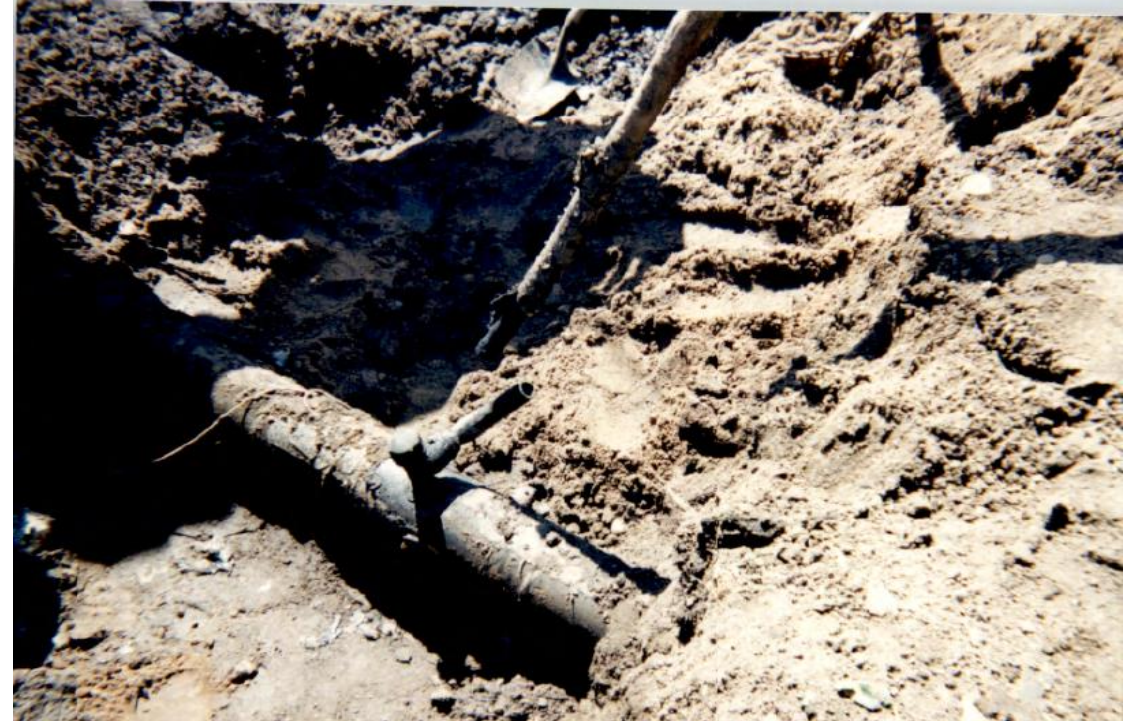
Wausau – Unmarked Service

- Construction contractor hooked steel gas service
- 1 ¼" service squeezed off after operator notification
- Explosion at vacant home next to damaged pipe
- No injuries and estimated \$100,000 damage

- Pipe separated from compression fitting
- Service not located or marked on contractor drawings
- Time between damage and operator notification
- Operator did not check entire area for leak

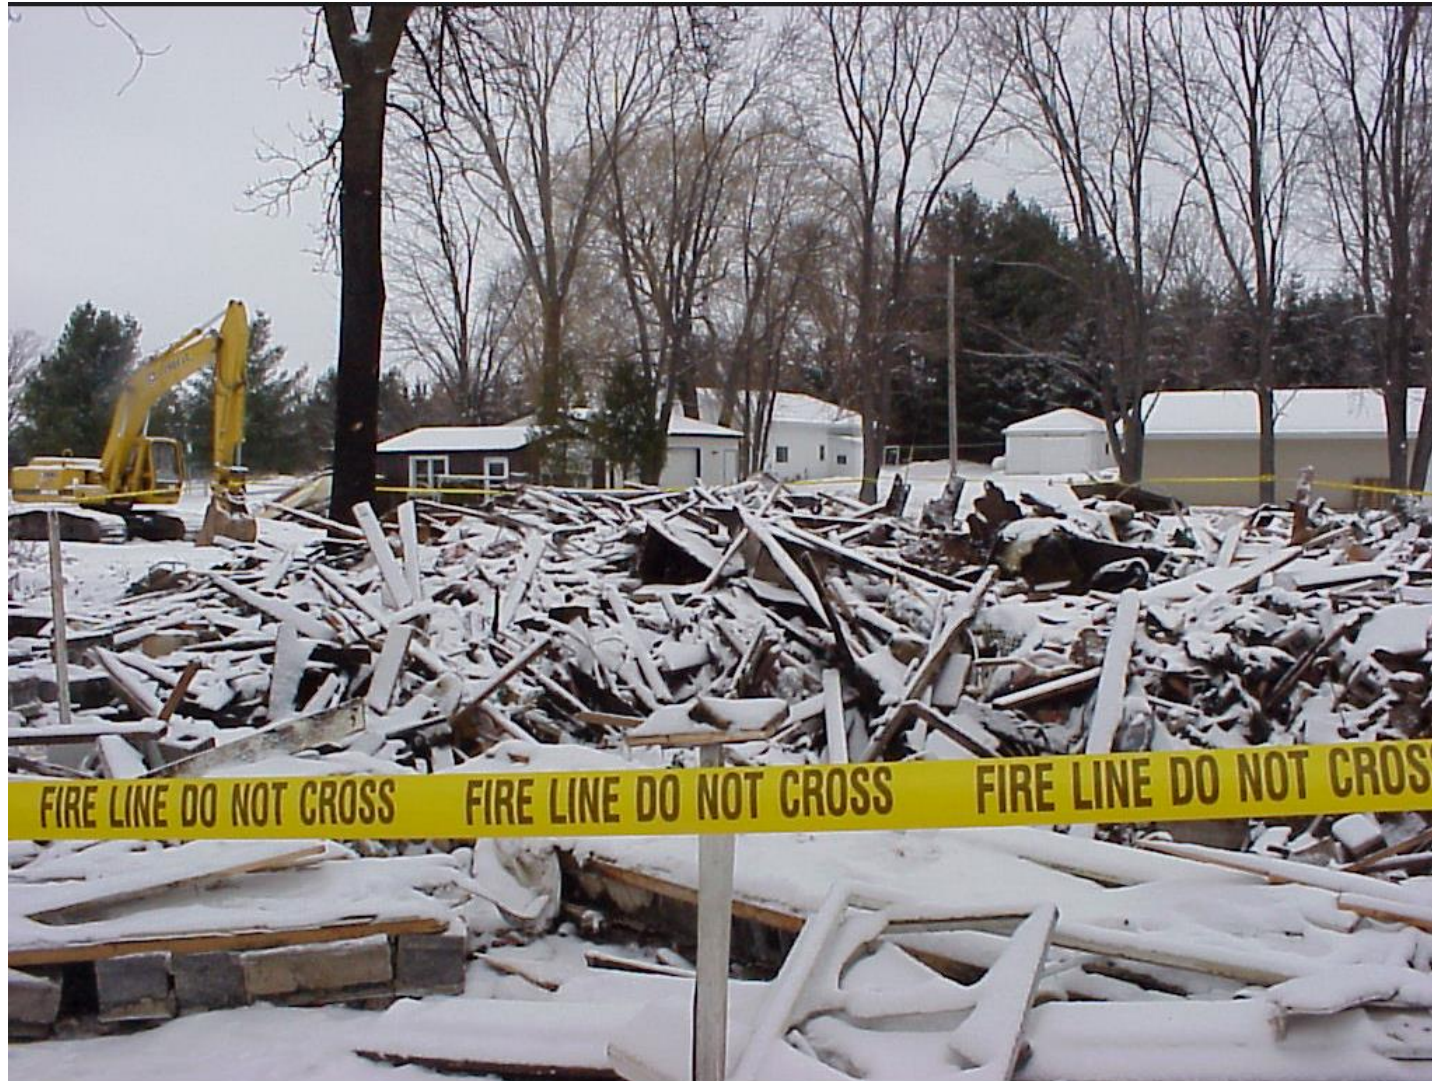
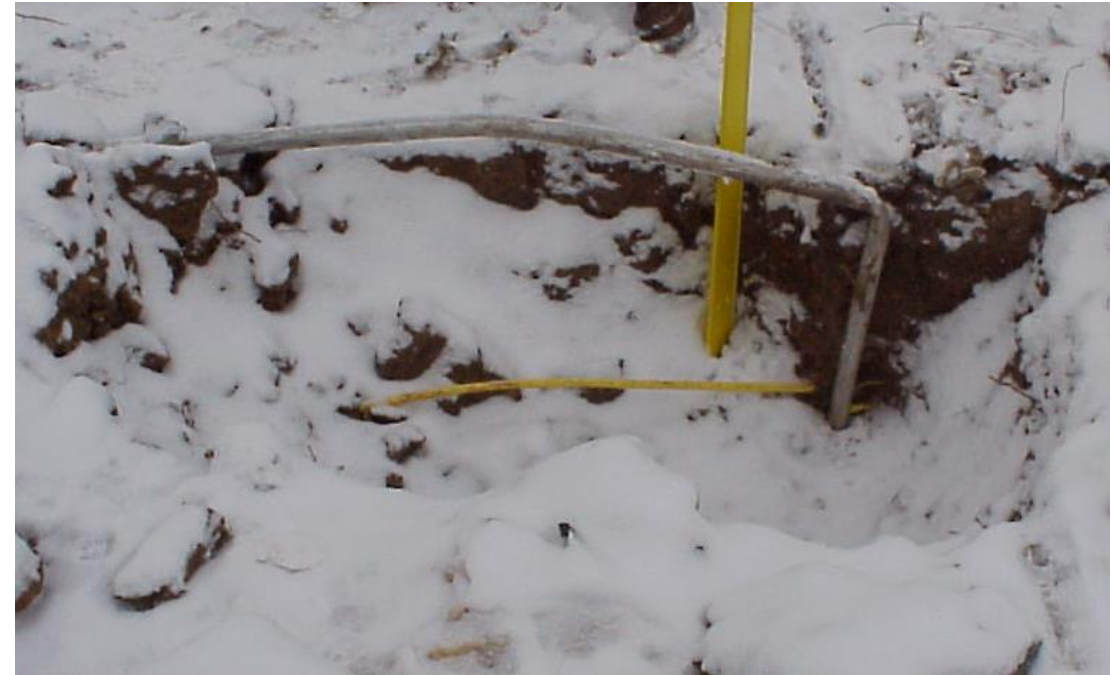
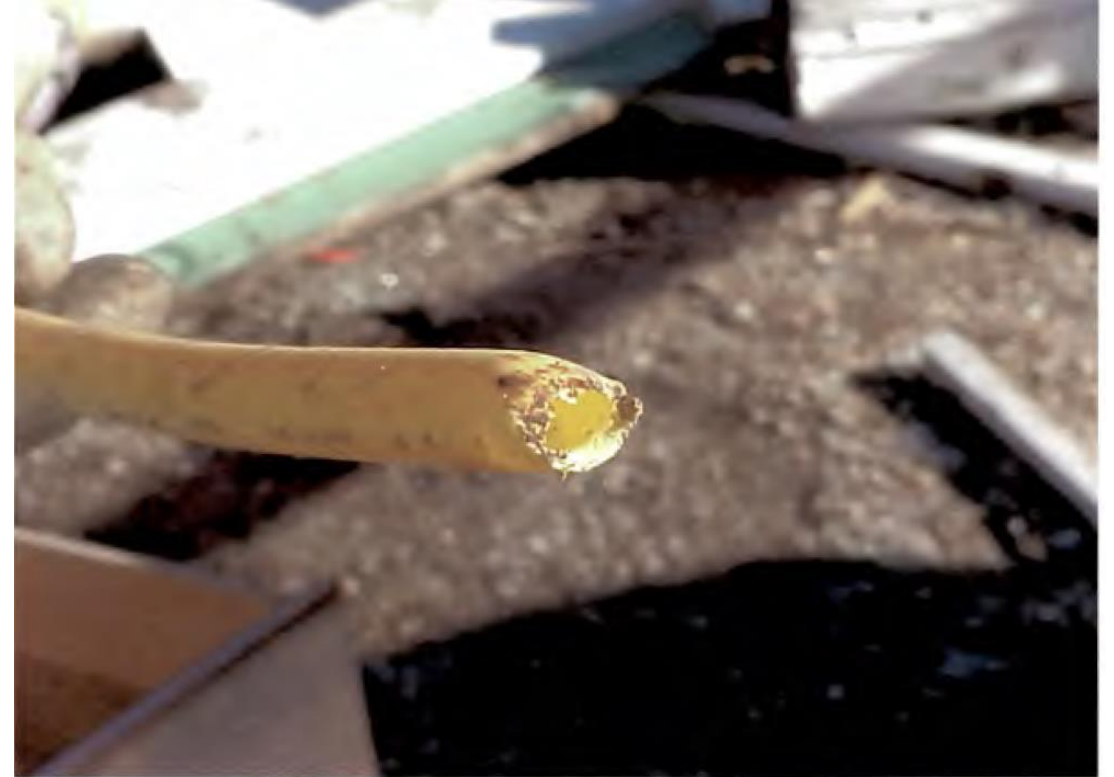
Stephensville – Bird Feeder Incident

- Post driver severed 5/8" service line
- Additional personnel requested for excavation assistance
- Home explosion with residents inside
- One fatality and estimated \$185,000 damage

- Resident did not call Digger's Hotline
- No communication of damaged line's proximity to house
- Operator failed to follow emergency plan
