# **Integrity Management Near Misses – Findings & Remediation**

Kyle Frayn – 2/5/2026 PSCW Safety Conference

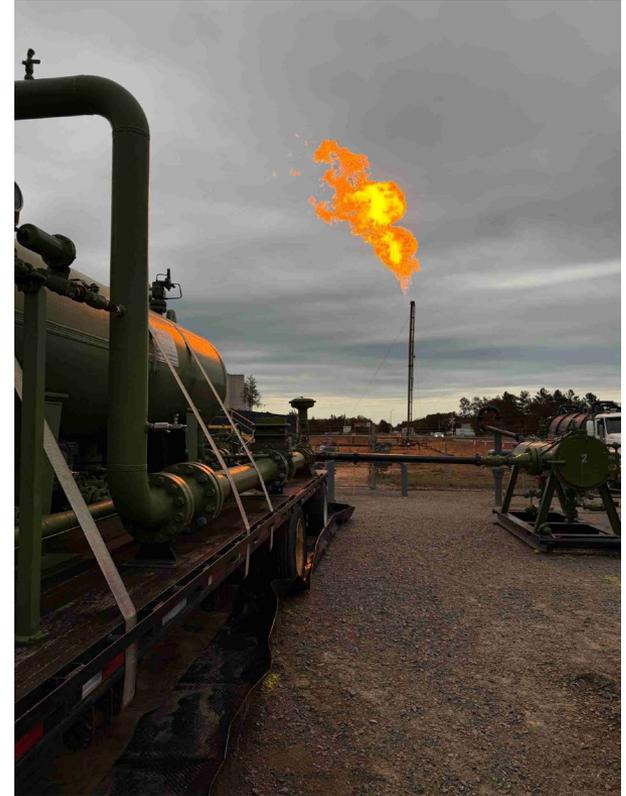
## **ILI Assessment in Jackson County**

- ILI smart pigs require a controlled gas flow rate to collect accurate data
- Unseasonably warm weather did not create enough gas flow
- Flaring equipment was used to increase gas flow
