# **NTSB Findings & Recommendations West Reading, PA candy factory explosion**

2026 Wisconsin Pipeline Safety Seminar  
Joe Murphy, PSC of Wisconsin

## UGI Corporation Natural Gas-Fueled Explosion and Fire

West Reading, Pennsylvania  
March 24, 2023

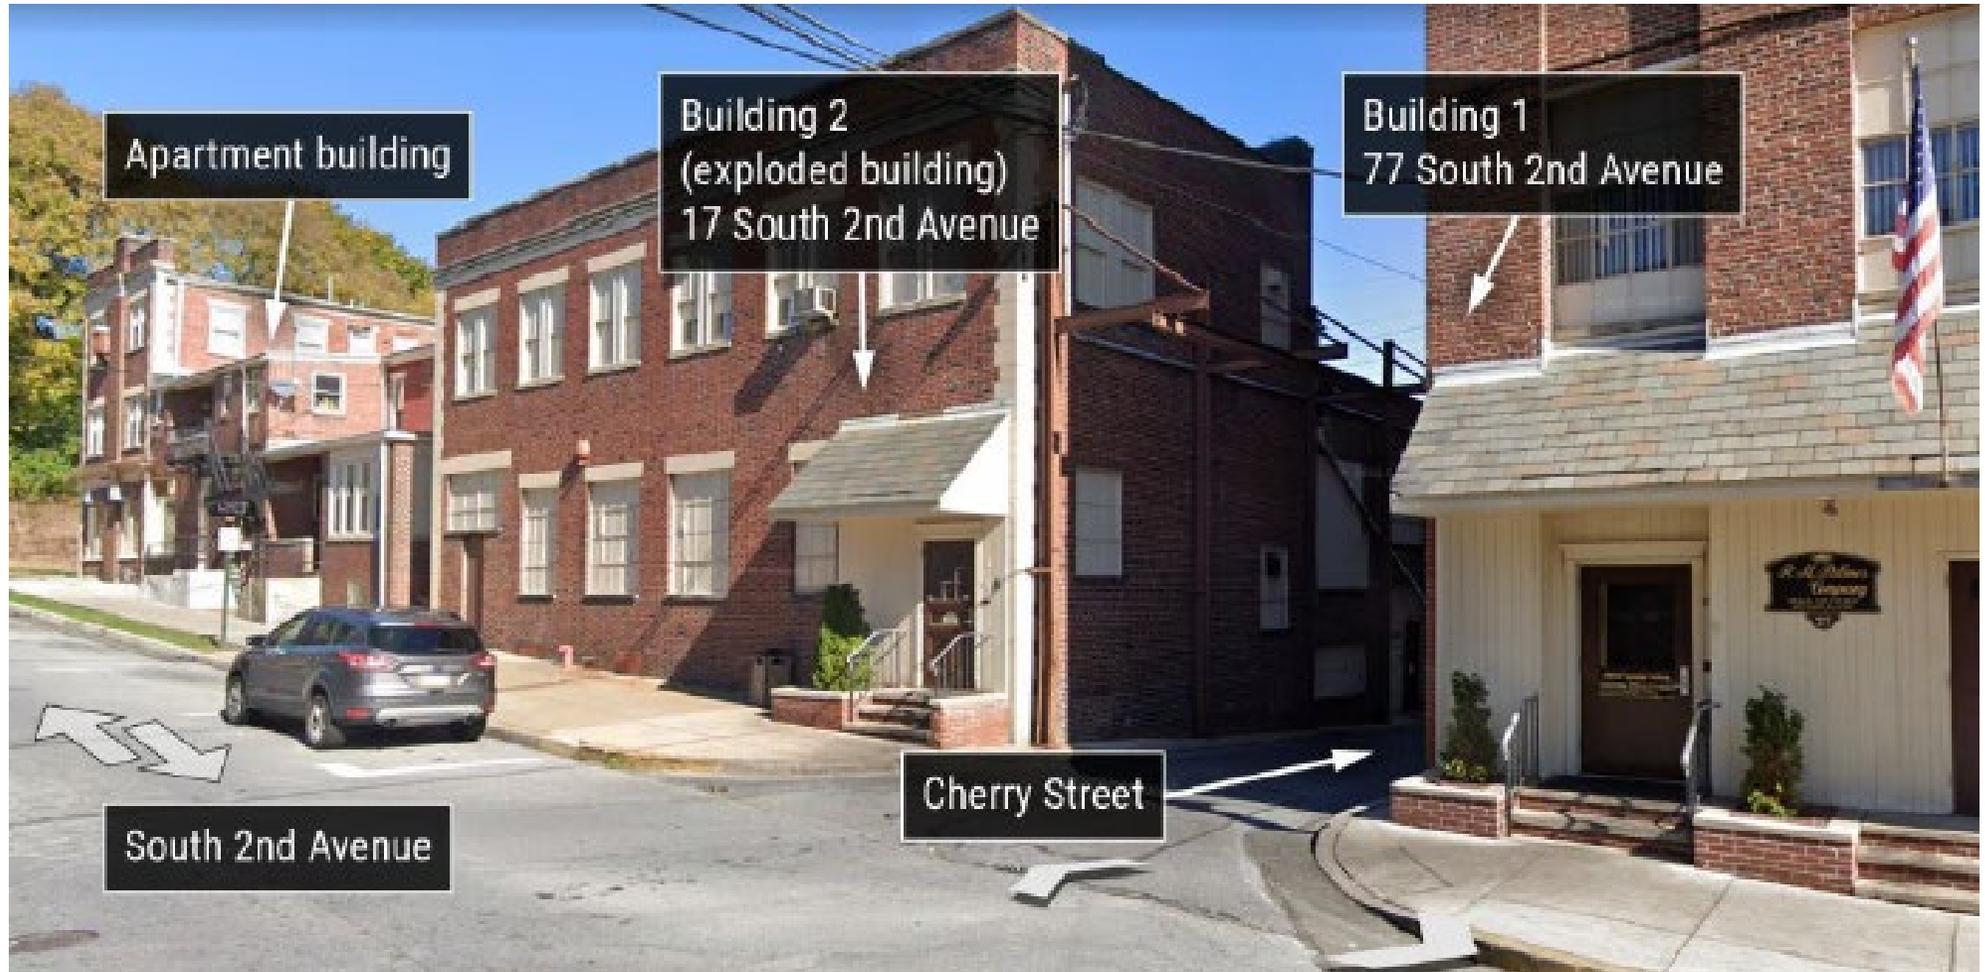
R.M. Palmer Company **before** the explosion

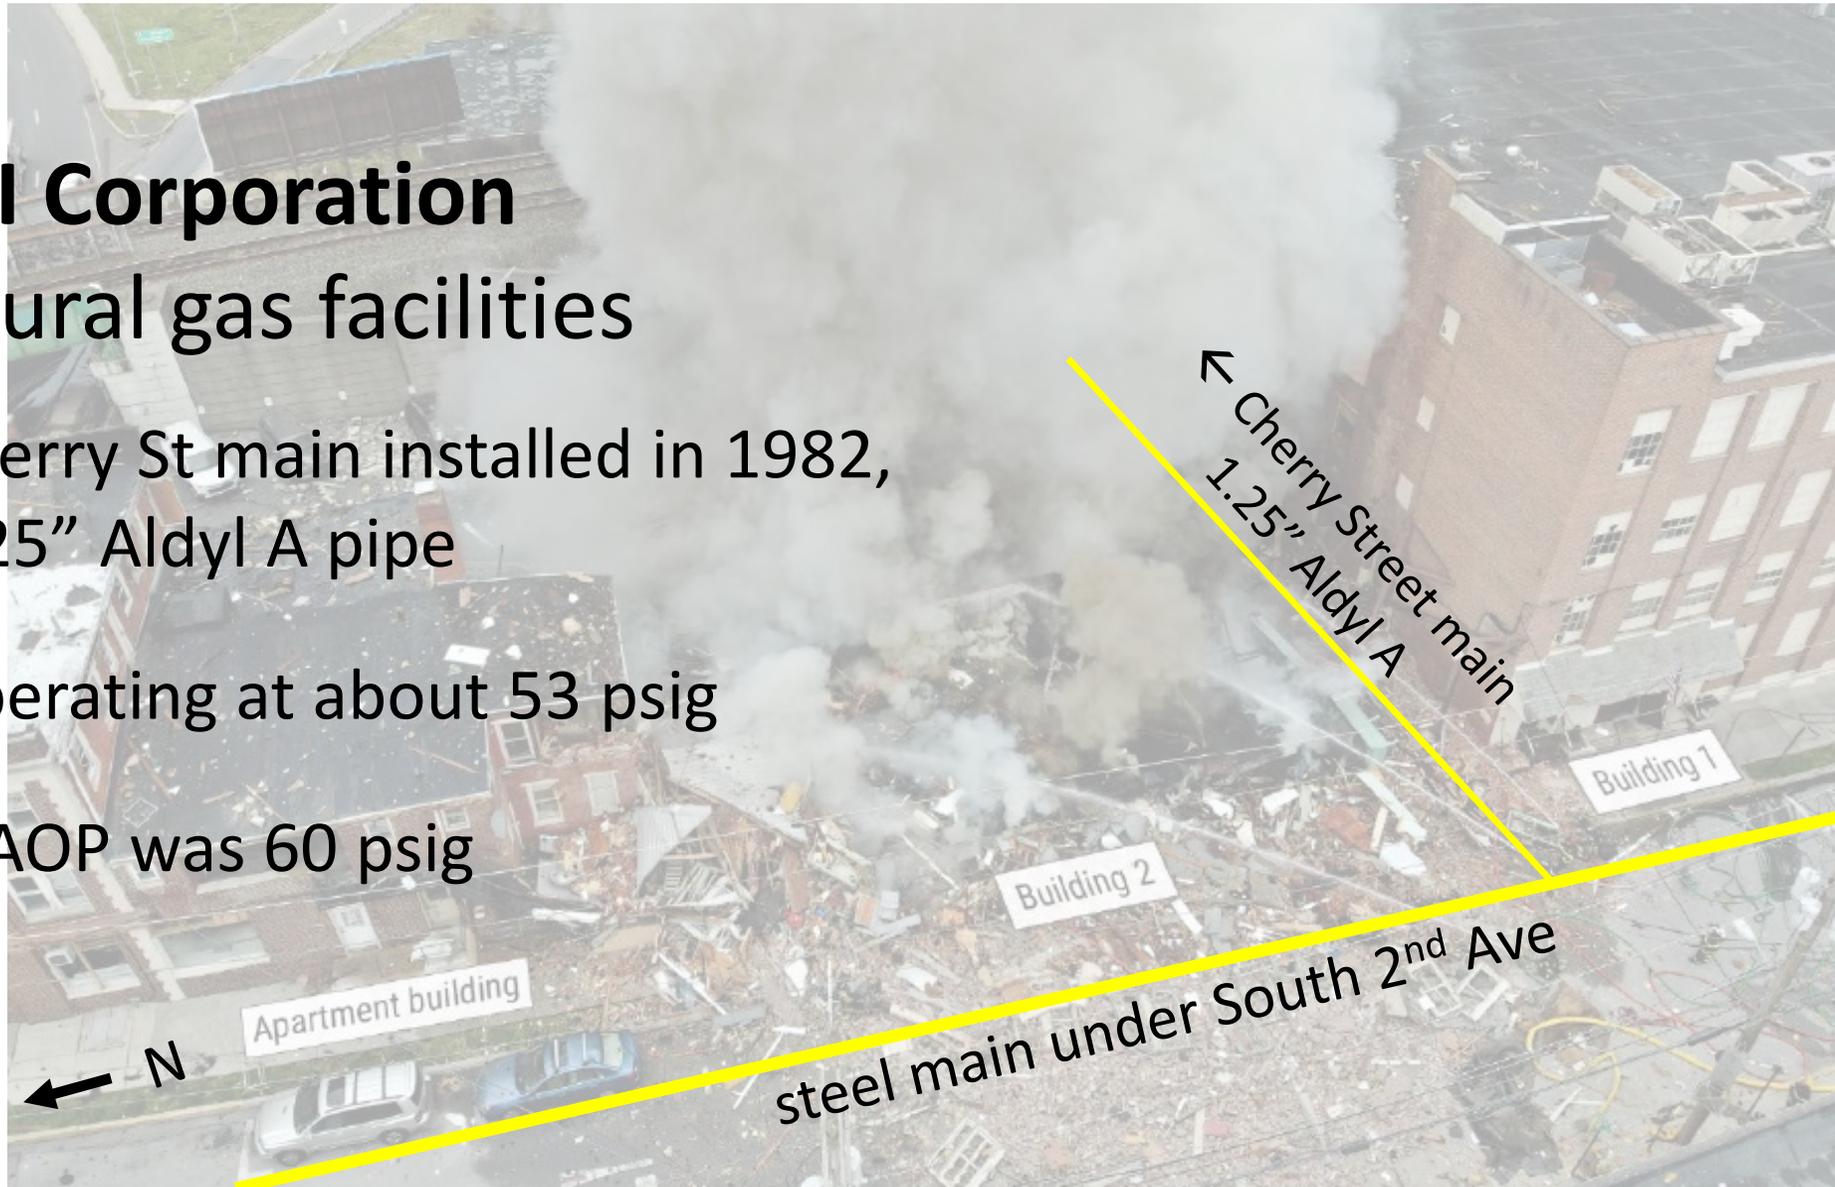
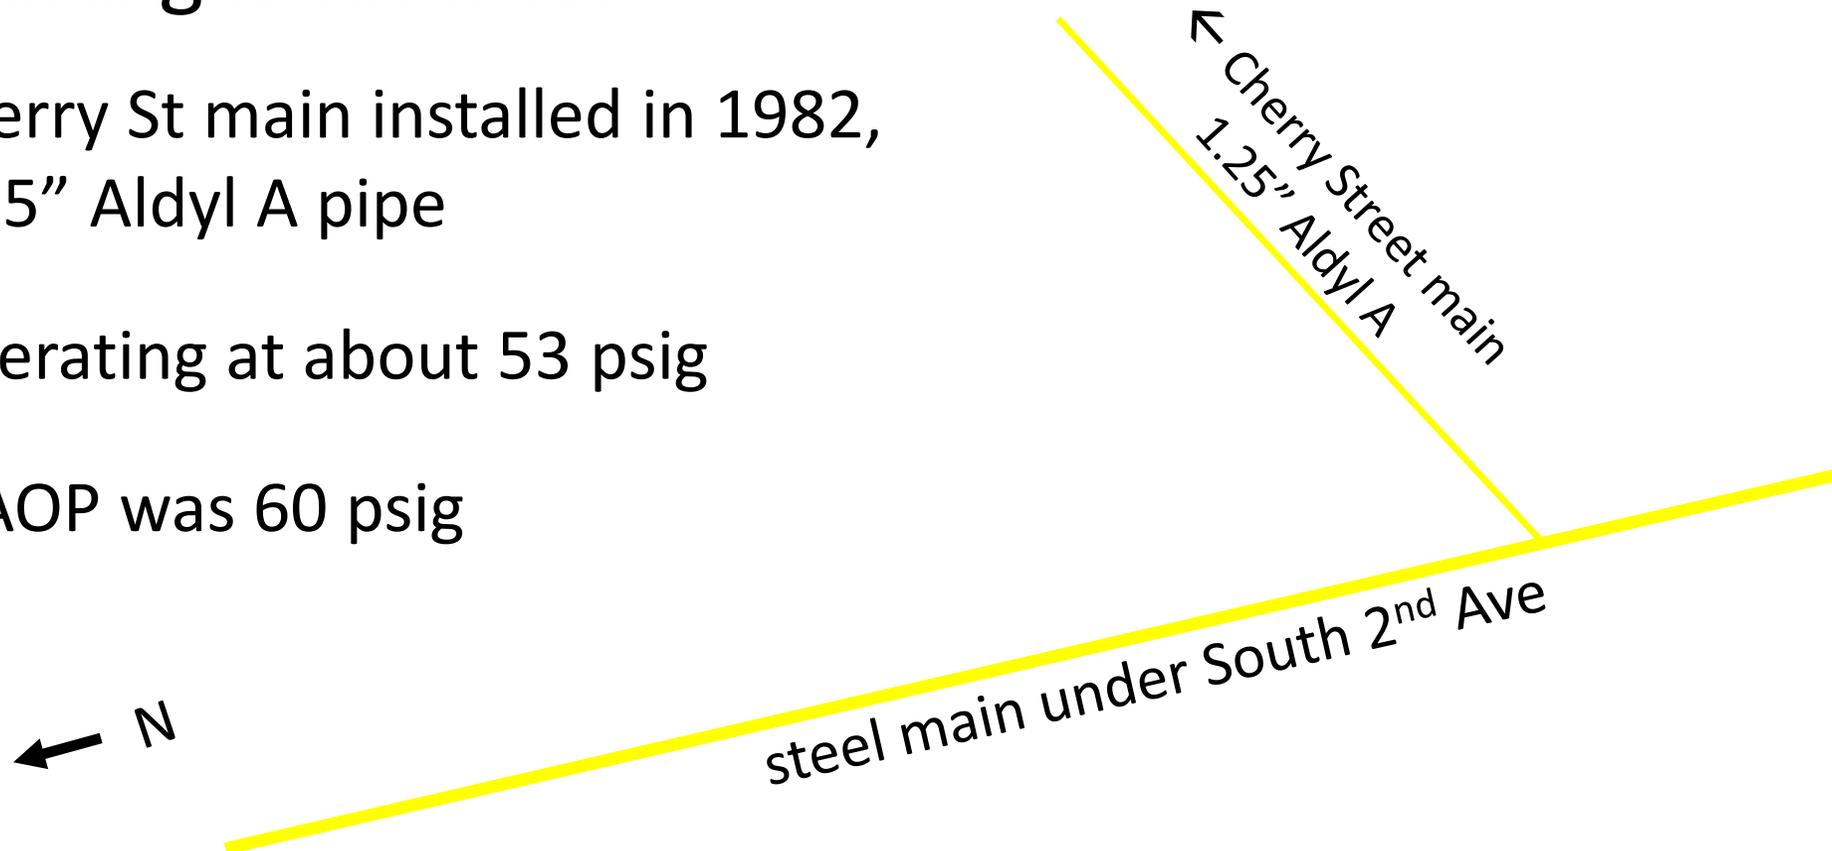
- Cherry St main installed in 1982,  
1.25" Aldyl A pipe
- Operating at about 53 psig
- MAOP was 60 psig

- Cherry St main installed in 1982, 1.25" Aldyl A pipe
- Operating at about 53 psig
- MAOP was 60 psig

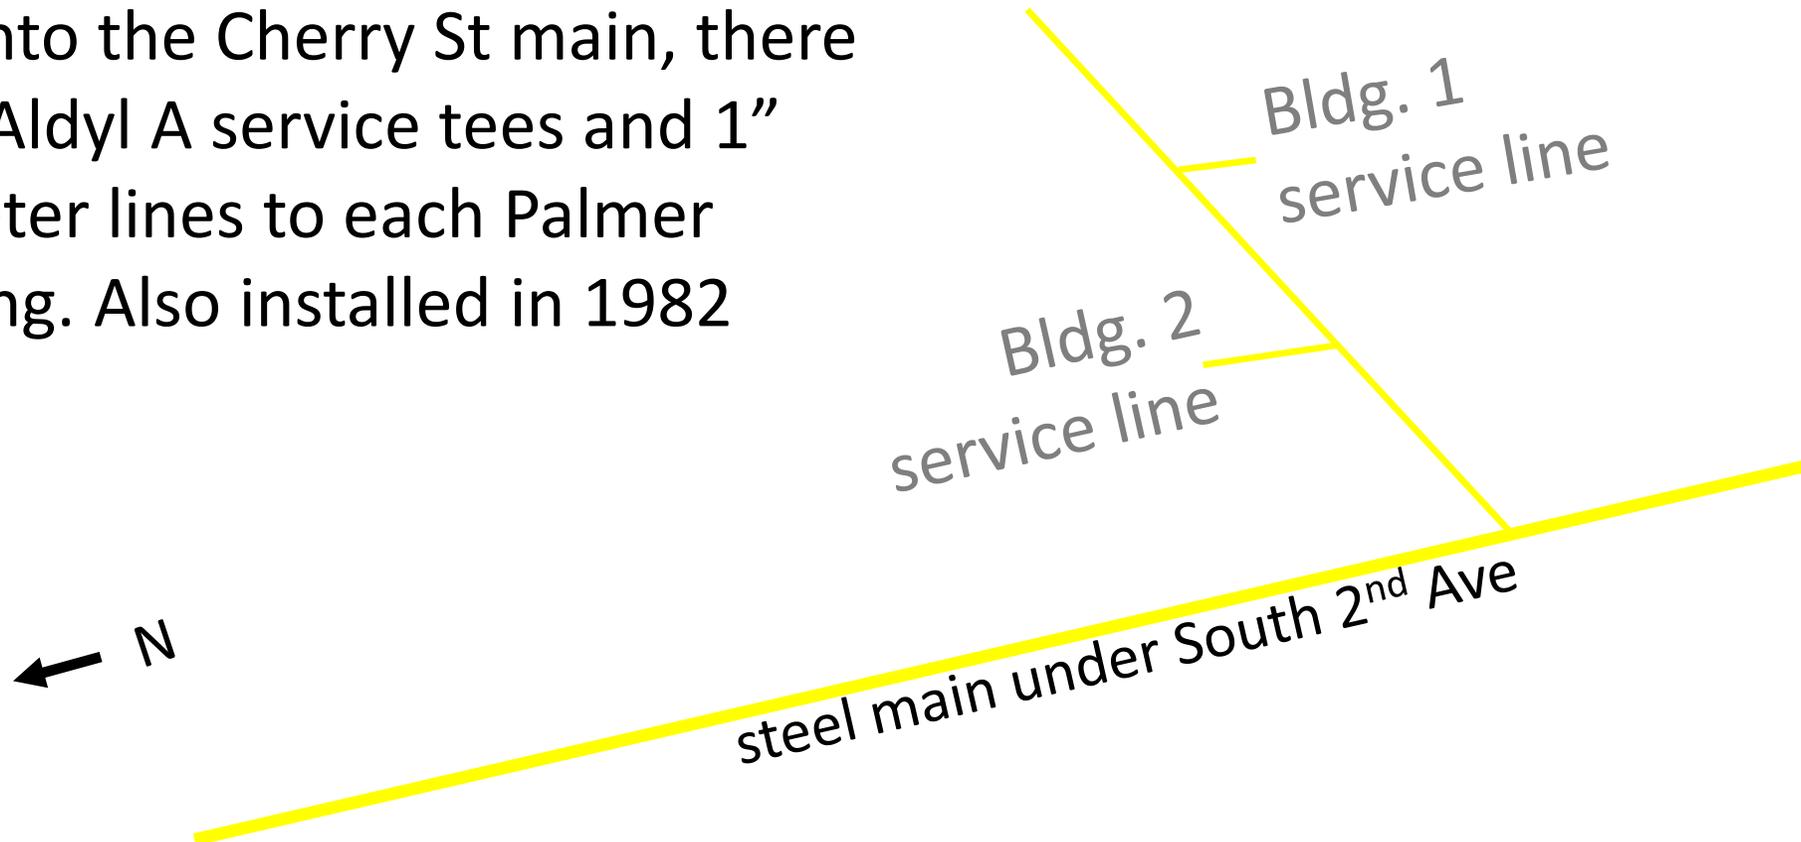
- Tied into the Cherry St main, there were Aldyl A service tees and 1" diameter lines to each Palmer building. Also installed in 1982

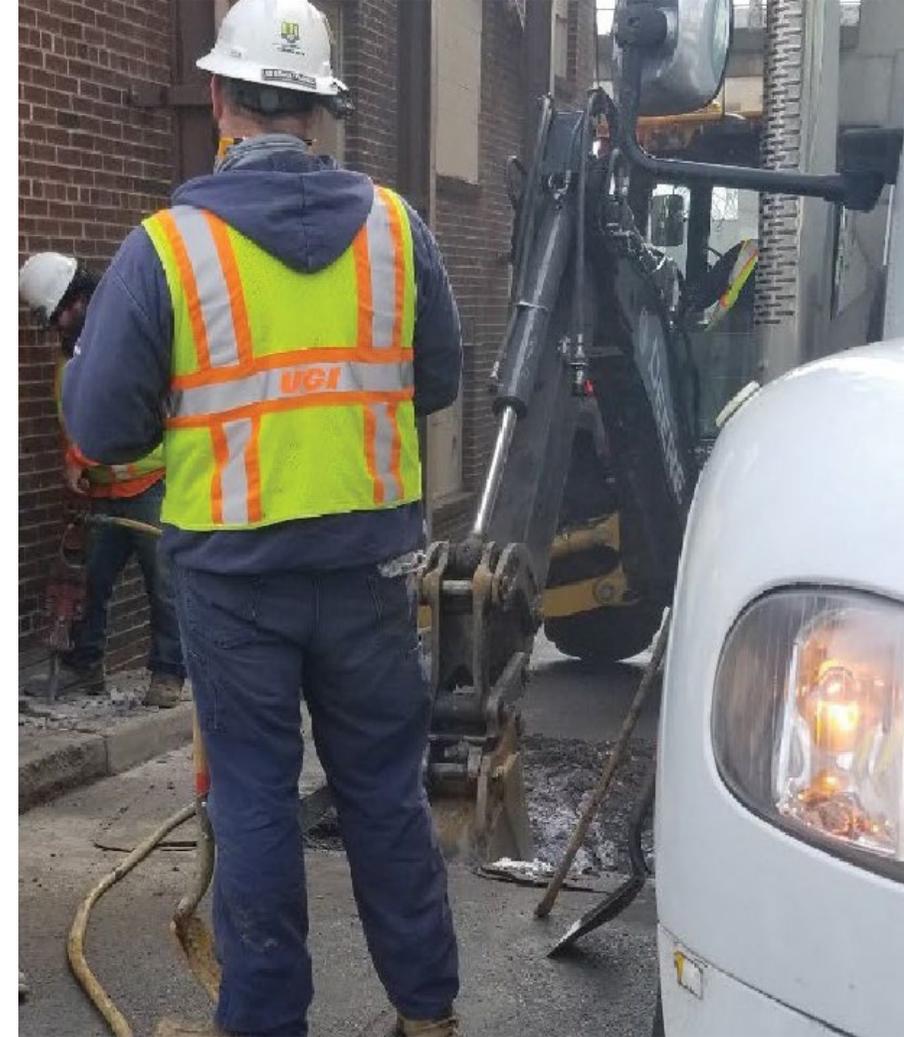
- As required by UGI procedures this grade of leak called for immediate attention, so UGI replaced the service line, service tee, and moved the meter from basement of Building 2
- As part of this process, the old Aldyl A service line and tee from 1982 was cut and capped and the stub left in place

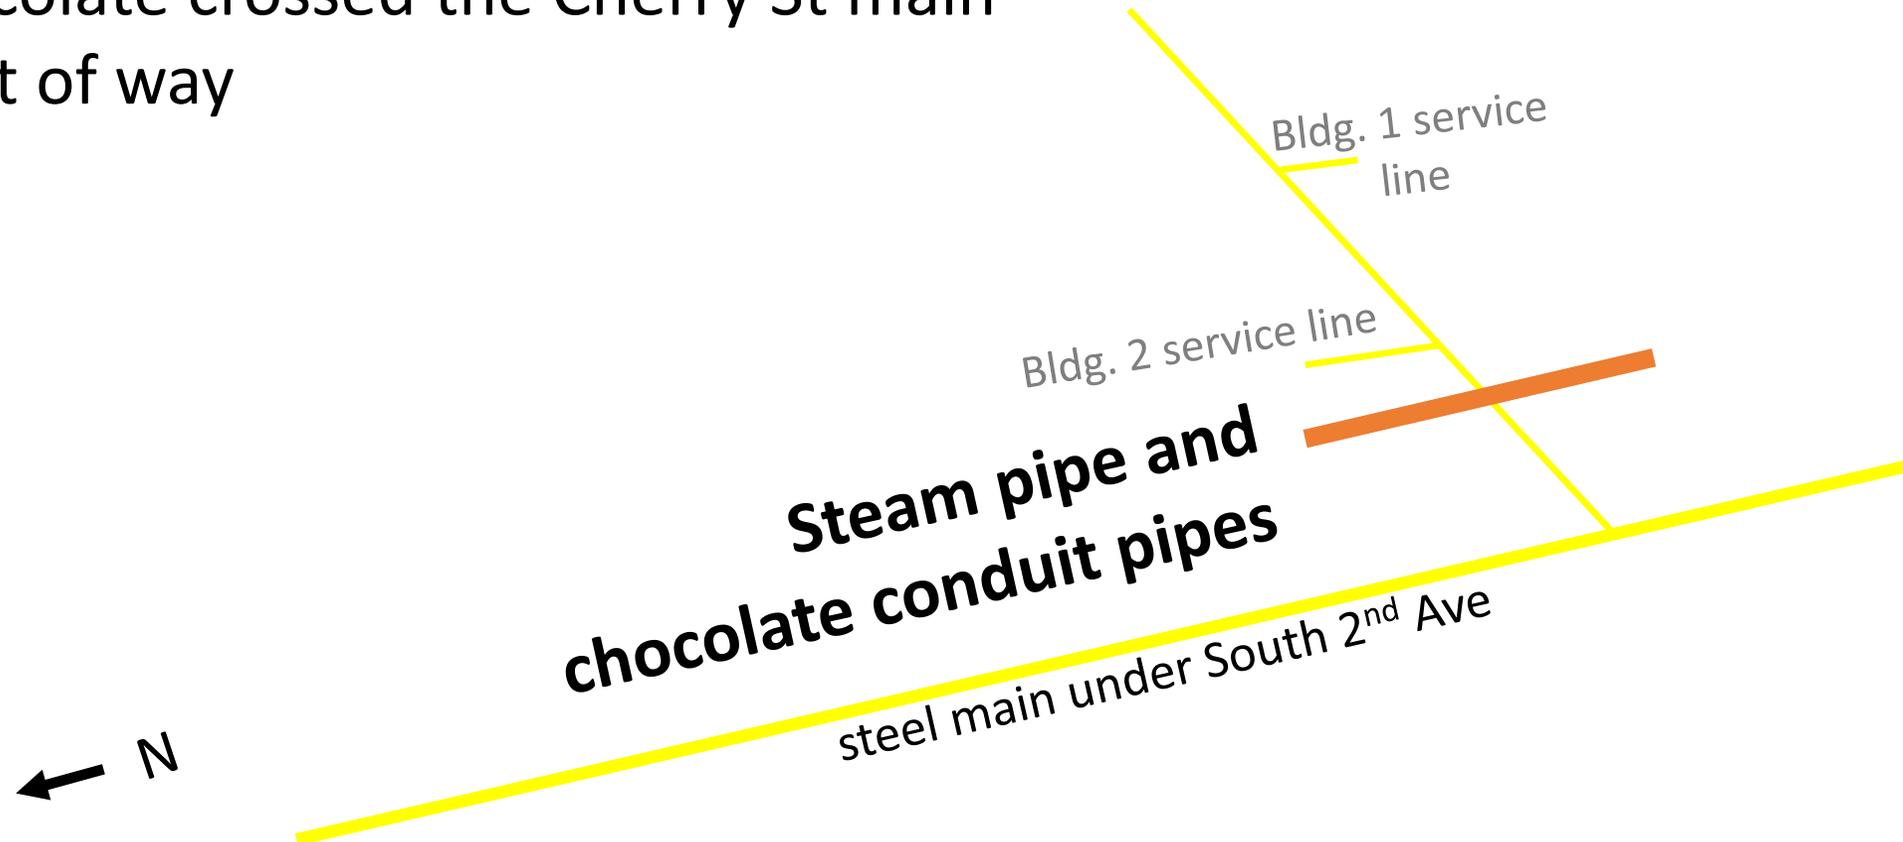
- Palmer-owned pipes carrying steam, condensate, and conduits for chocolate crossed the Cherry St main right of way

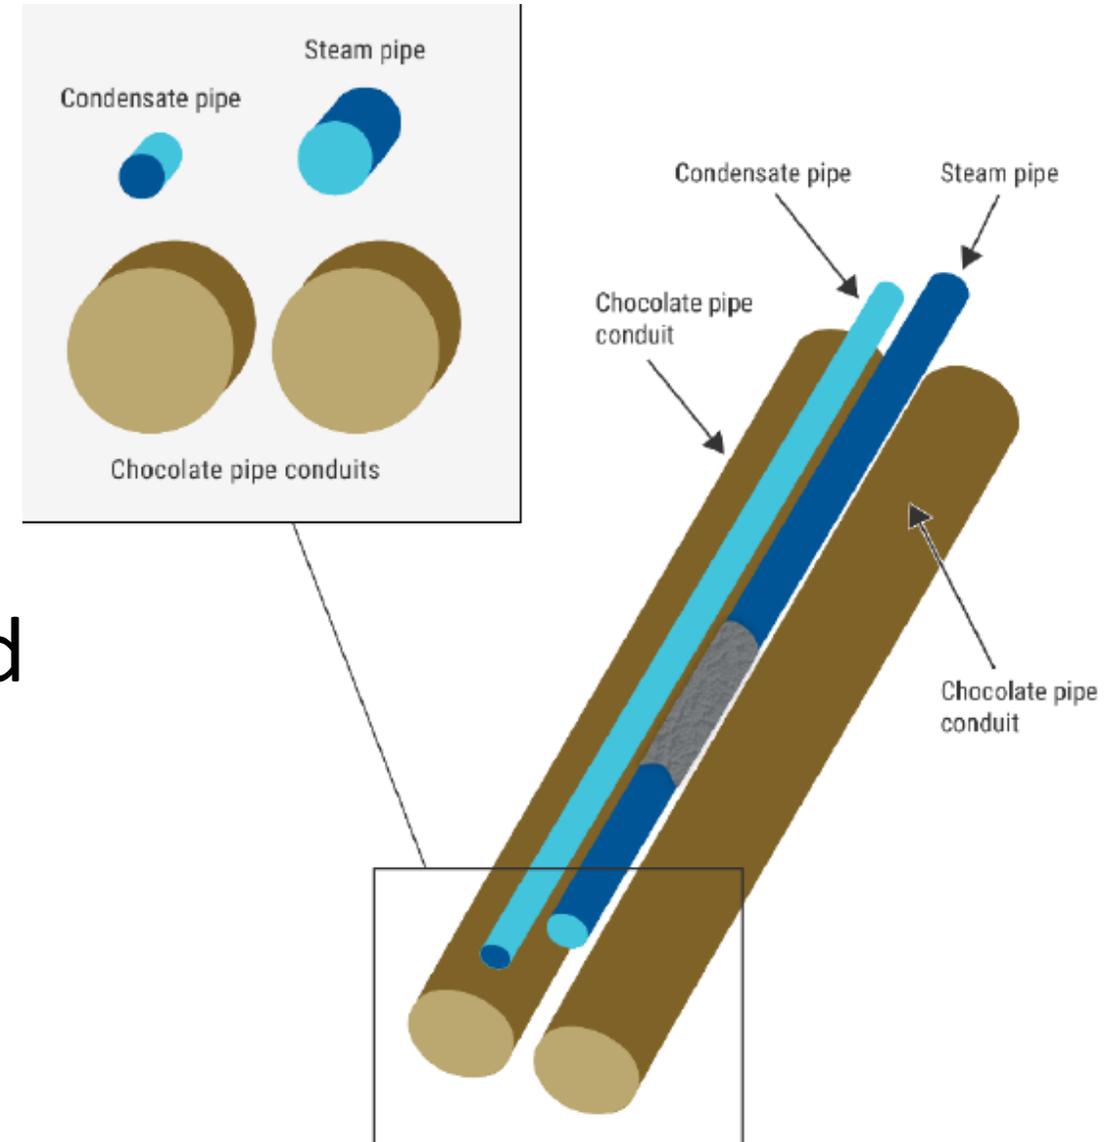
- Steam was used for heating the two Palmer buildings
- Chocolate pipe conduit carried smaller pipes for candy production

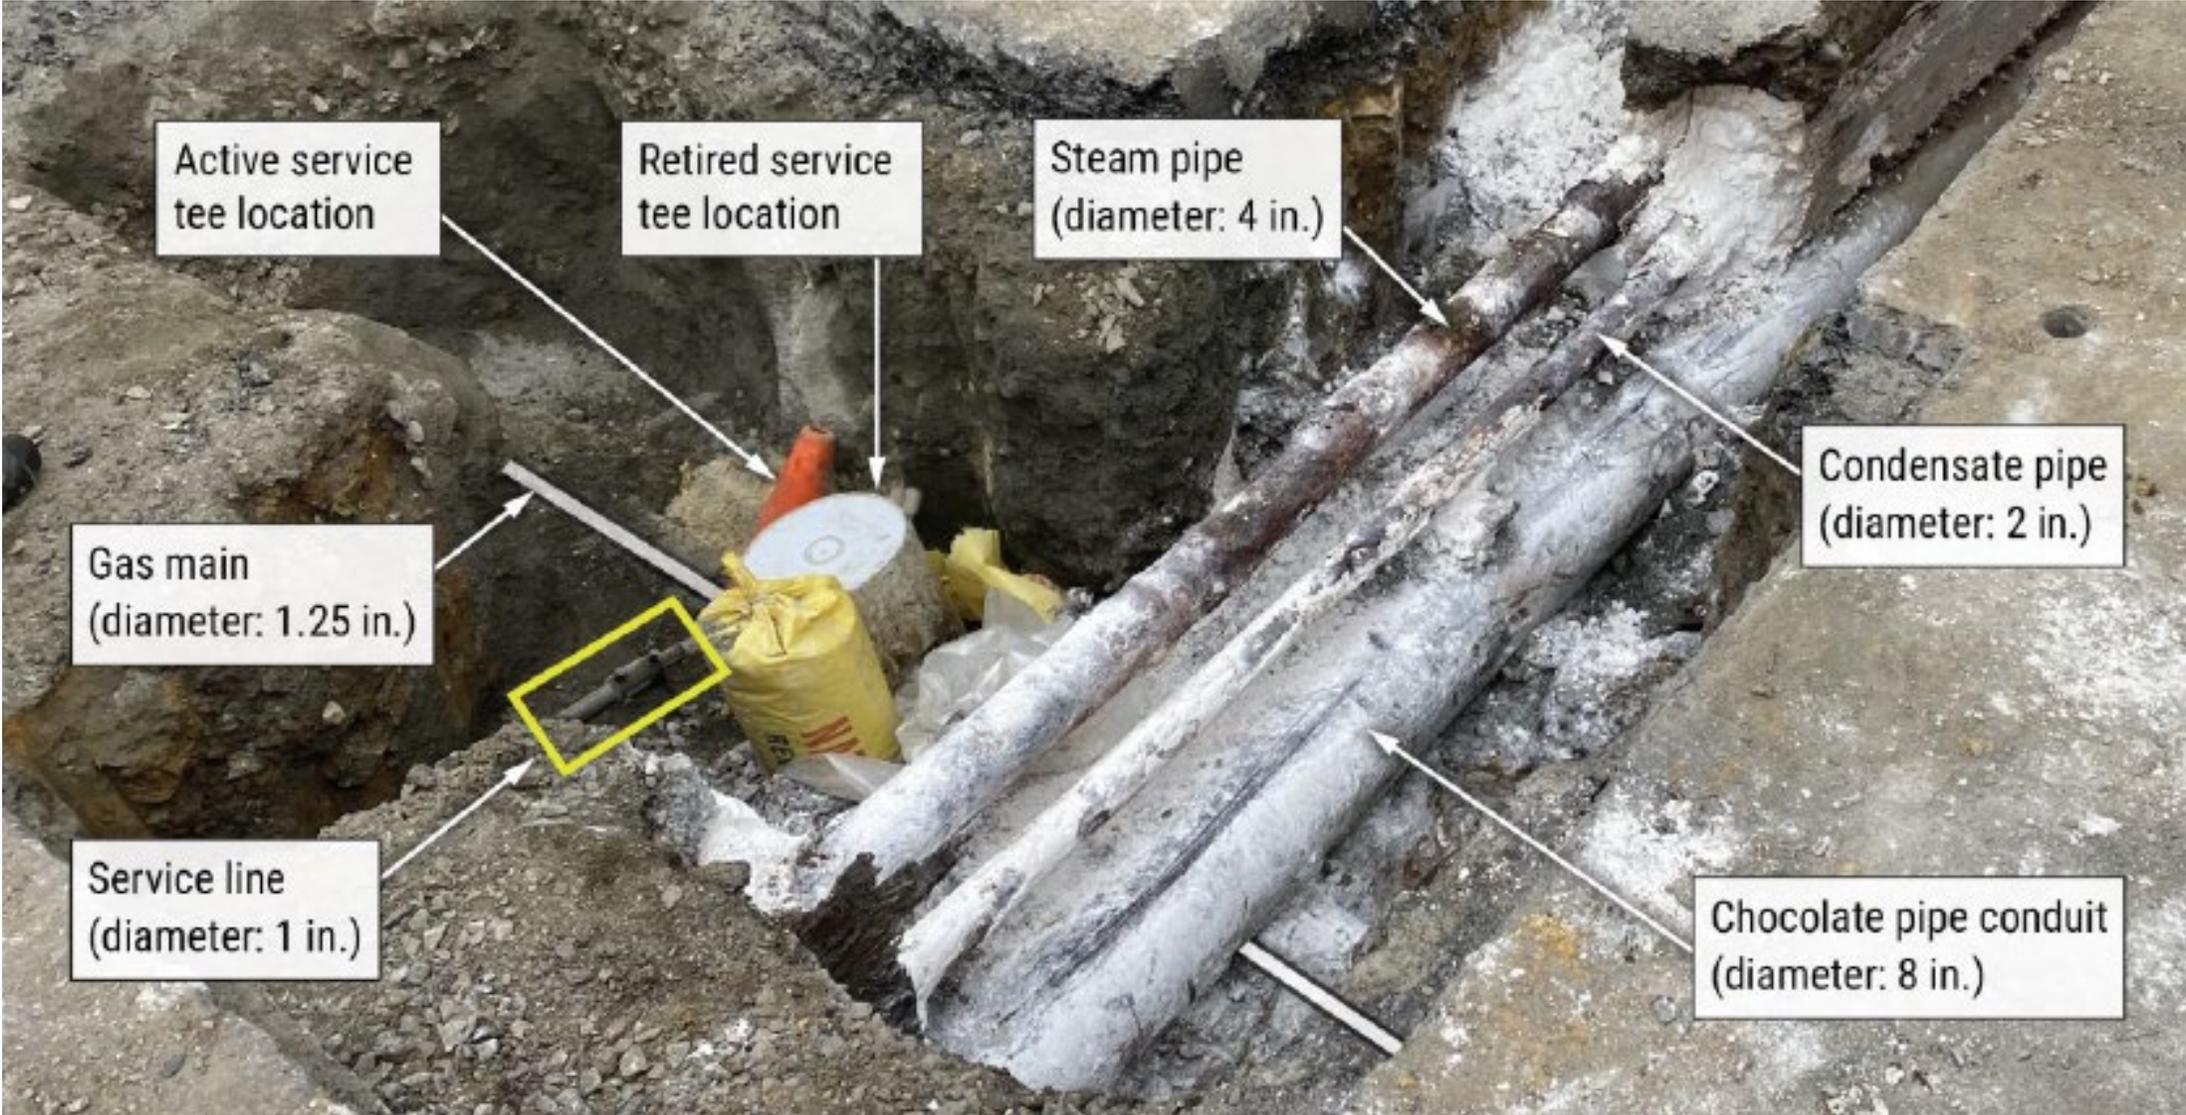
# Palmer Pipes

- The retired service tee failed due to elevated ground temperatures from steam escaping R.M. Palmer Company's corroded underground steam pipe, located near the retired service tee.
- The steam pipe had been unmarked and cracked.
