Wisconsin Incidents 1986 - Present

Wisconsin Pipeline Safety Seminar

Public Service Commission of Wisconsin

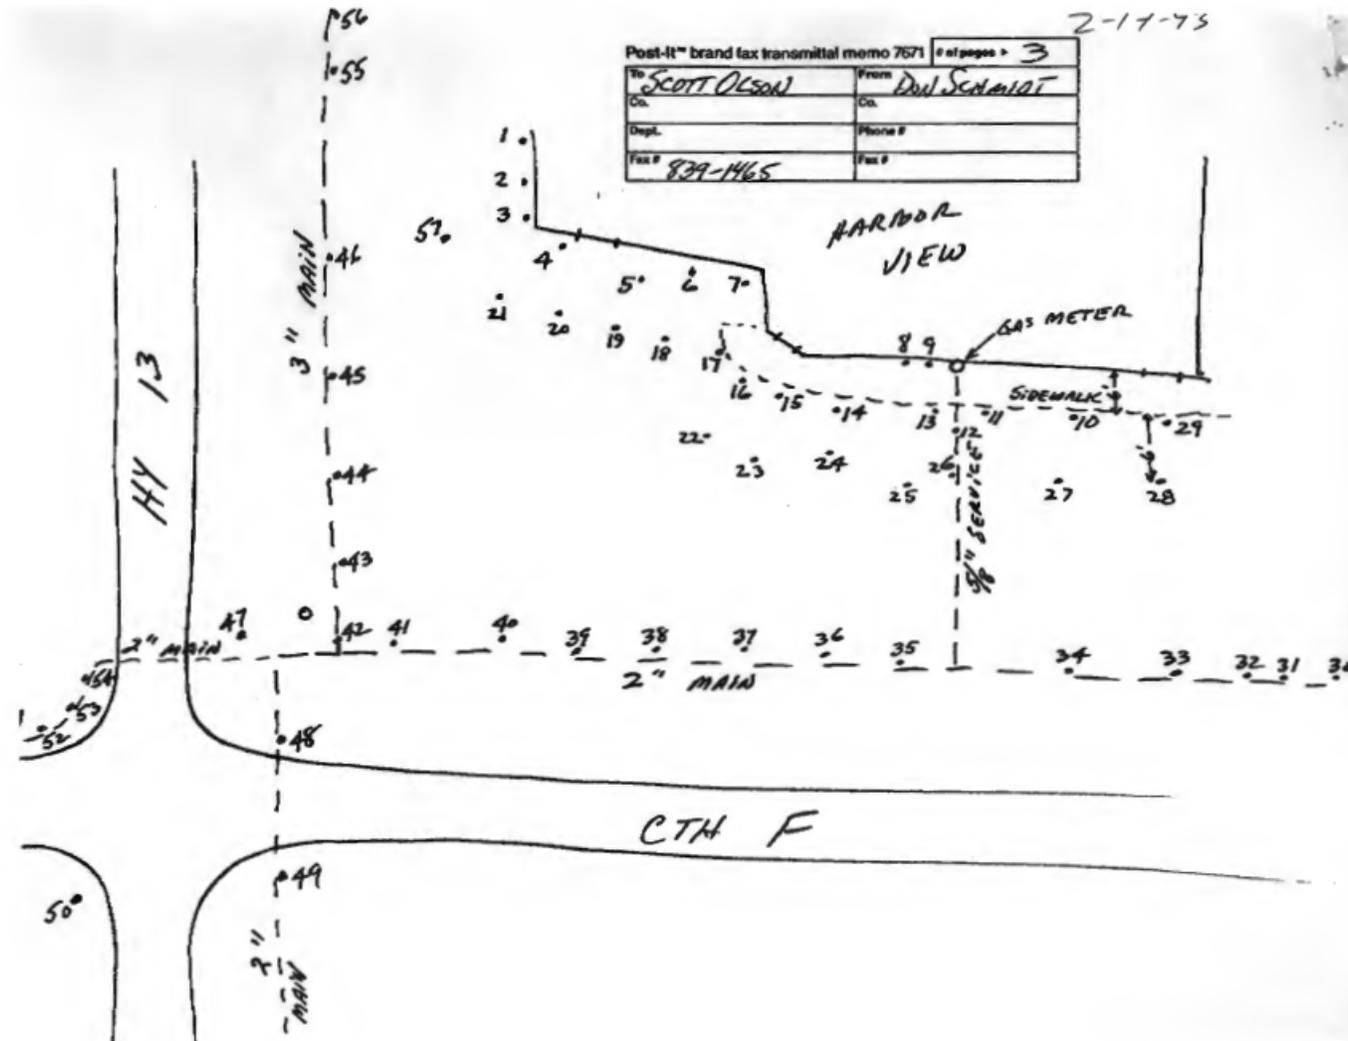
- Bar-holing in grid pattern around the building and then along main.

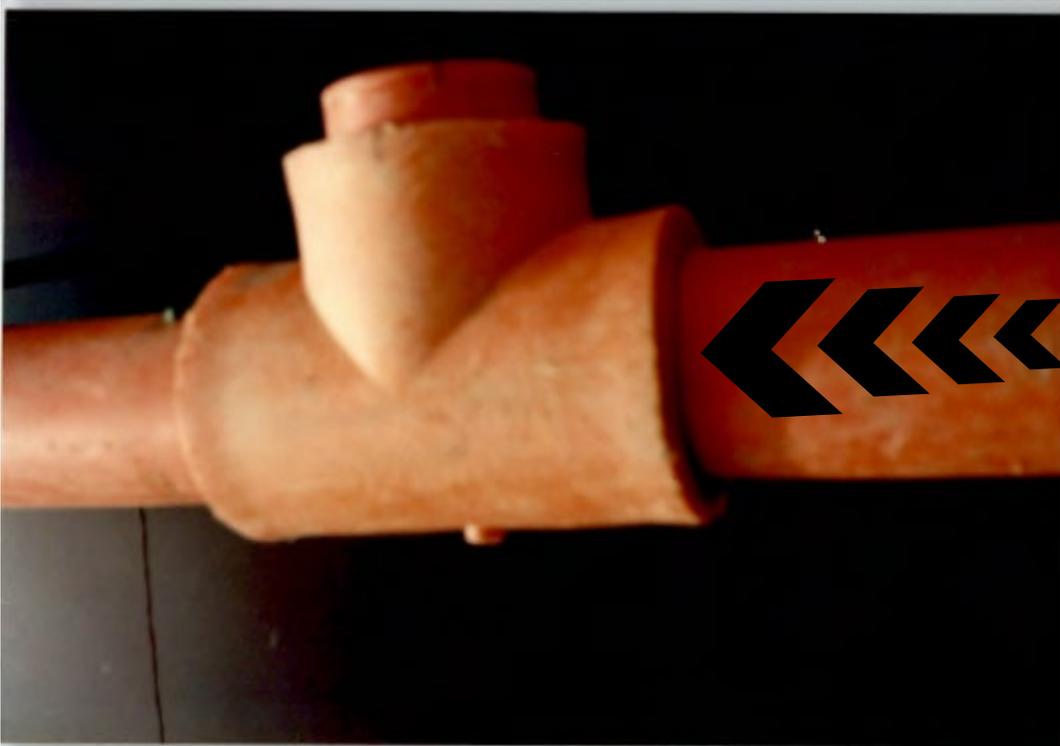
FIG. X2.3 Unacceptable due to angular misalignment

- Portion of the main going into the 3x3x3in tee was at an angle.
- This portion of main was cracked next to the tee.
- Portion of damaged main was below parking lot, heavier frost effects.
- There had been recent third-party excavation work for a new sewer lateral in November 1992.

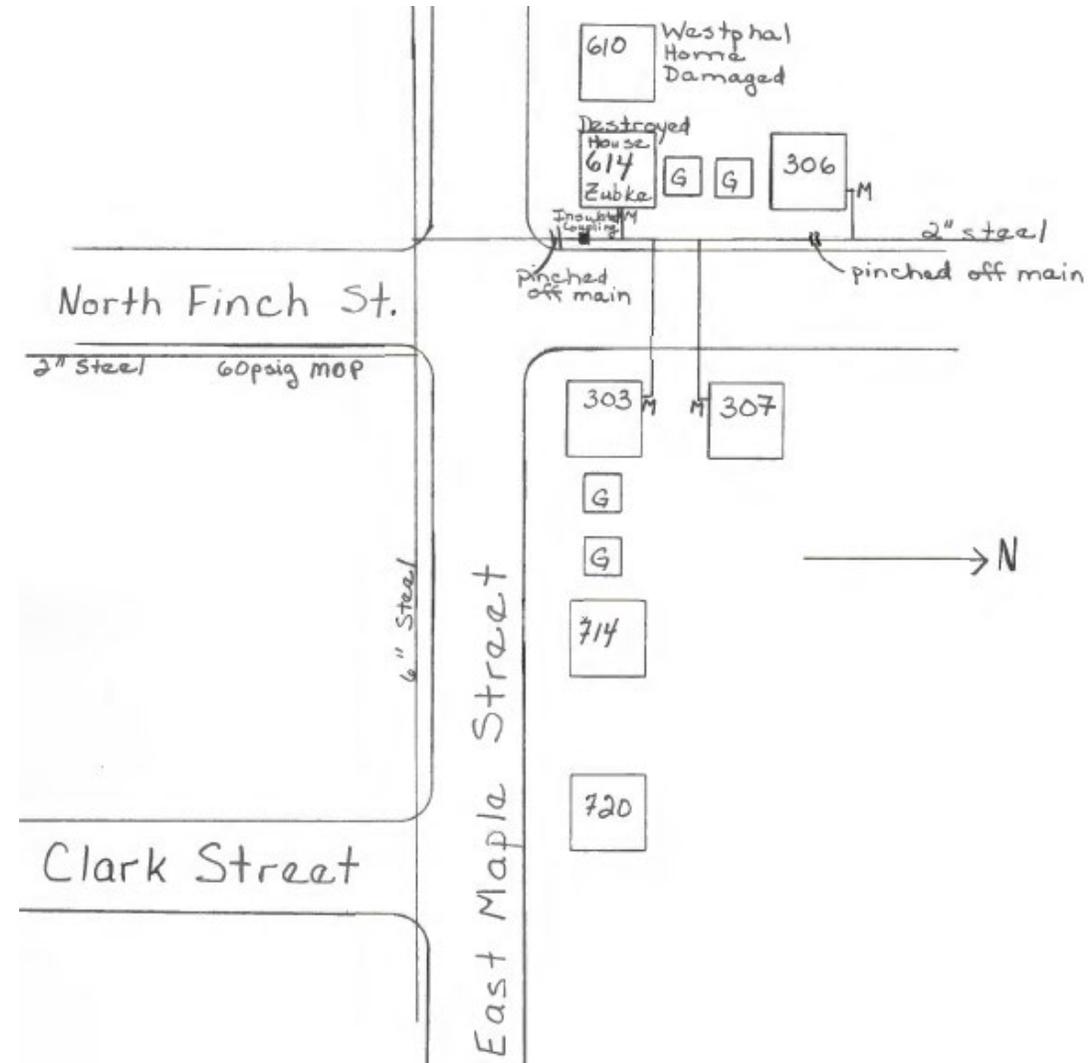
- Explosion occurs at approximately 5:30am.
- Operator is notified at 5:45am and informed police and fire are on the scene.
- Operator arrives on scene to find service sheared off and gas fueling the fire.
- Operator works to squeeze off steel main.

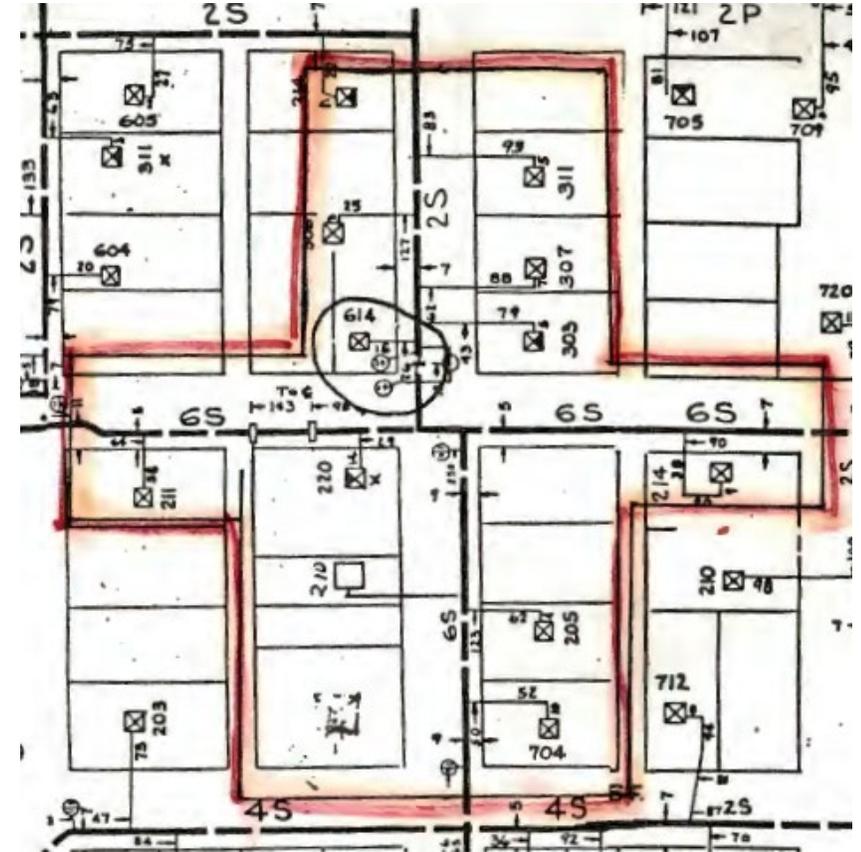
- Operator begins bar-holing the highlighted area and checks street openings.
 - 5% gas-in-air found at the intersection's manhole
- Smell of odorant evident during excavation.
- At 7:45am the Commission is notified.
- At 8:30am the section of main is stopped.
- By 10:45am the fire is out and the Commission arrives onsite.

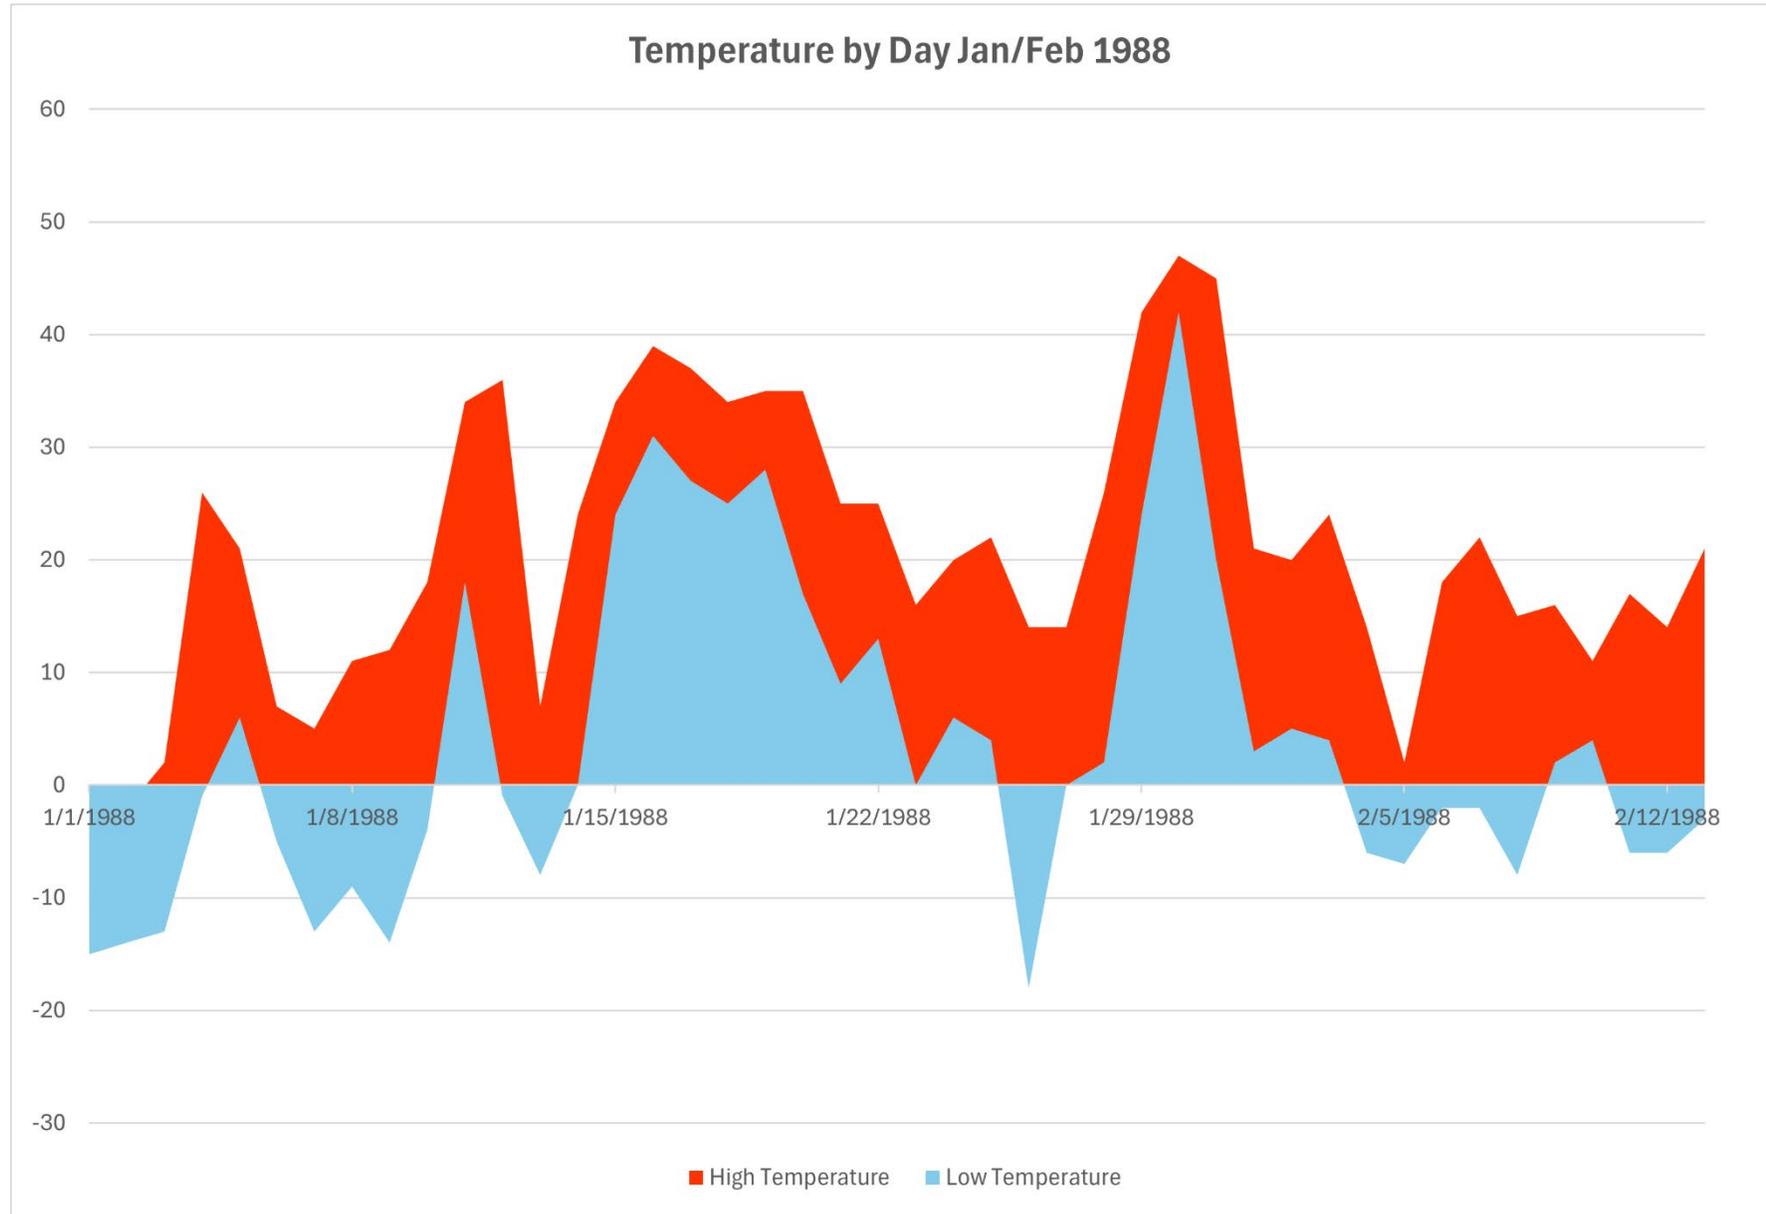
1. Failure occurred due to stress overload, impact fracture or transition temperature fracture.
2. Stress for failure produced by ground surges due to freeze/thaw, or vehicles going over the road.
3. Coupling believe to not be stress relieved after forging.

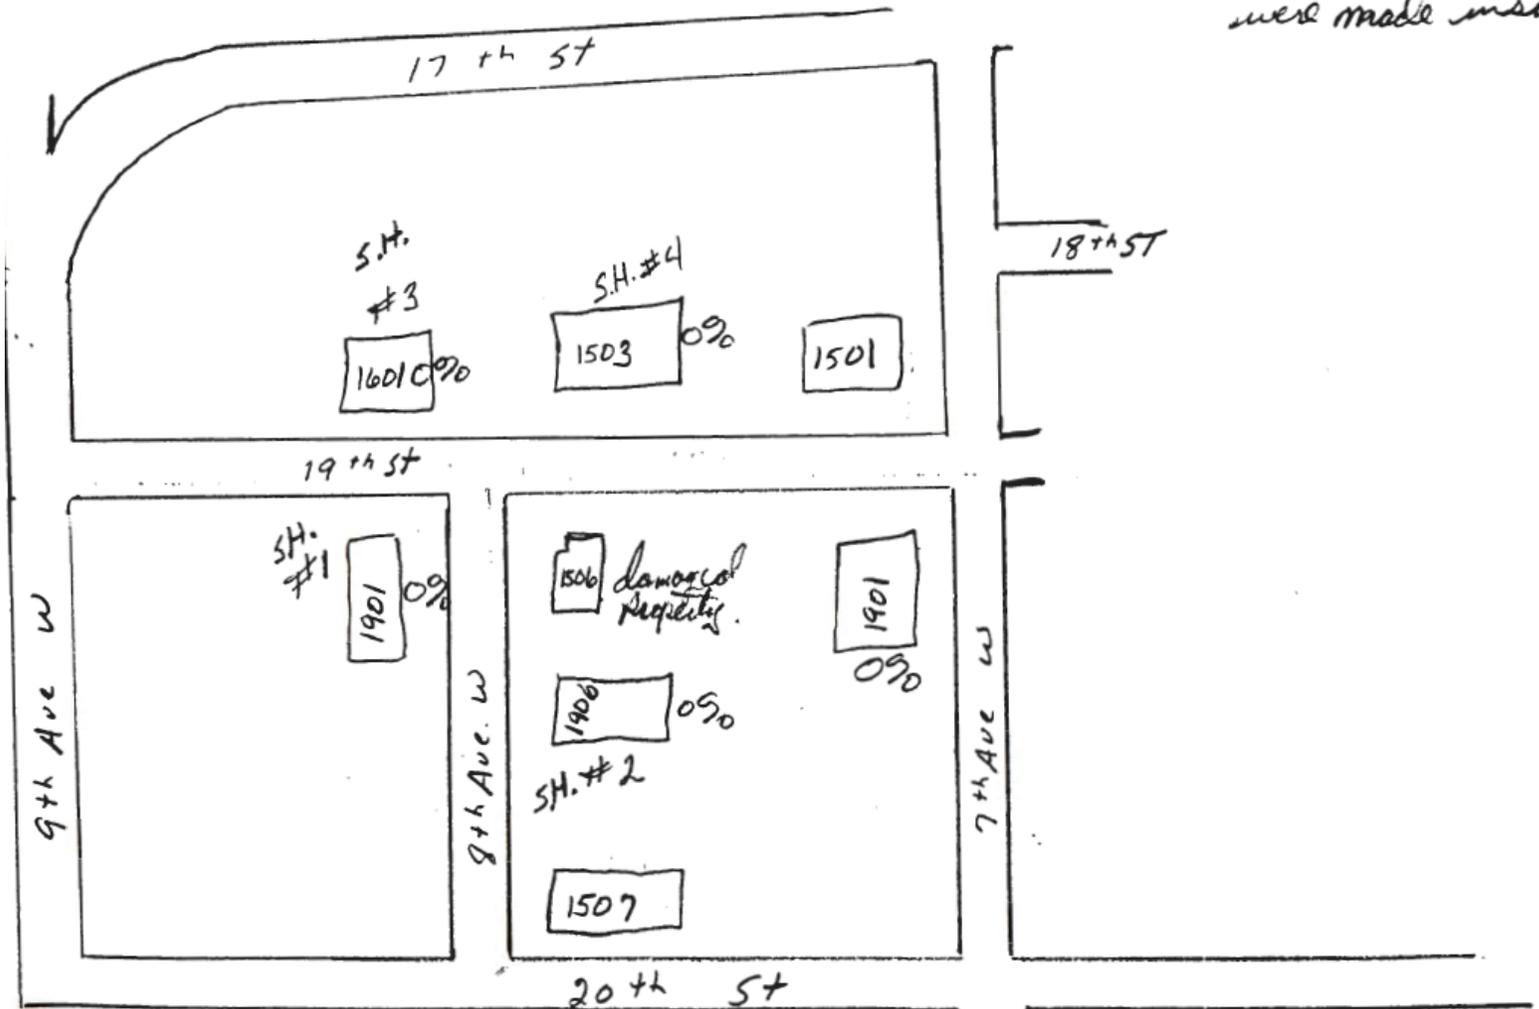
Interior of house
surveys were negative
for gas

#1. Shows ^{where} inspections
of surrounding homes
were made inside.

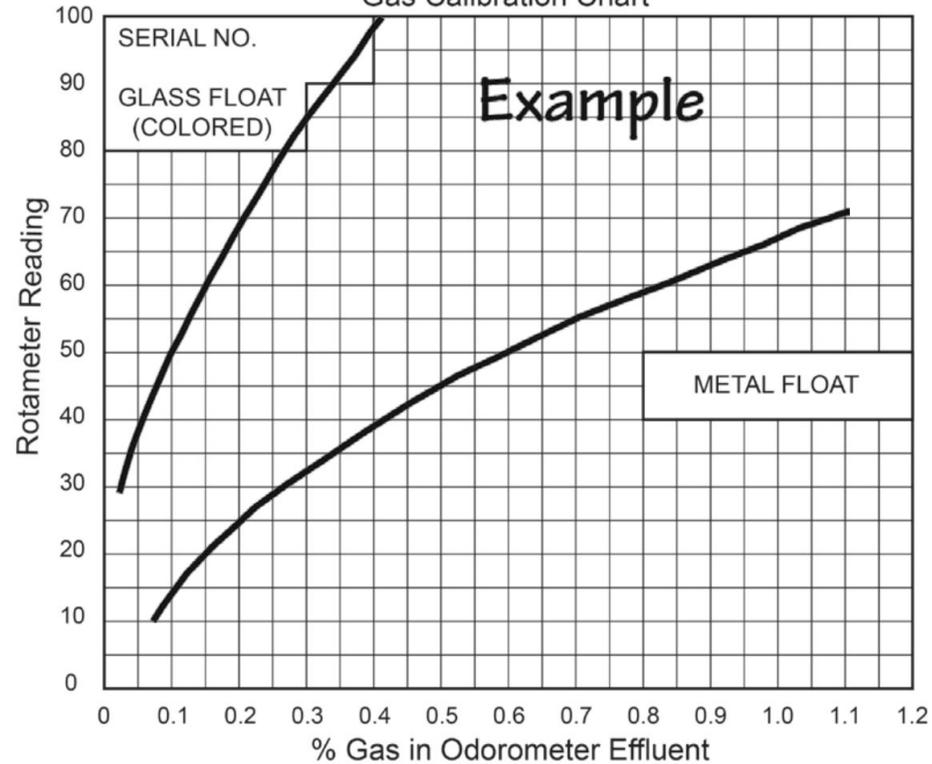
- Odorometer test had had found odorant to be acceptable.

* This shows where the odorometer was taken at kitchen range. Approx 6:30 PM.

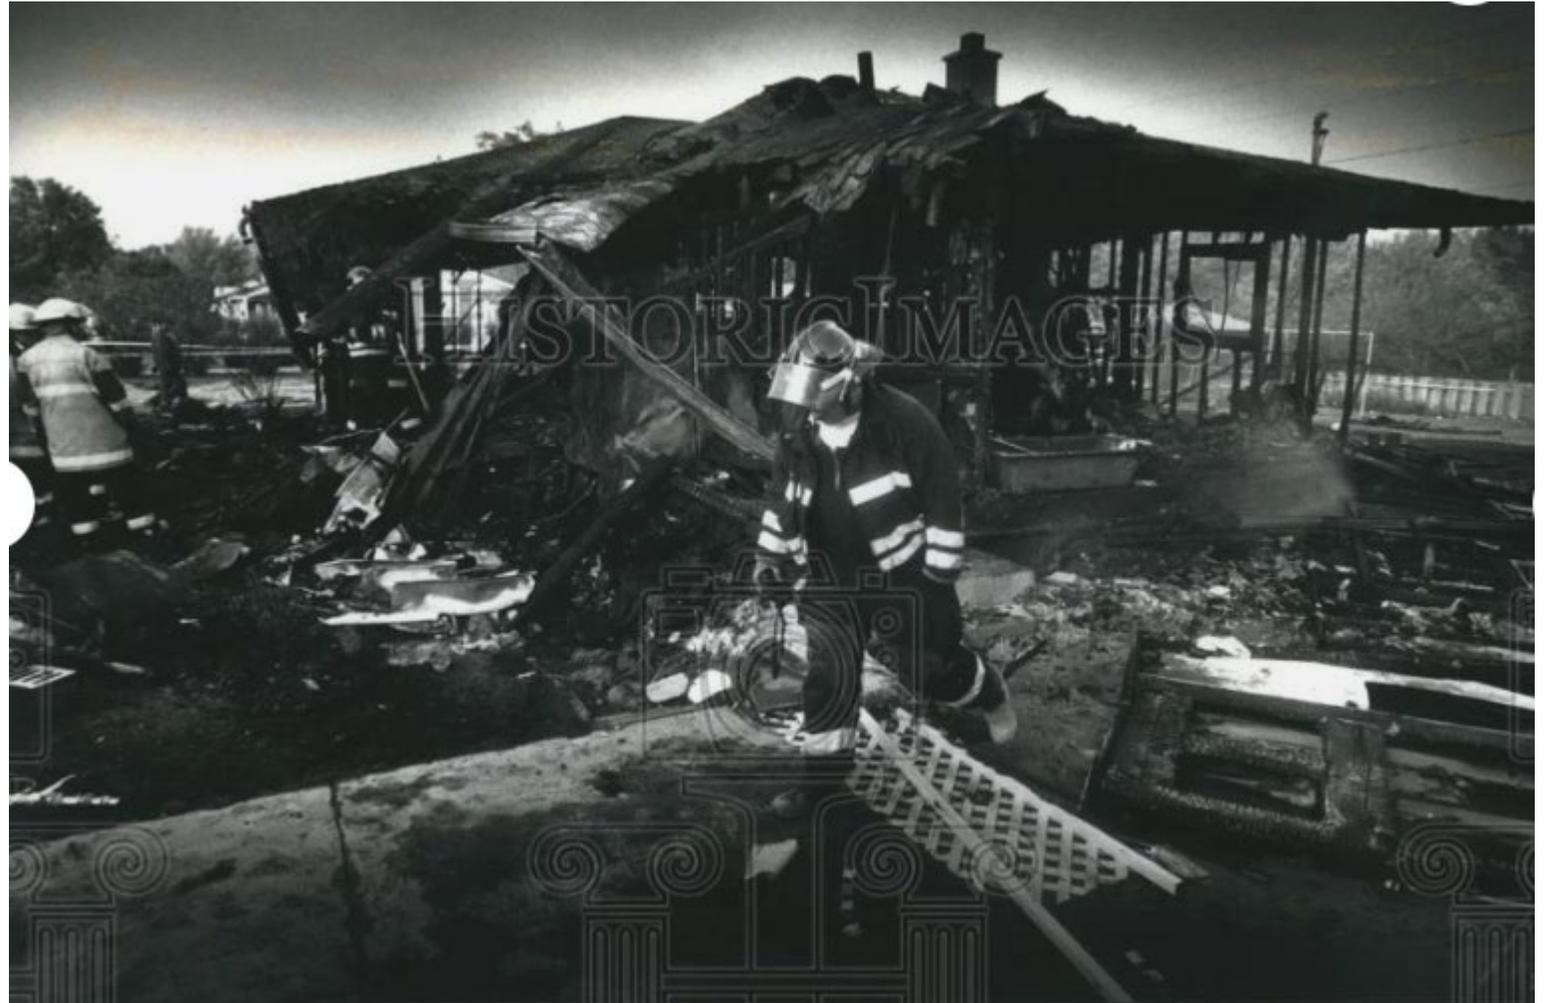
- Oct 13, a trench was dug in front yards to allow for venting.
- Oct 15, other services on block exposed. Six services reported as bowed, and two of those had pulled out of mechanical couple ~1/4"

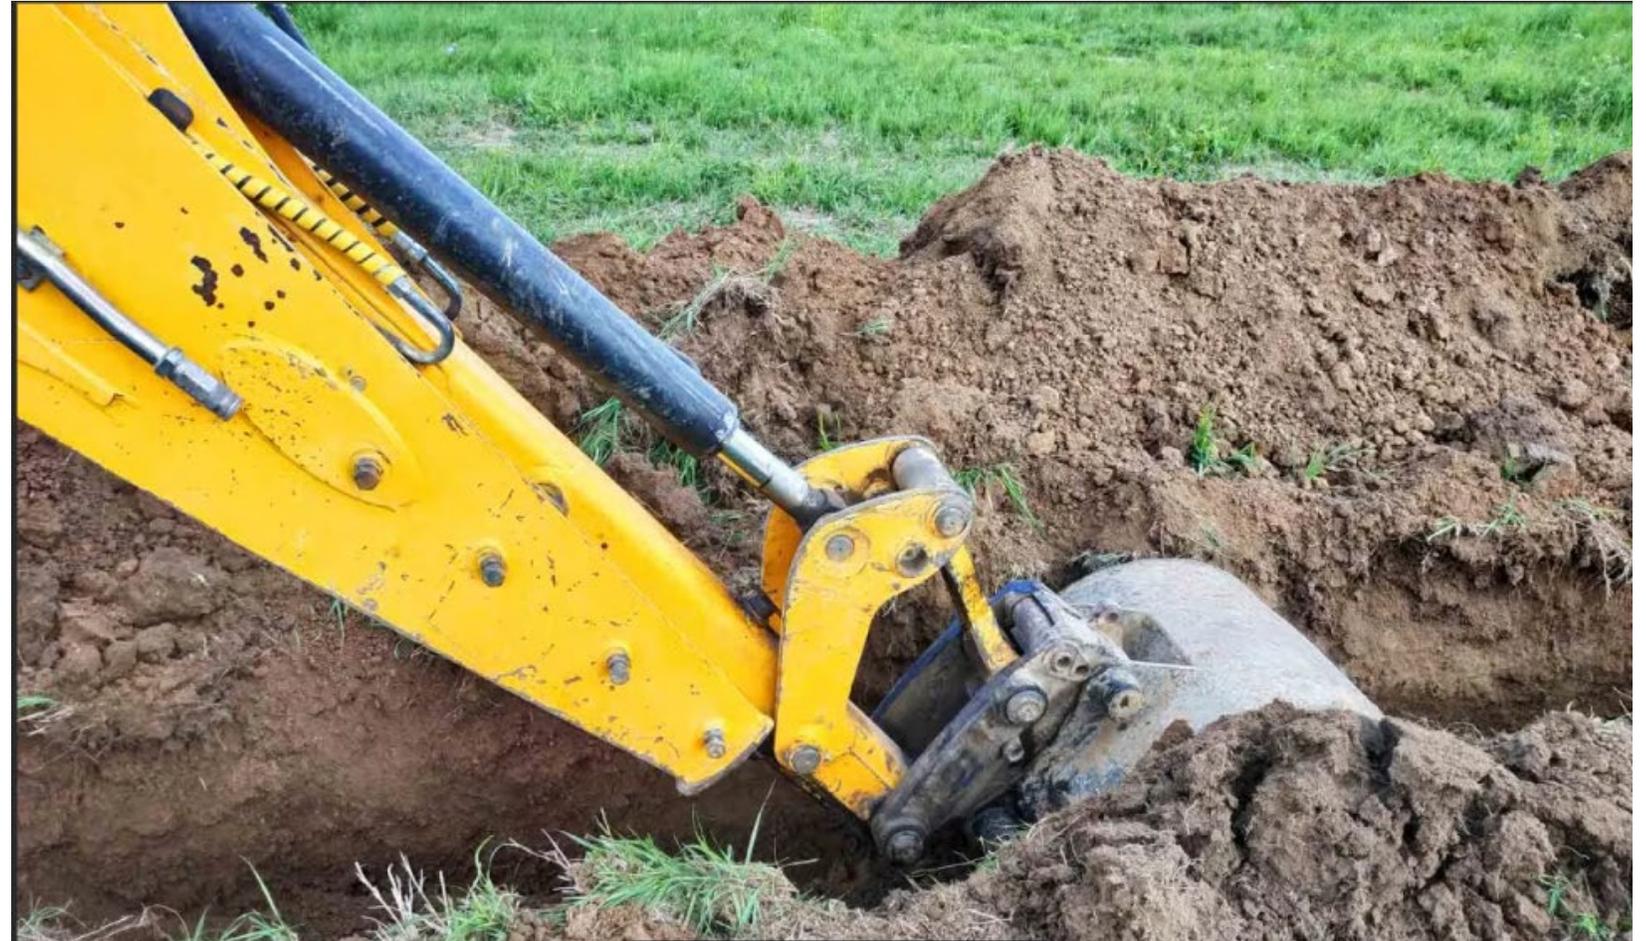
Sewer foreman thought the gas was deeper.

Pipe struck was 31" – 39" below grade.

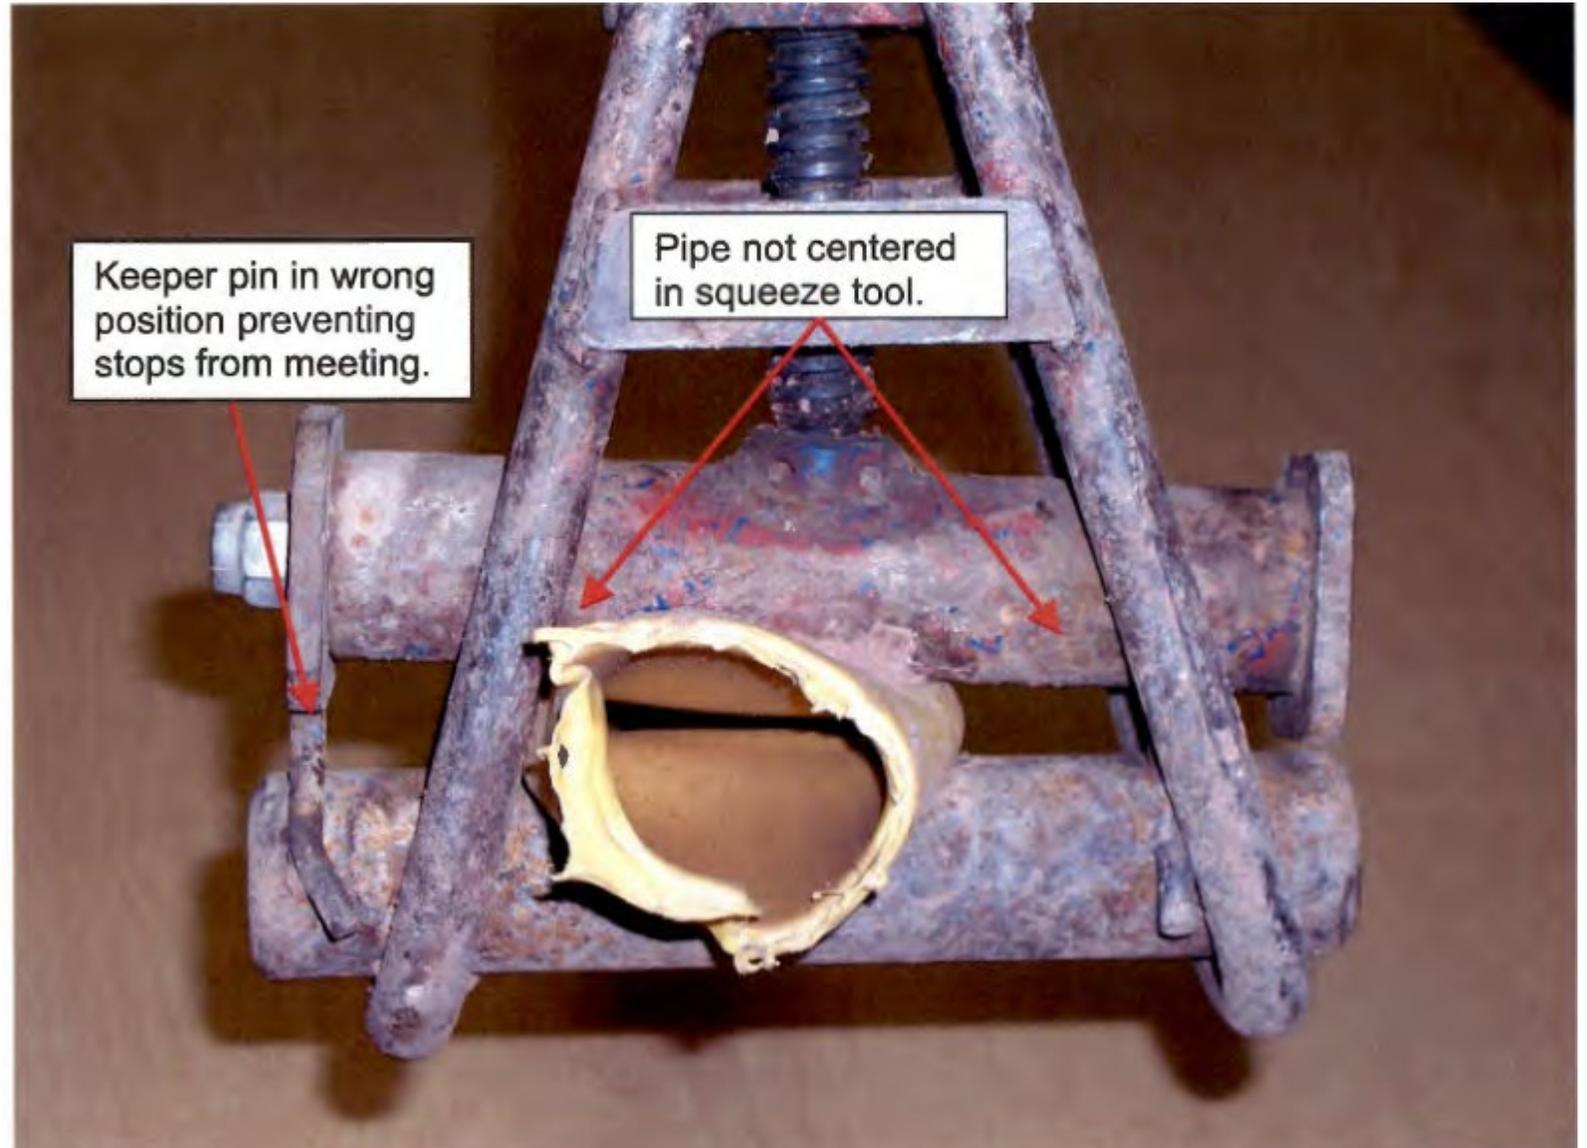
Sewer construction crew jumped into hole and tried to squeeze gas main with sewer pipe squeezer.

Squeezer was not grounded for static electricity.

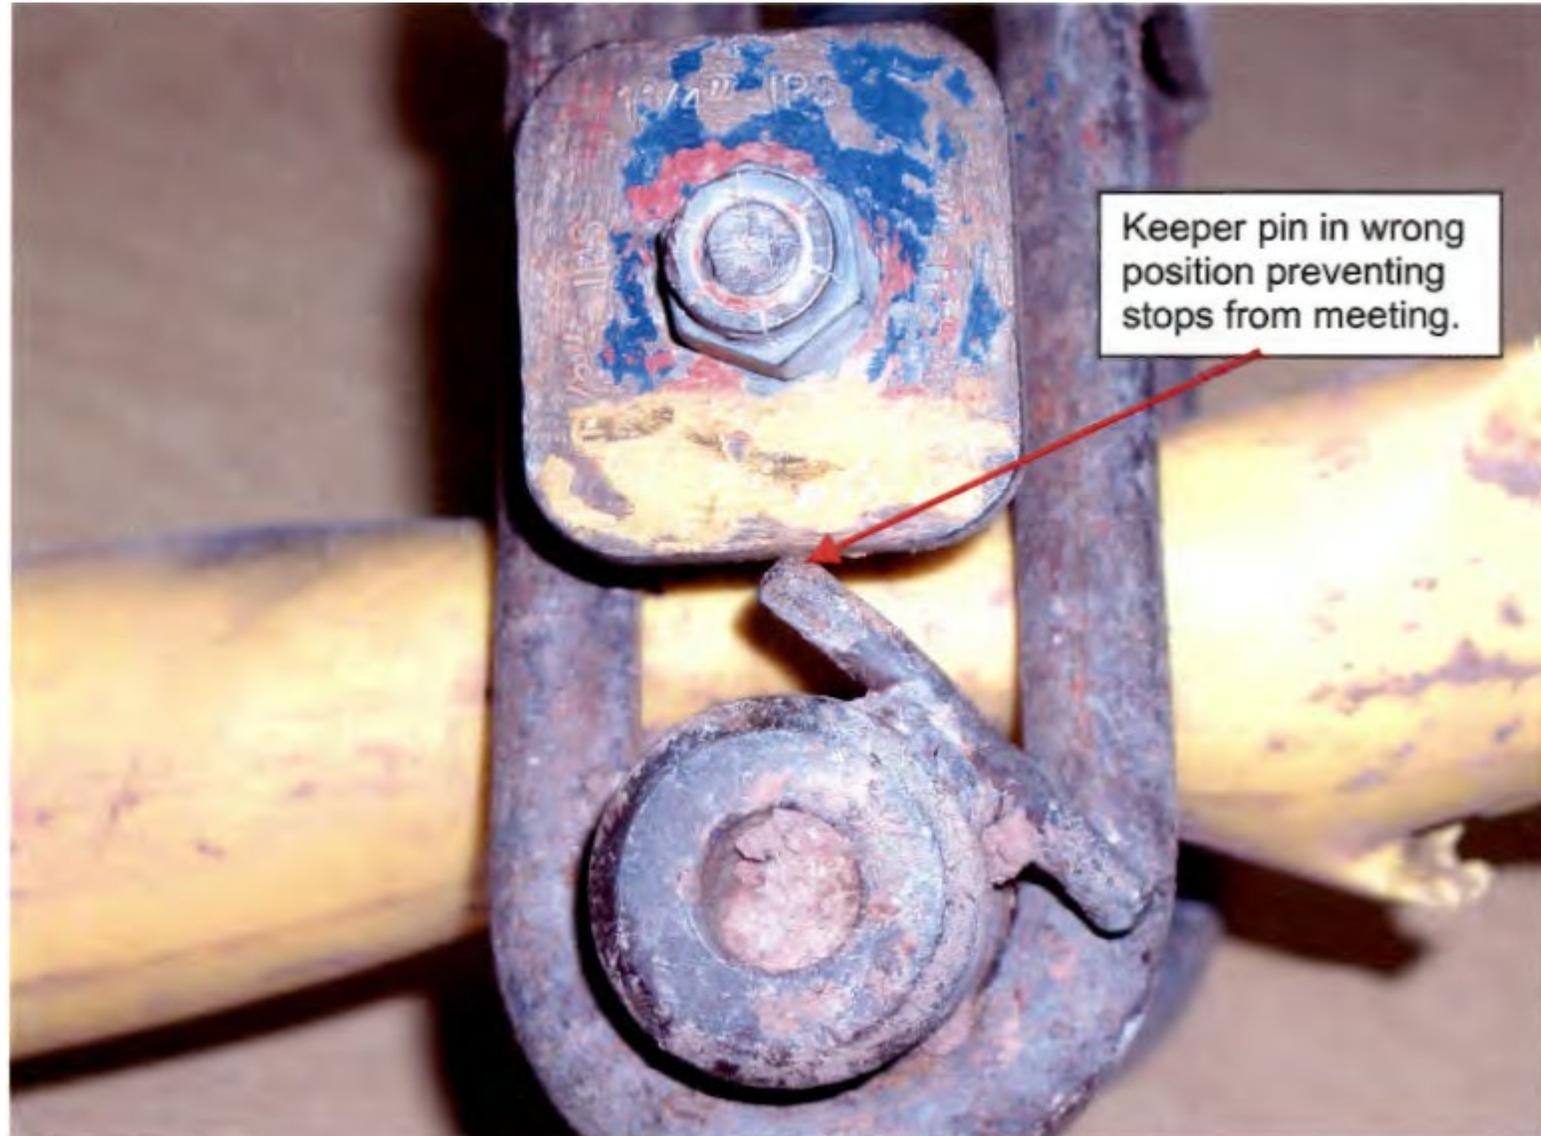
A full squeeze was never going to happen.

After ignition, back hoe operator attempted to fill trench to smother fire.

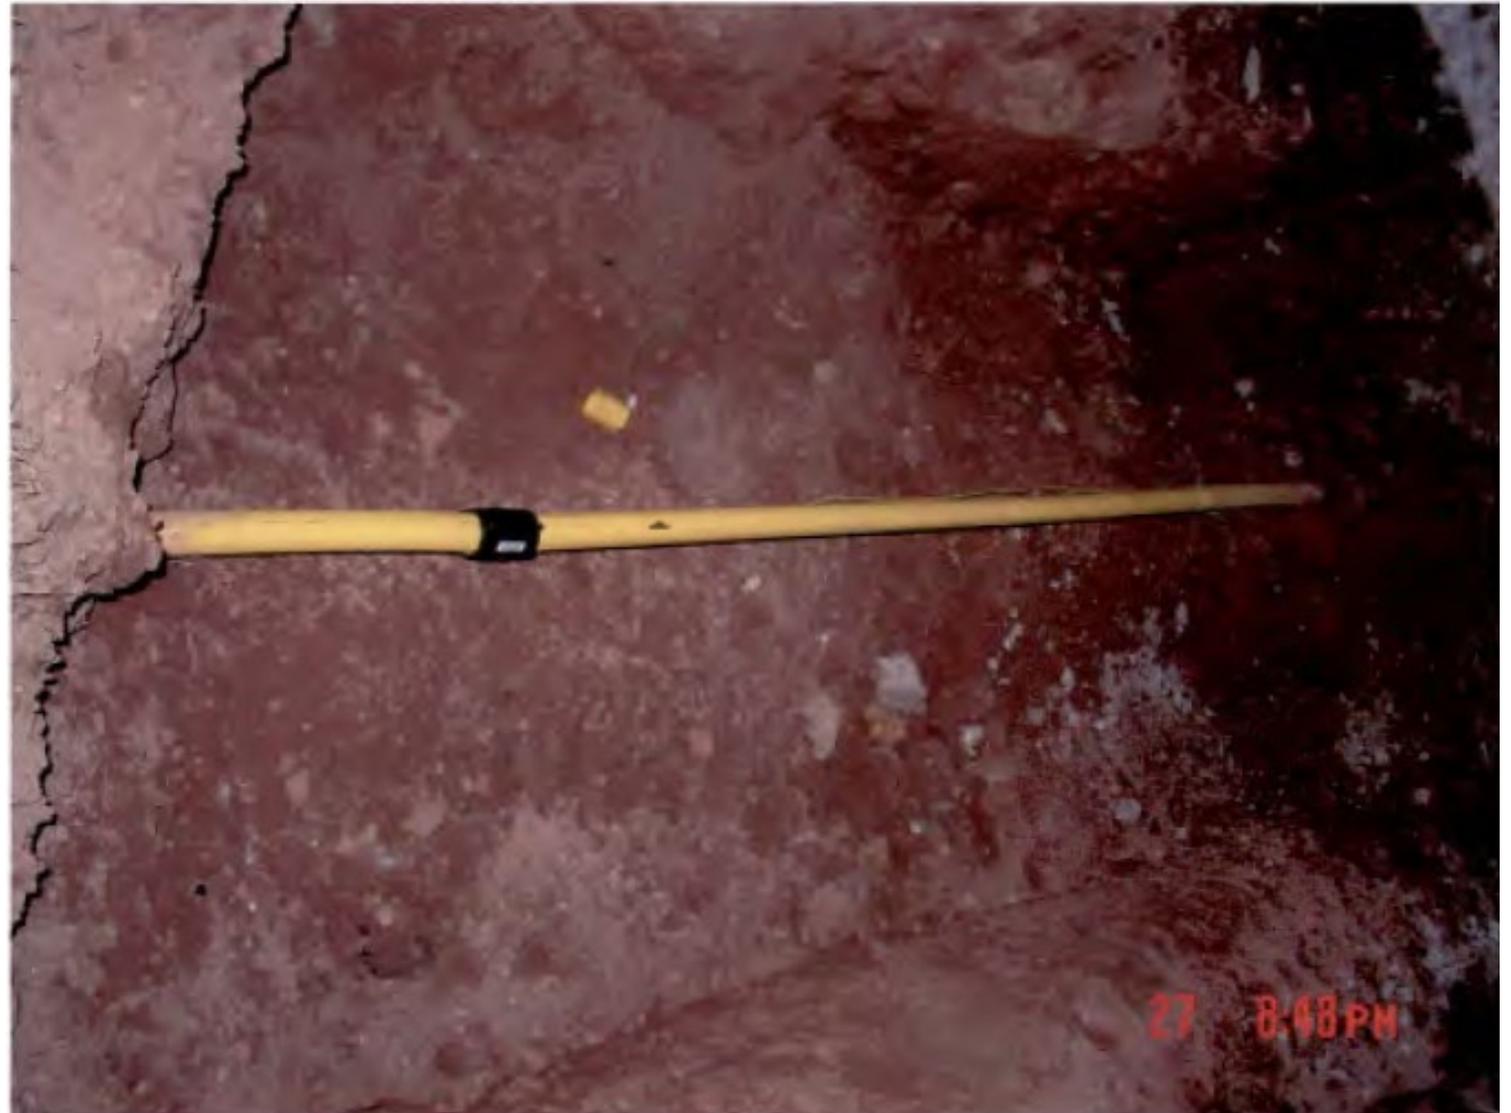
Fire burnt out within
23 minutes.

Repaired in 2.5 hours.

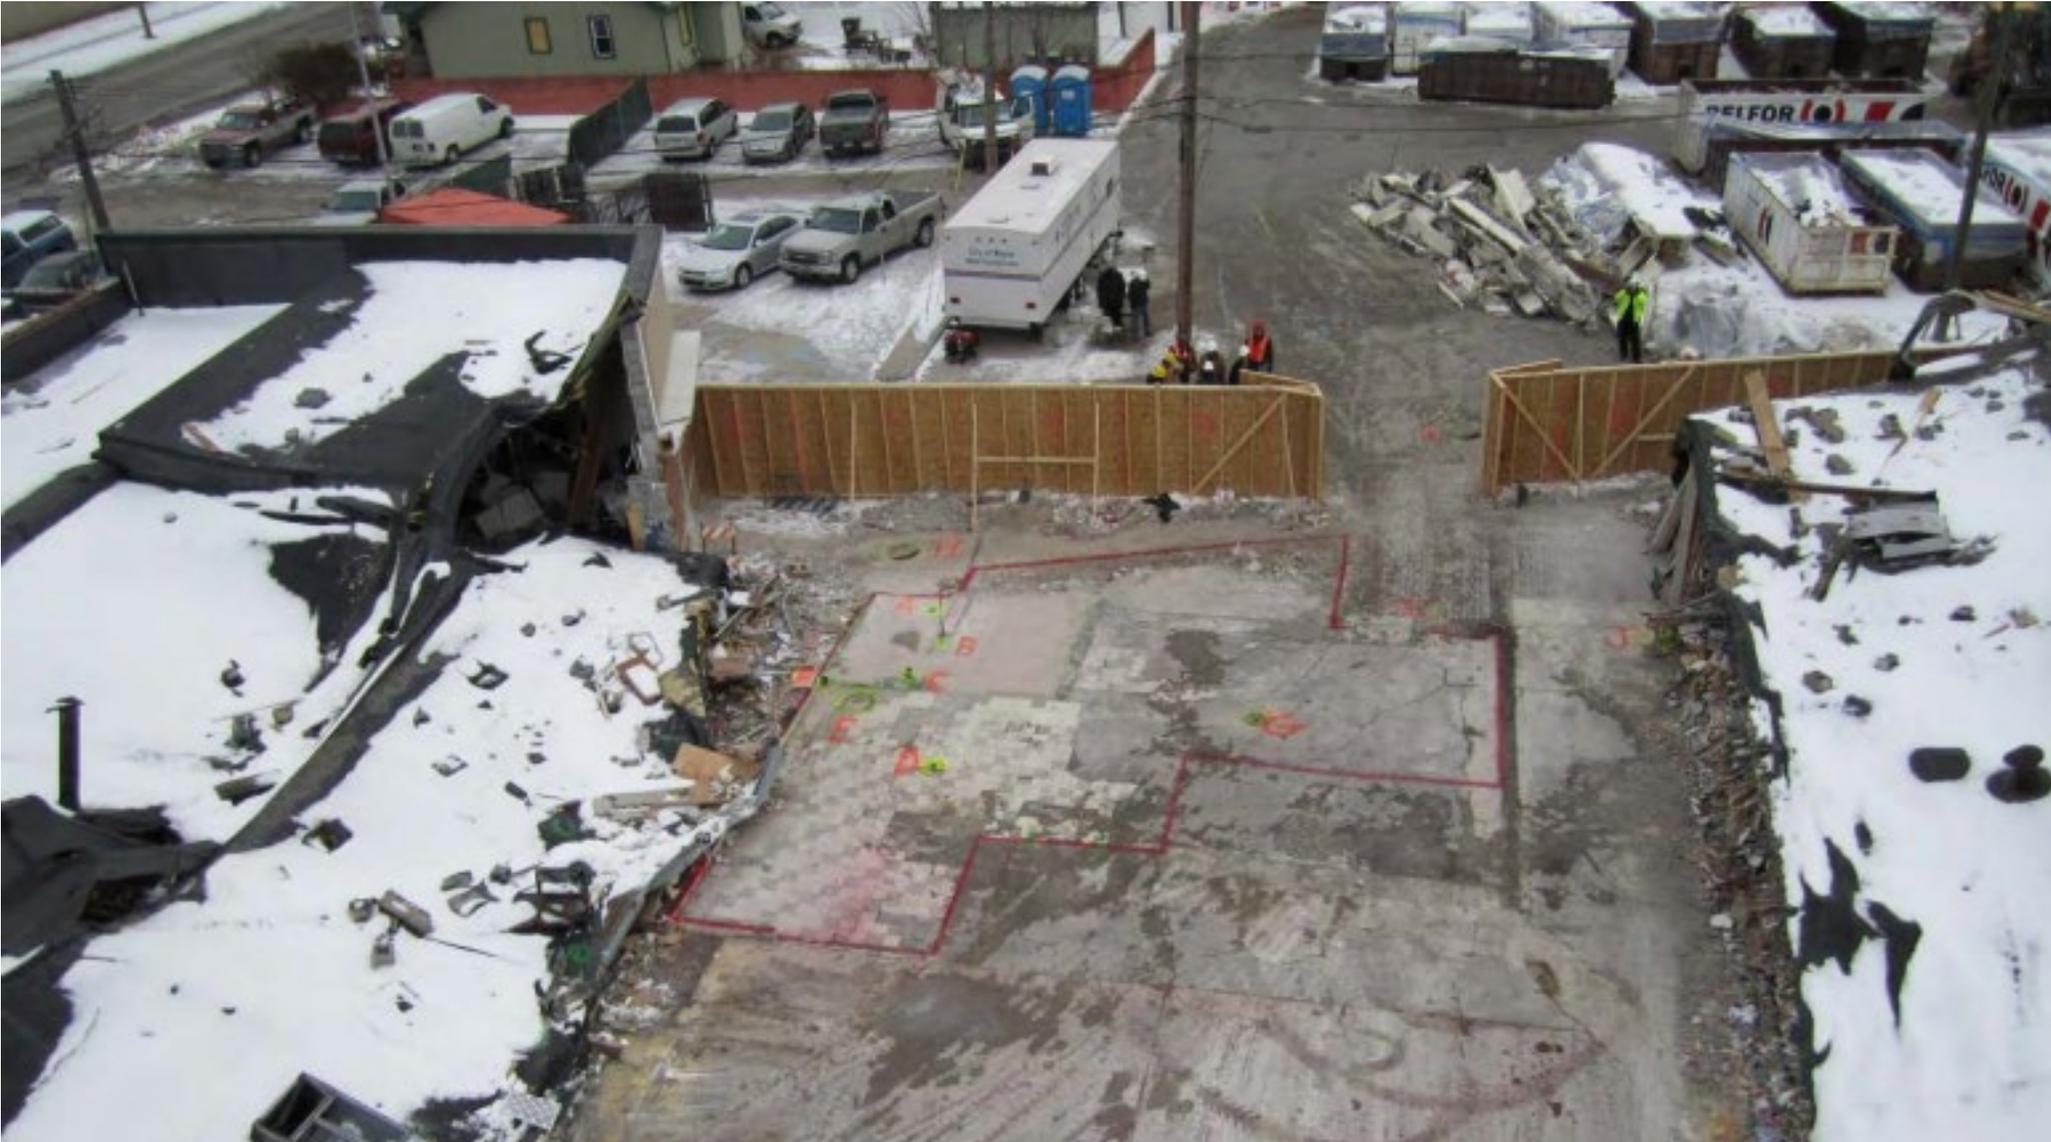
Incident Area

- Gas main located in abandoned alley/right-of-way
 - 2” bare steel
 - Cathodically Unprotected
 - Installed in 1940
- Residential Fence built above gas main in ROW
- Concrete wall built directly around gas main
- Sanitary sewer directly next to gas main
 - Travel parallel for 233 ft to back of furniture store
 - Manhole 18 in from failure

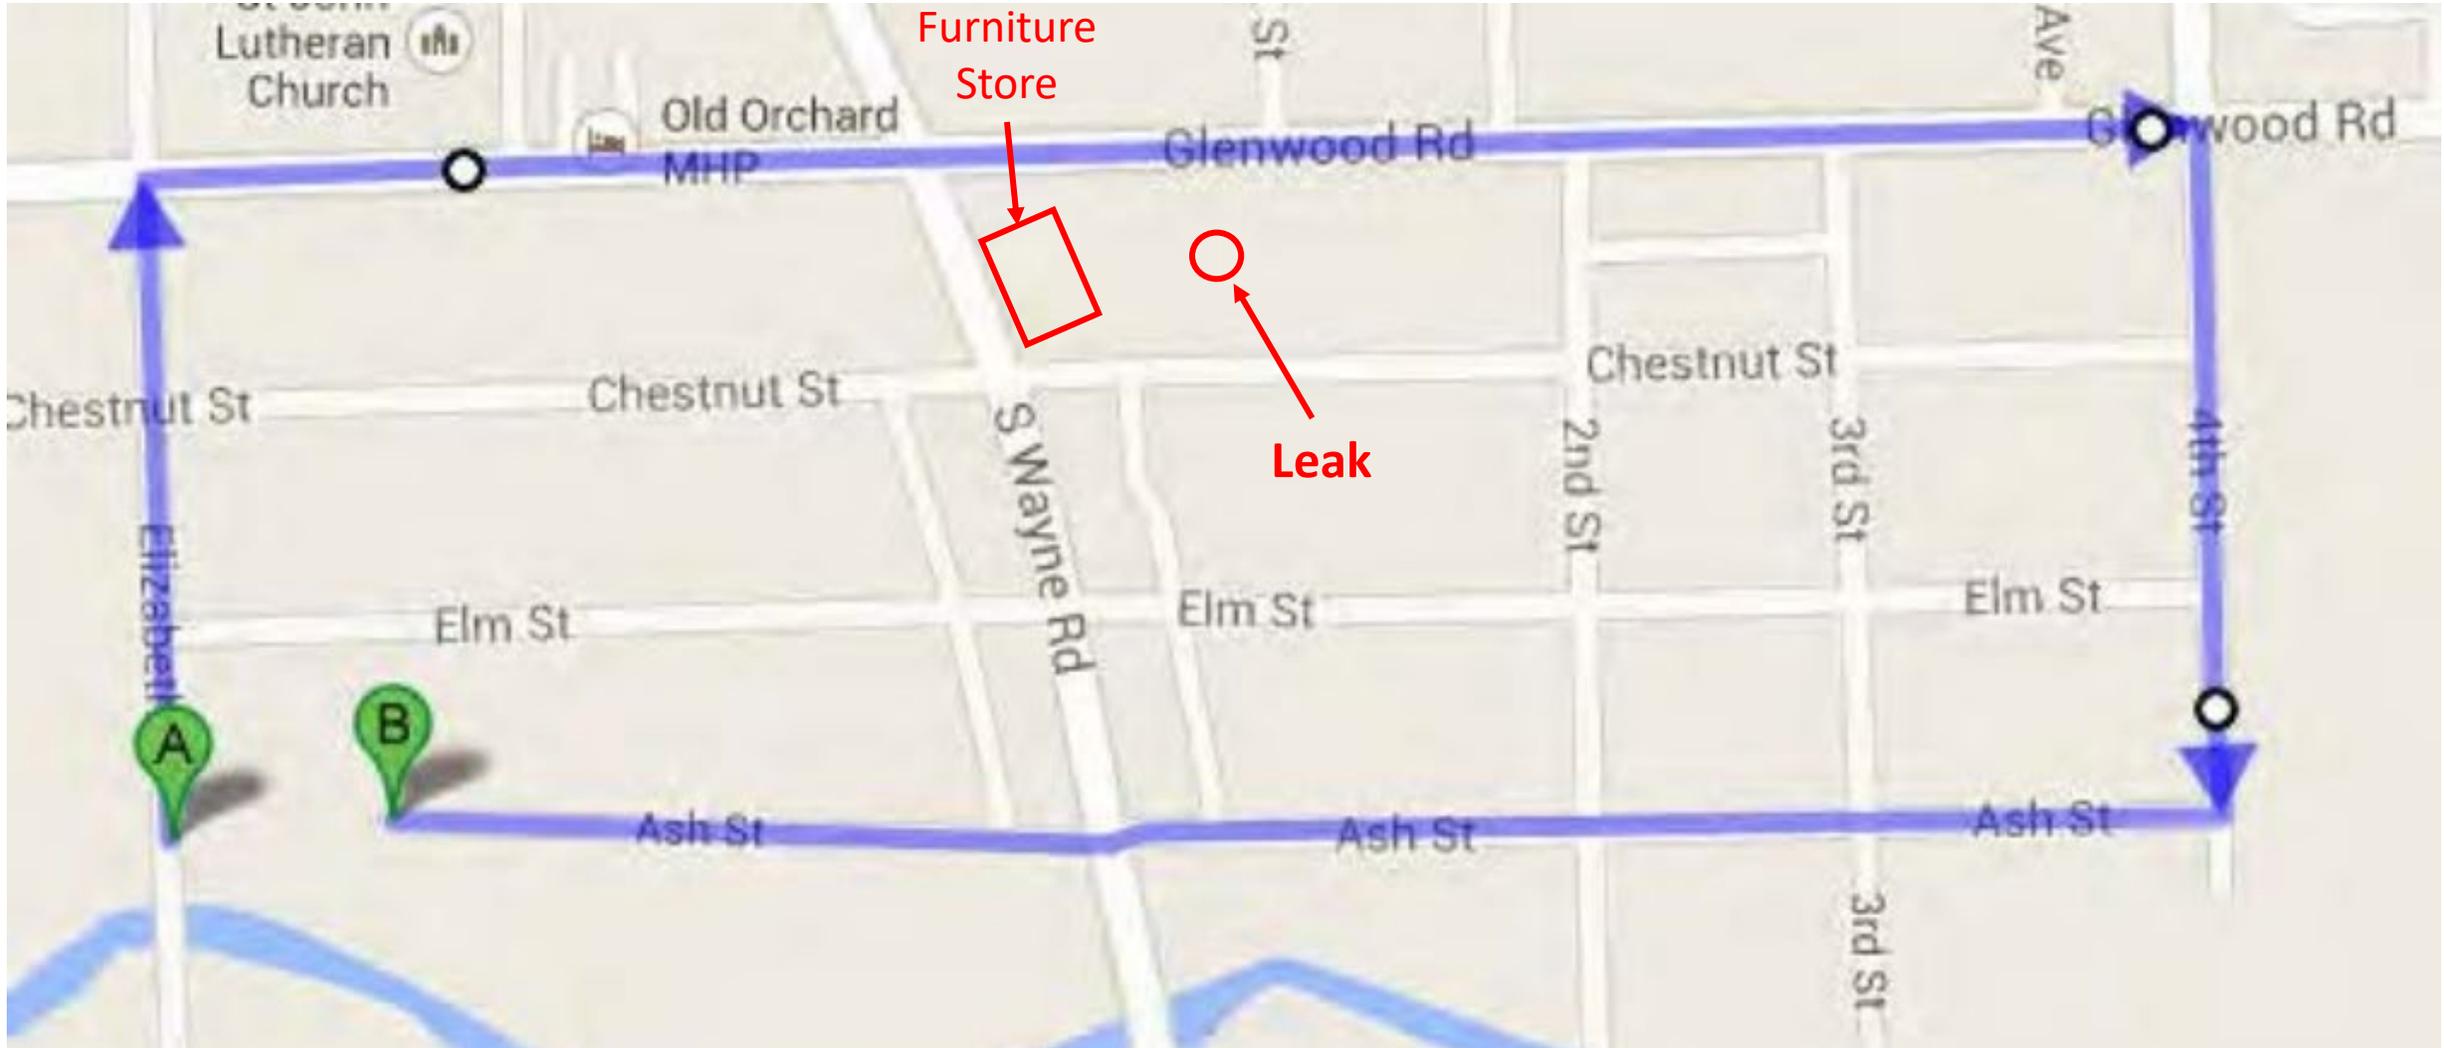
Evacuation Zone

- Between 12:30 pm and 1:30 pm the leak source was found
 - 100% gas read in sanitary sewer manhole east of furniture store
- Bar-hole tested above 2-inch steel main near sewer
 - 100% gas read and gas noted to be blowing out of the hole
- Hand dug over leak location
- Removed sewer cover to vent
- Adjacent blocks evacuated
- Removed manhole covers in 6 block radius
- Bar-hole and gas in air testing done in vicinity of leak
 - Gas discovered in house on parallel street at 7% LEL
 - Gas discovered in garage on same street at 24% LEL
 - Gas migrated underground from main failure to houses
