Wisconsin Incidents 1986 - Present

Wisconsin Pipeline Safety Seminar

Public Service Commission of Wisconsin

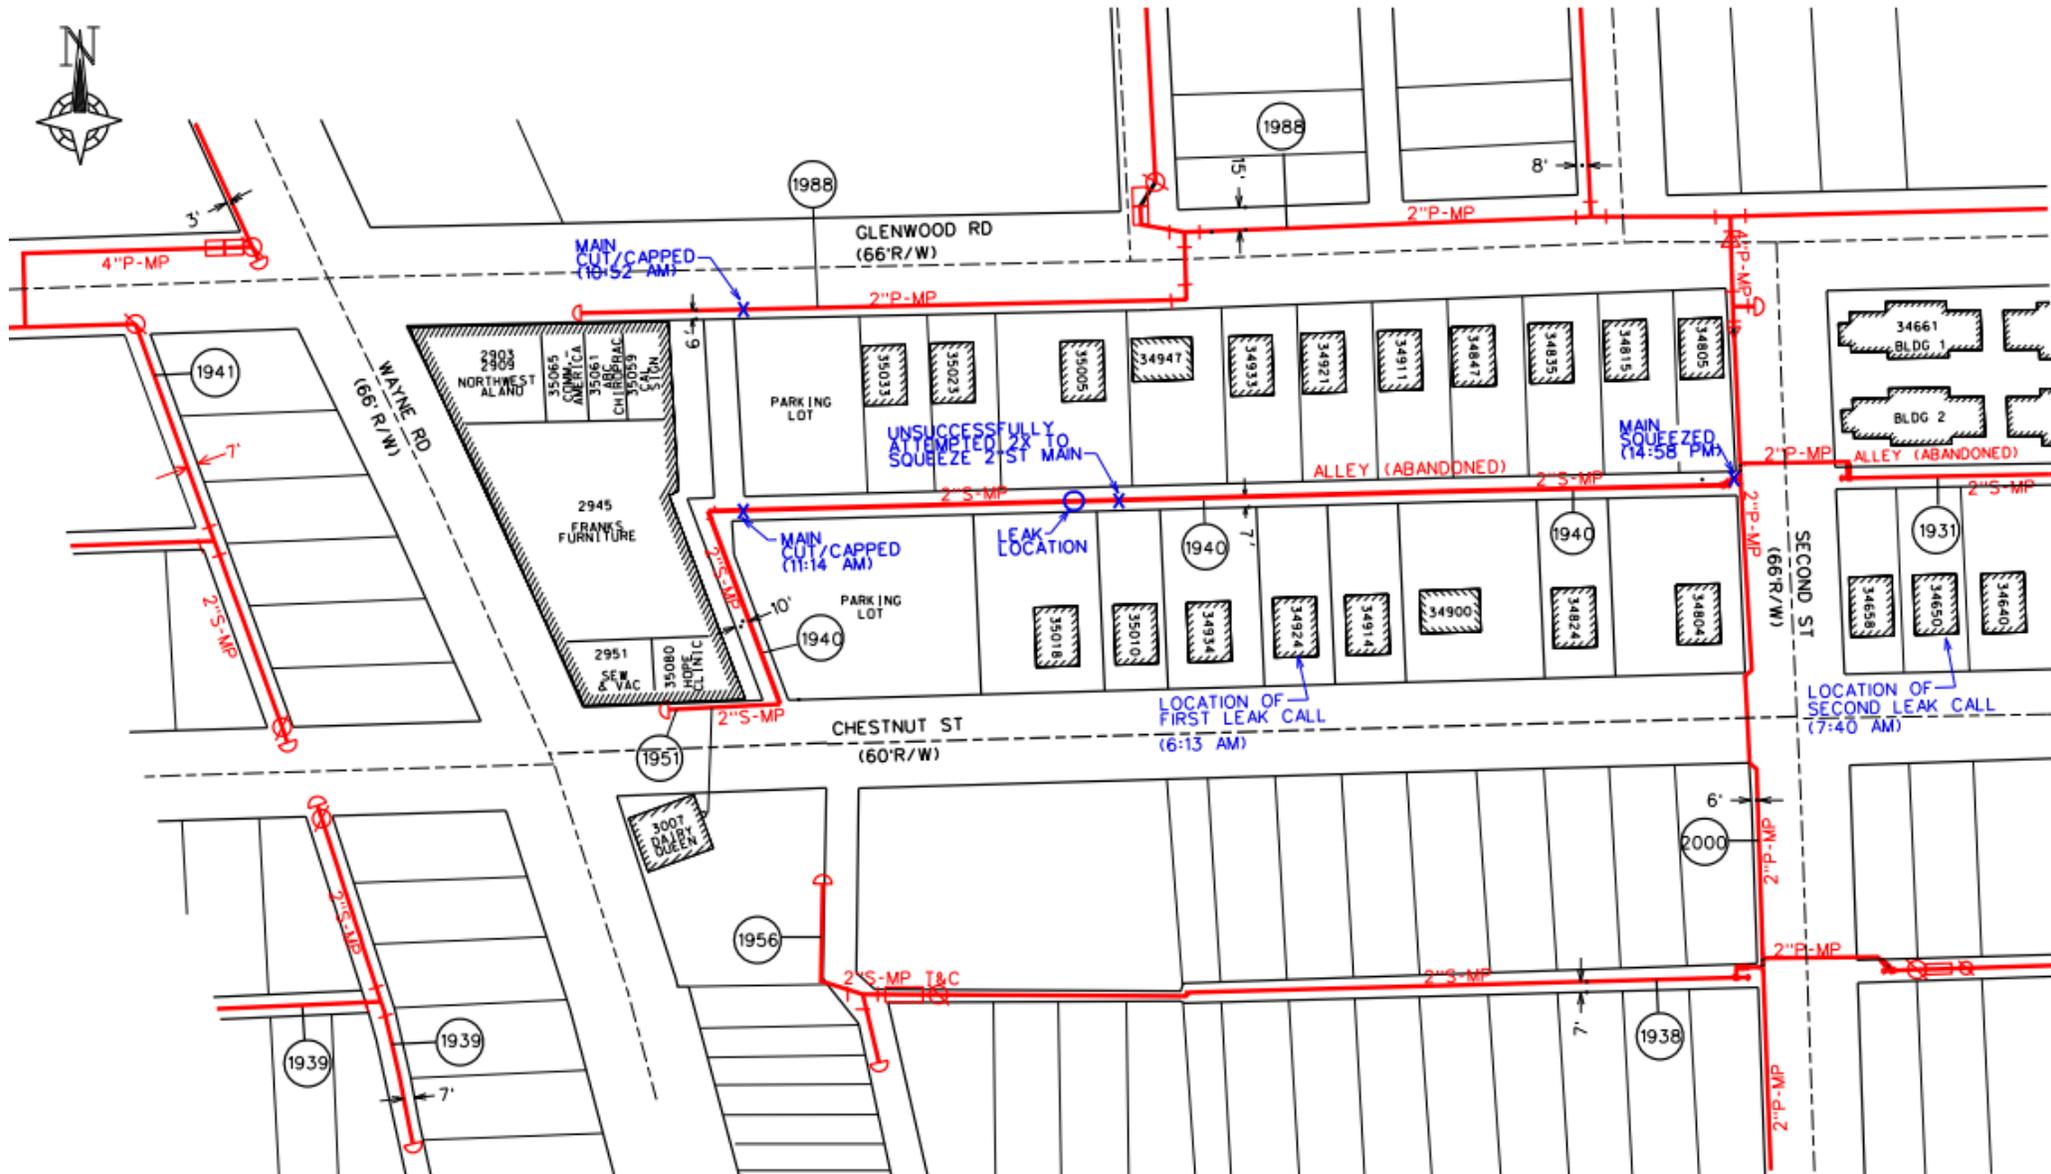
- 1:50 pm attempt to squeeze steel main upstream
 - Each attempt resulted in seam failures
- 2:58 pm squeezed plastic main further upstream
- 3:05 pm found no gas freely flowing at leak location
- 4:30 pm excavated leak location and found failed threaded coupling
- Continued leak surveys to the next day
- Bar-hole tested leak location daily for 8 days
 - Repeated detection of gas
 - Soil was excavated, replaced, and no more gas was detected

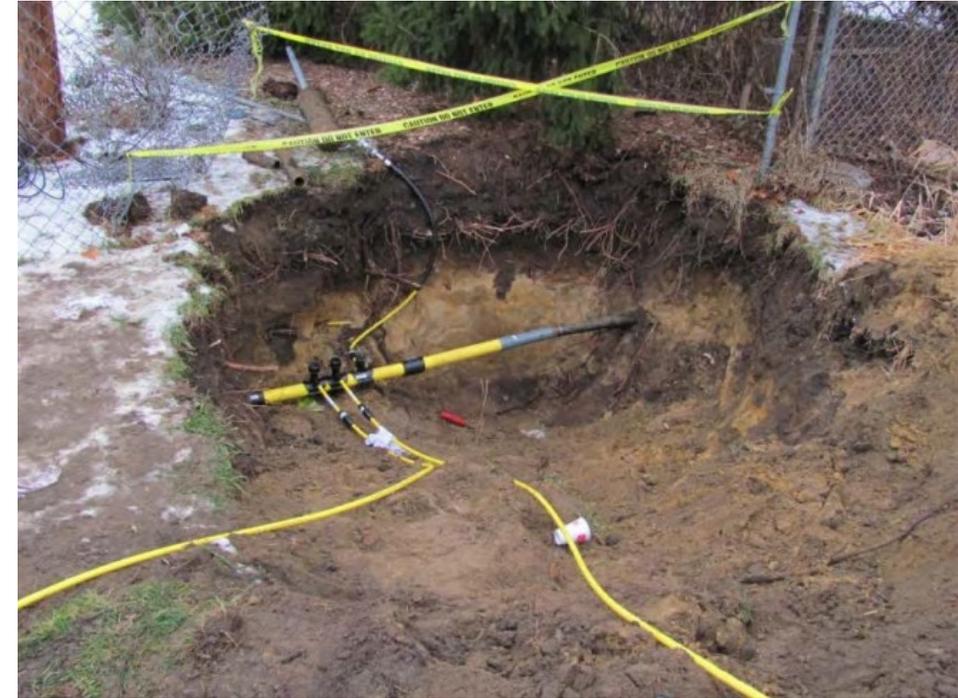
- Service interrupted to 20 customers
 - 9 residential
 - 11 business
- Temporary service installed to houses
 - Free air reading given before returning to homes
- Permanent main installed 1 week later
- Additional businesses returned to service almost 4 months later
