WI-PSC Conference February 2024

Accident Investigation
Division (AID)

Case Study
Atmos Energy
Dallas, Texas
Gas Migration
One Fatality and
Three Injuries
February 23, 2018

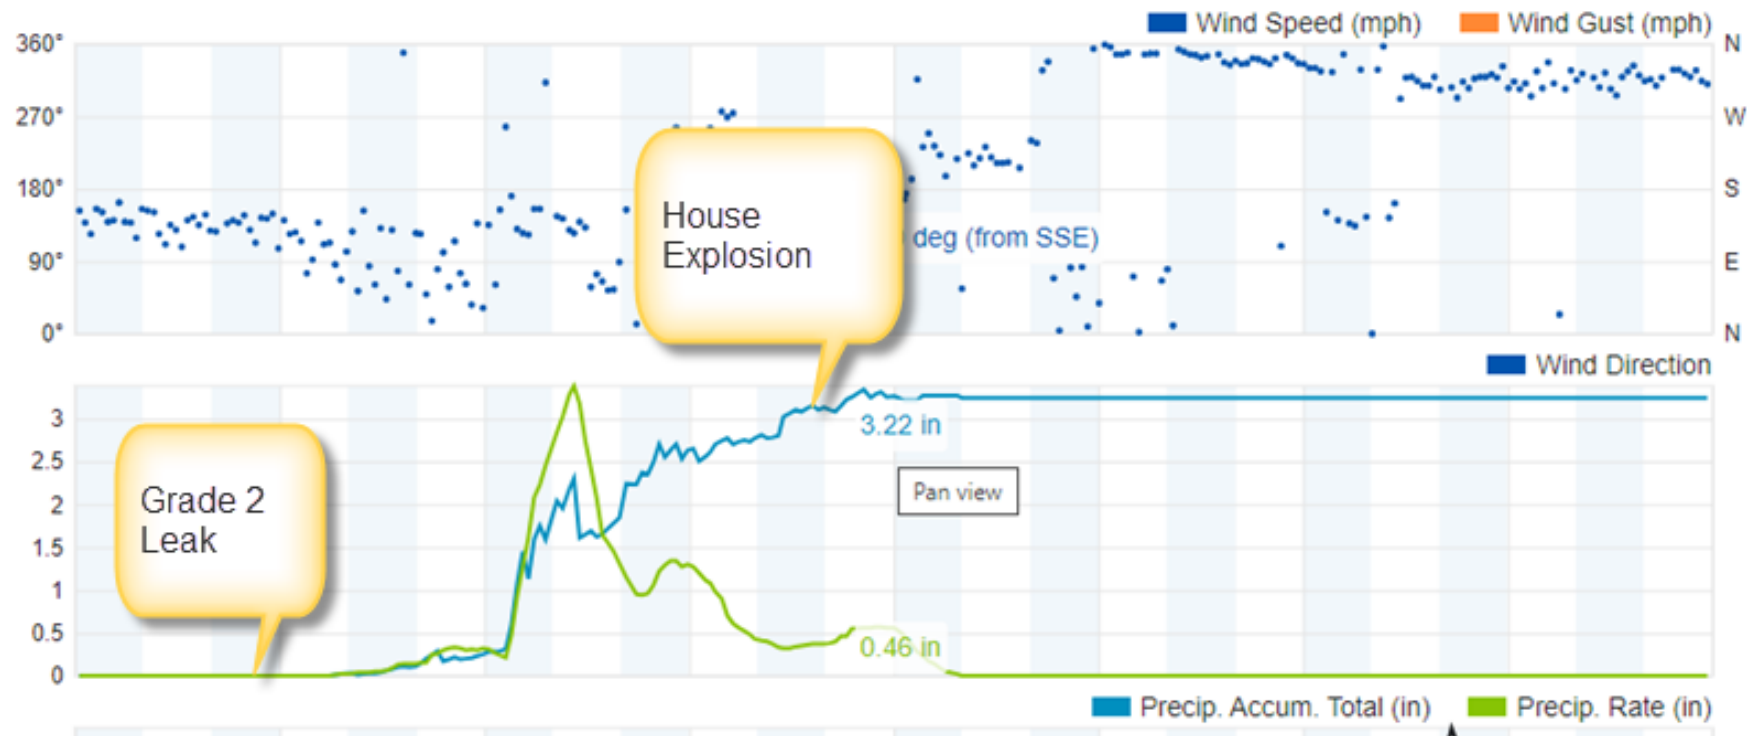
* Each bar represents 1-hour. 5 hours of heavy rain capped the gas plume. Leak was graded 3 months prior to explosion.

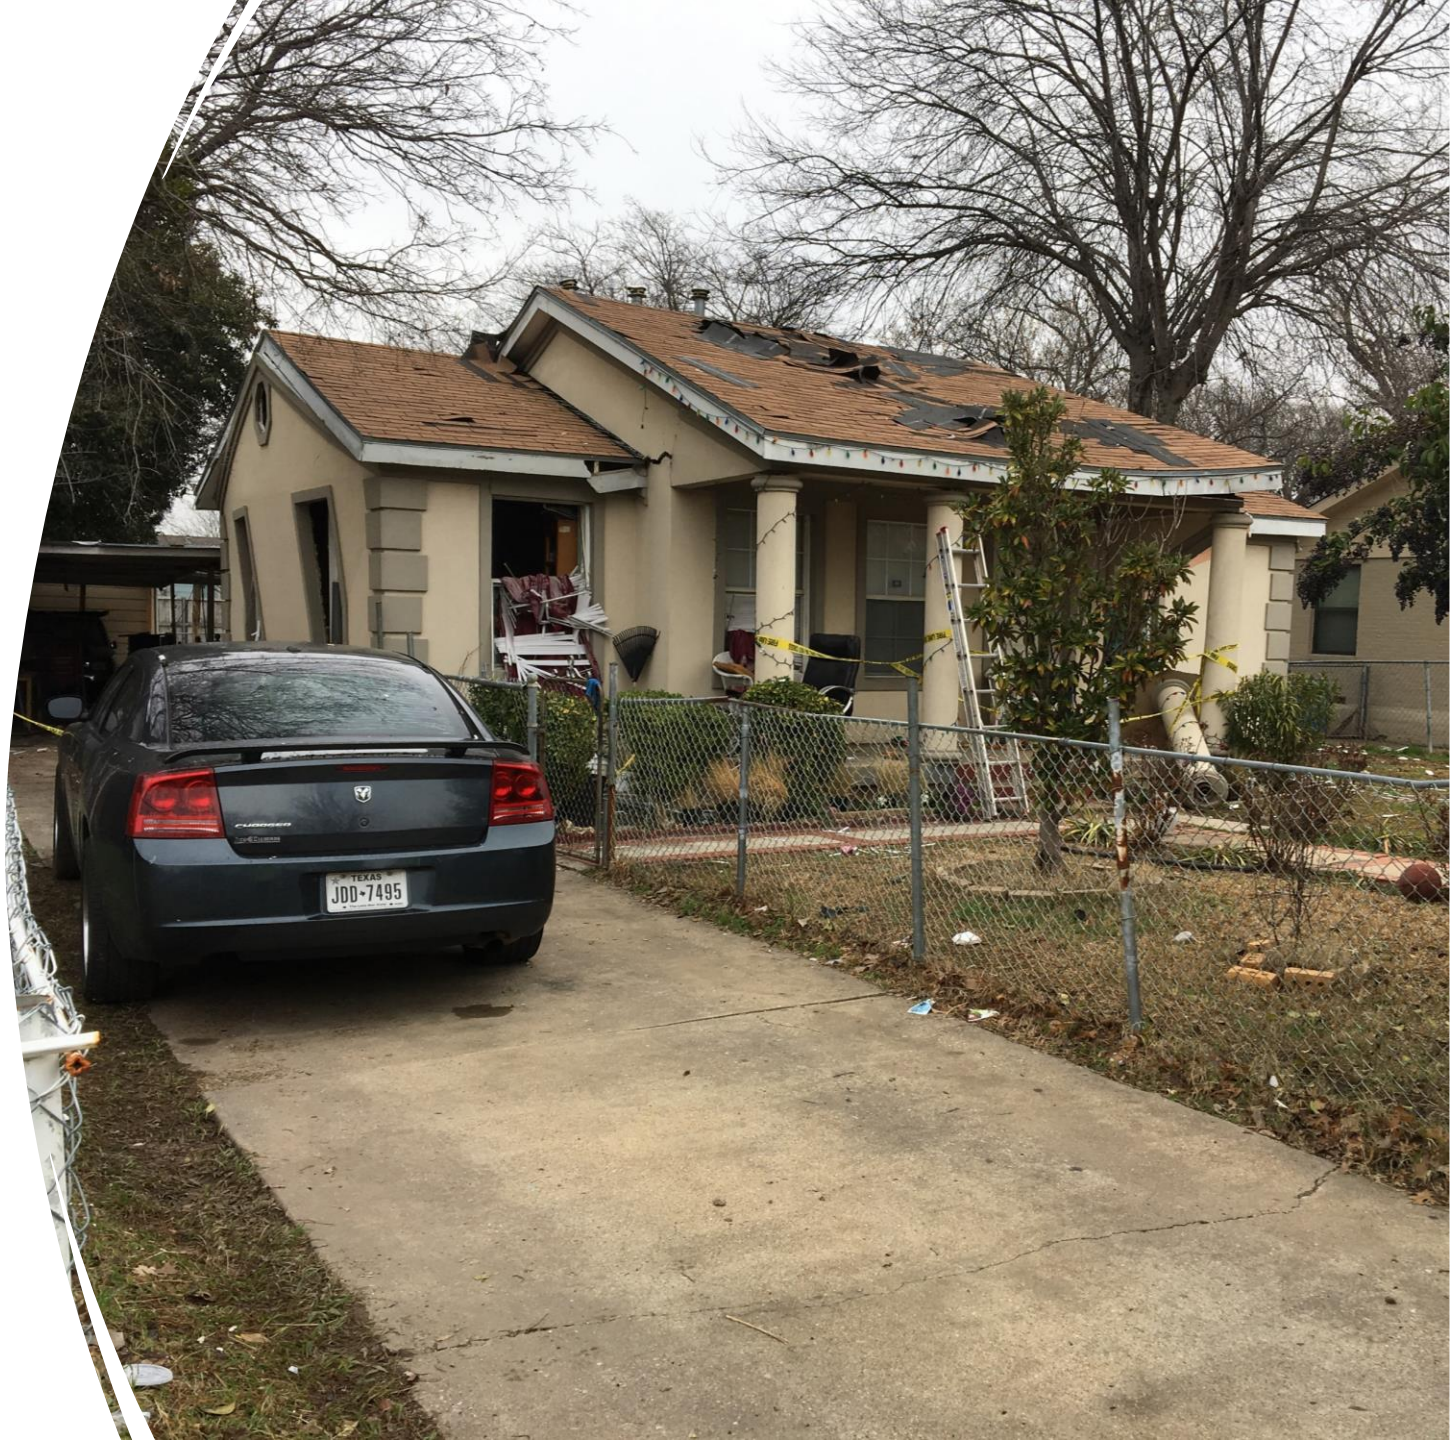
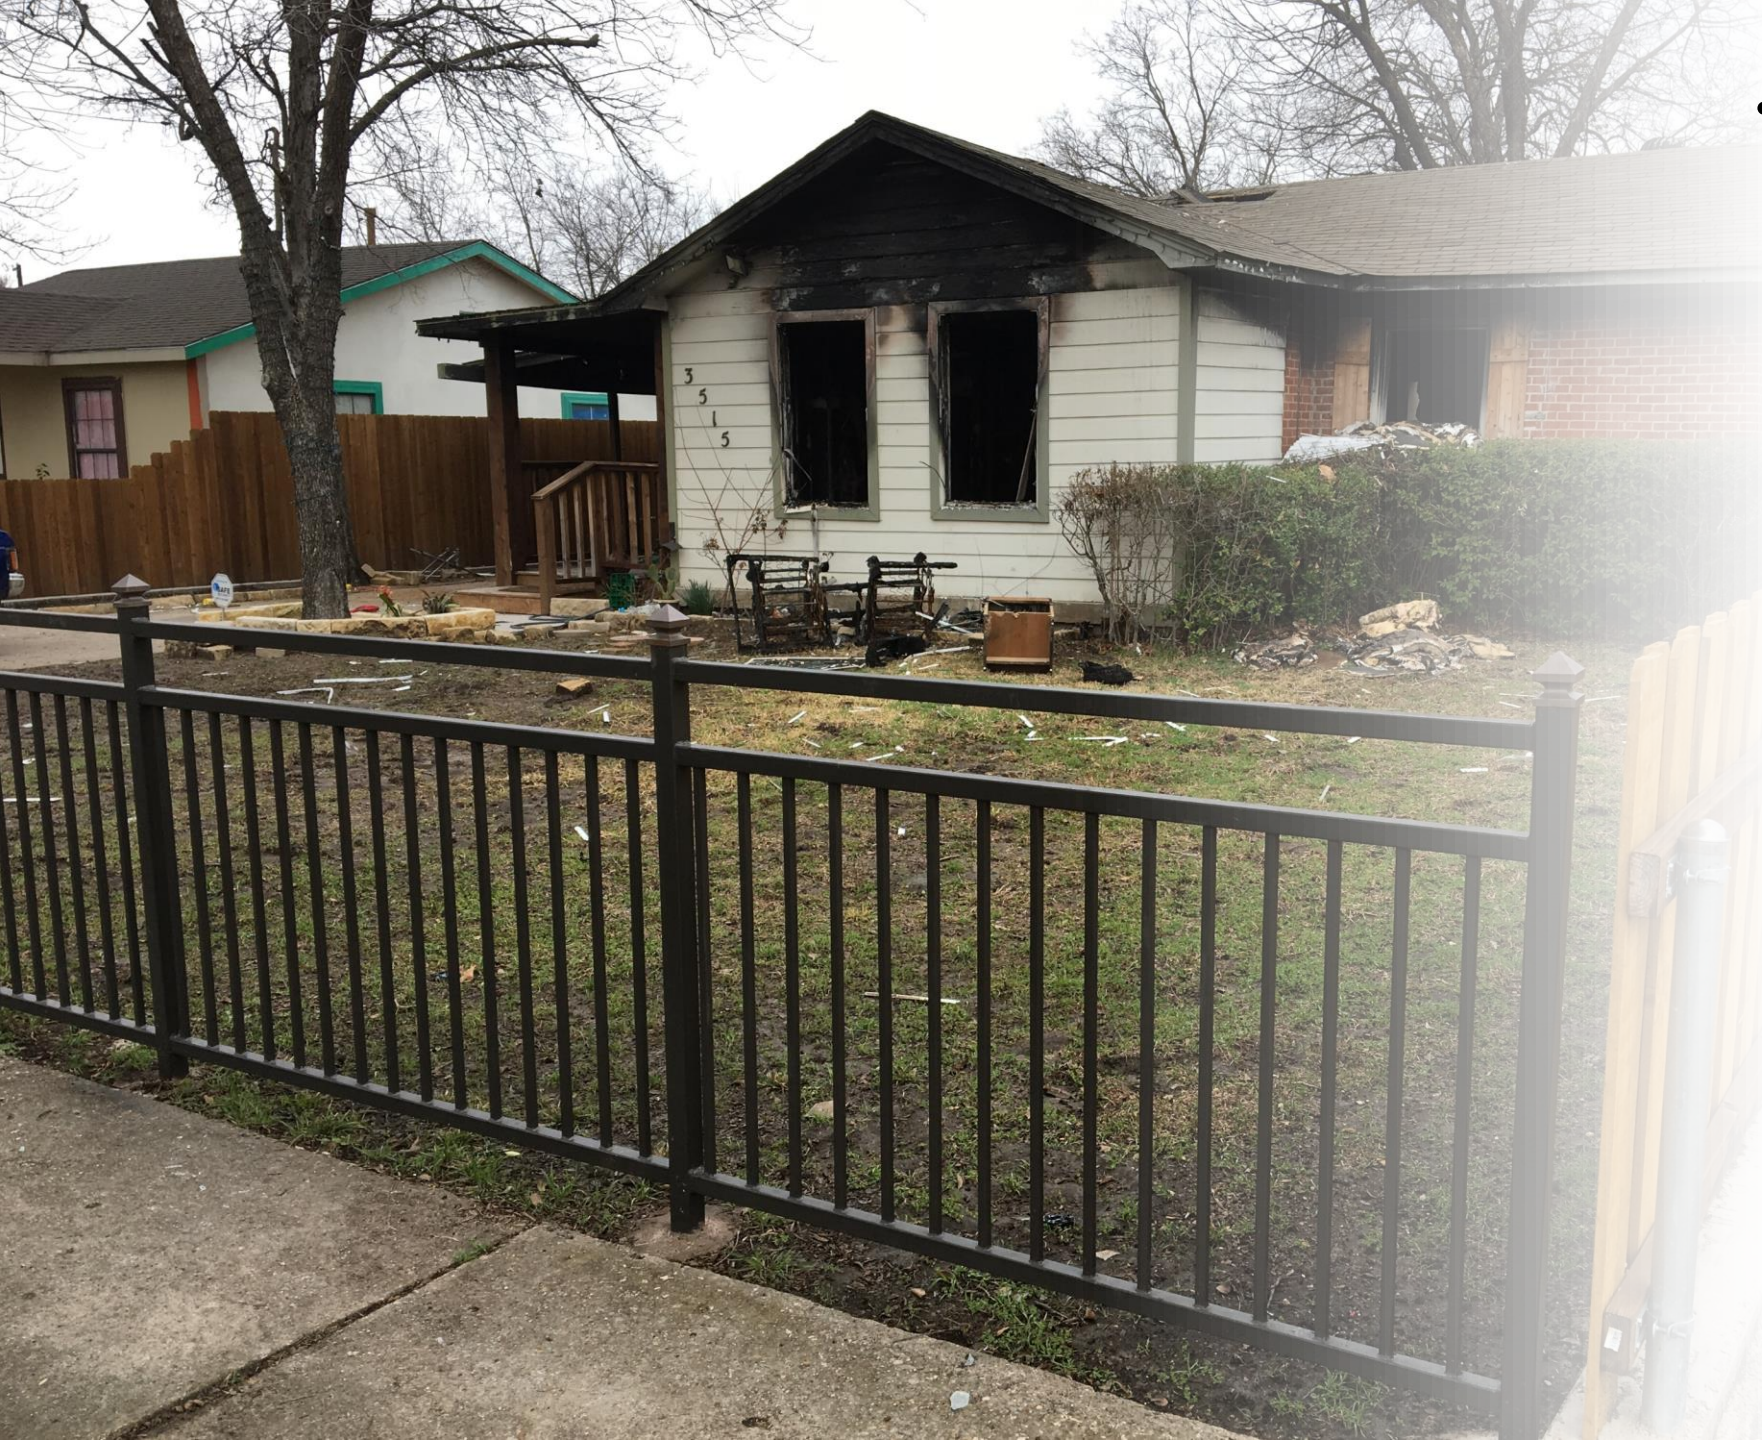
- February 21, 2018 – Day 1
- House 3527 has an incident at 5:49 a.m.
- Homeowner heard a popping noise in the attic where the heater unit is located. He investigated and found the steel cover to the furnace not on the unit.
- When the cover was reinstalled, the furnace operated the pilot-light igniter operated and an explosion occurred throwing him backwards. He never smelled any gas odor.
- Arson investigators responded and determined the cause as “undetermined”.
- Gas company was also on site but not allowed to test service due to structure damage.
- Ground saturated from exceptionally heavy rains

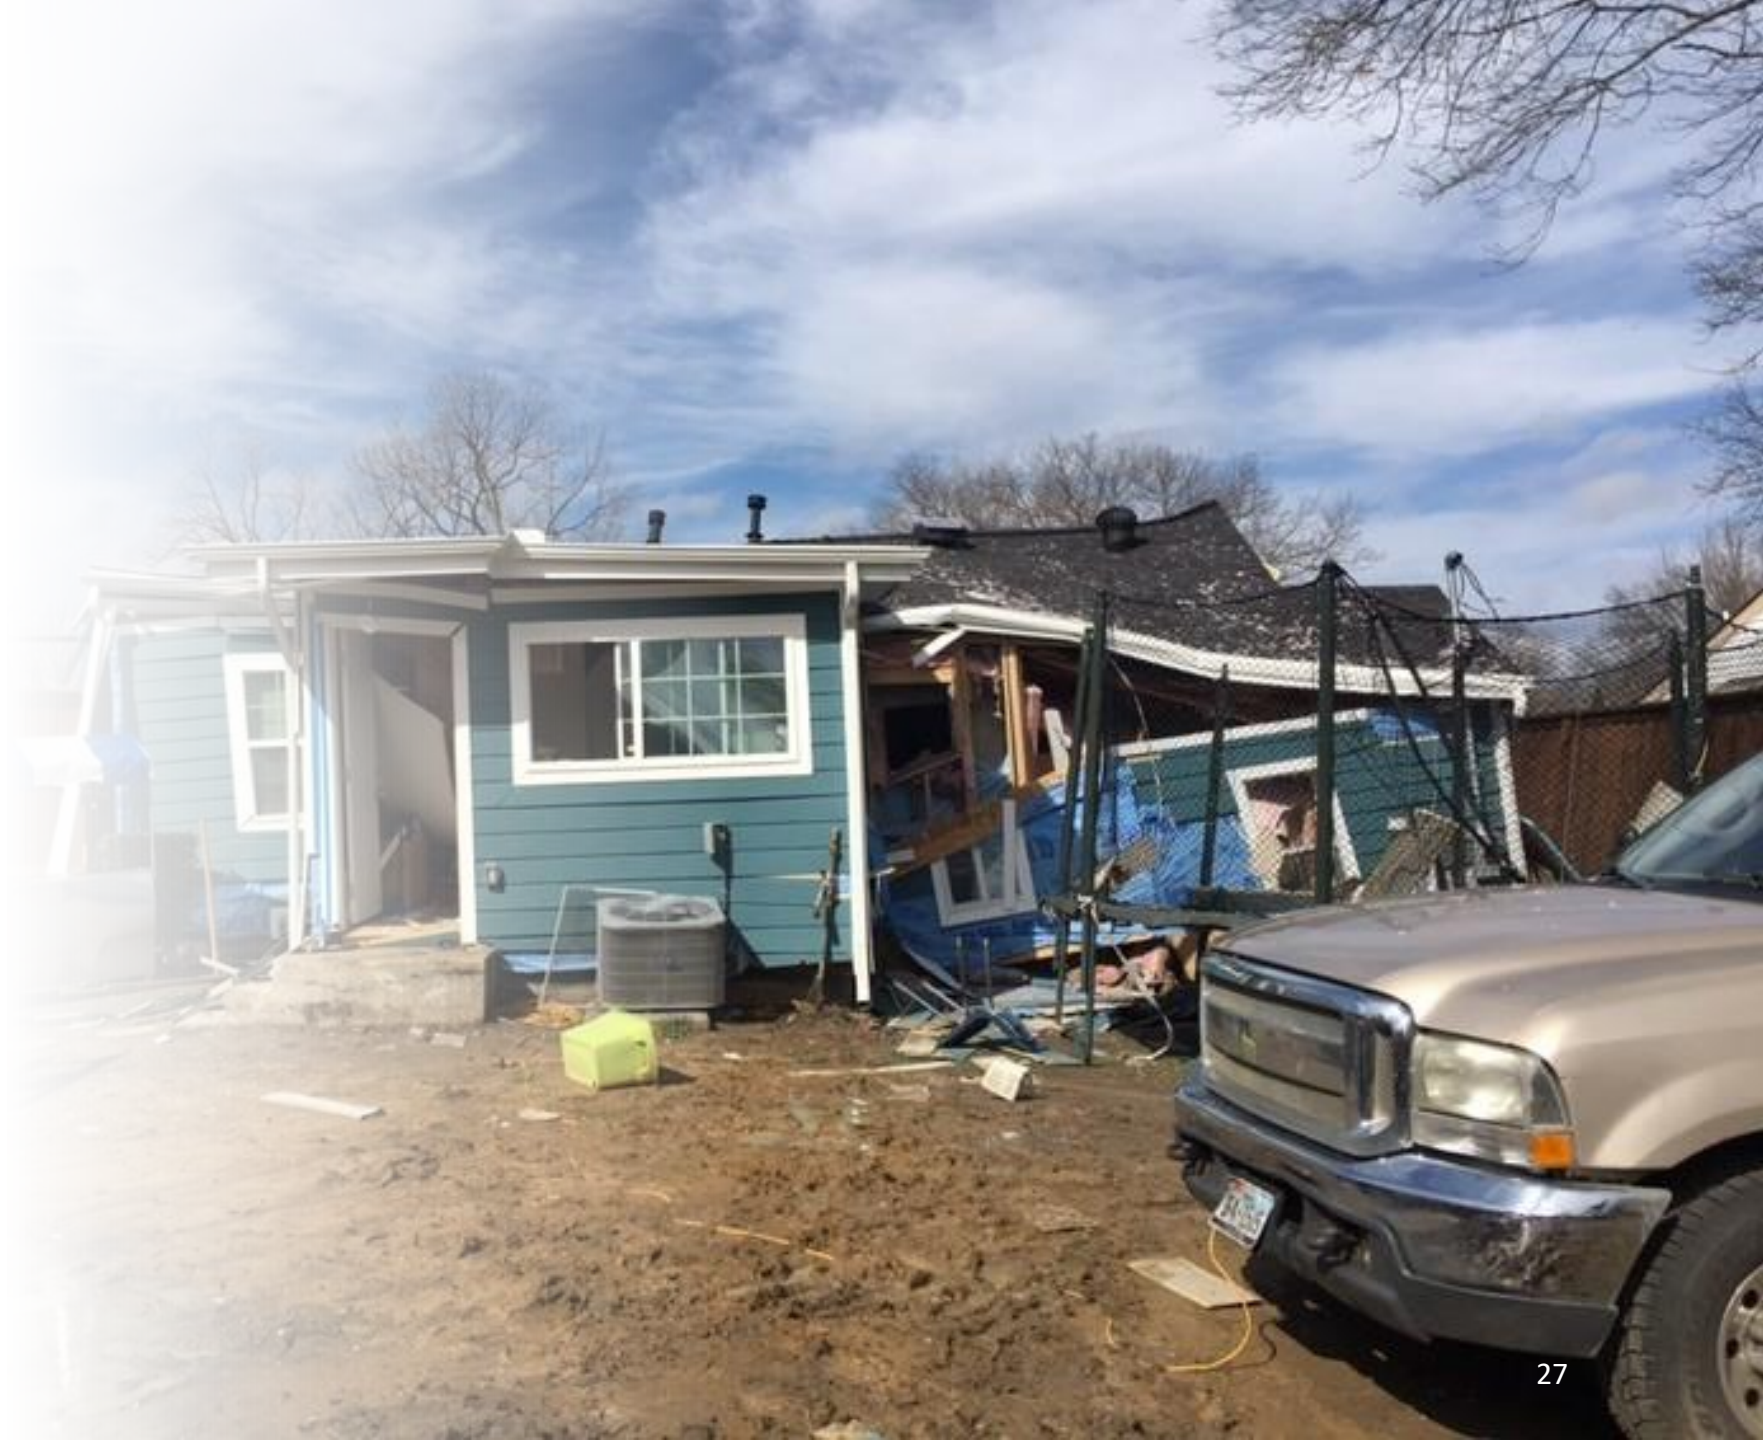
- February 23, 2018 – Day 3
 - House 3534 has an incident at 6:38 a.m., with a fatality and 3 injured, 1 released
 - Lived in home one month after full renovation. Including new gas and sewer service lines to alley.
 - Homeowner heard a loud pop in kitchen around 11 p.m. but found no source.
 - No gas smell prior to explosion
 - TX-RRC, NTSB and PHMSA launched to investigate.

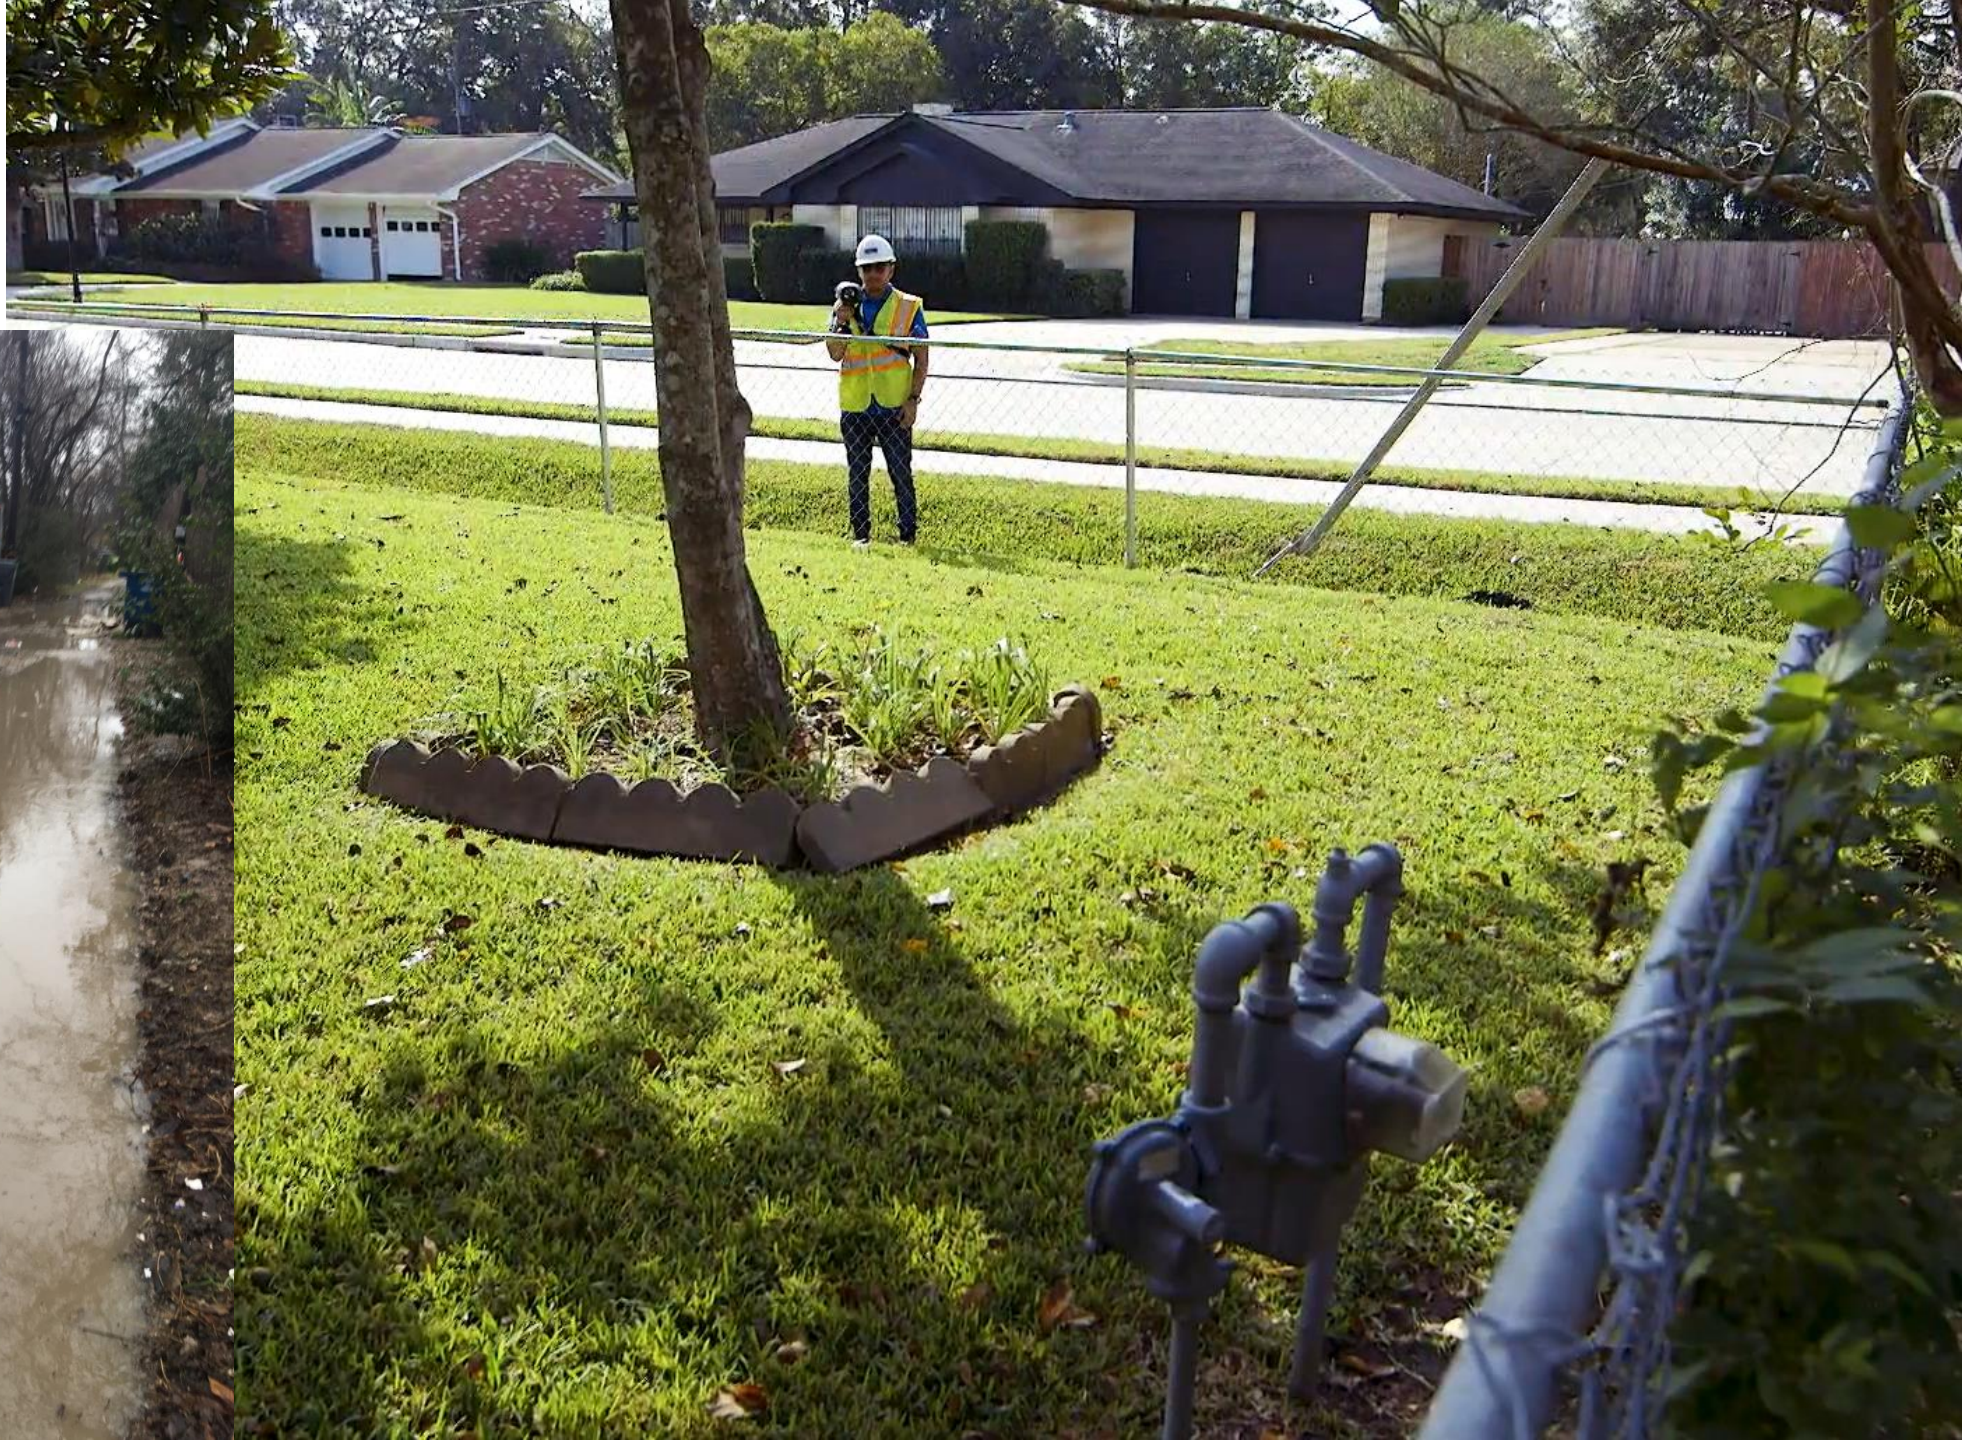
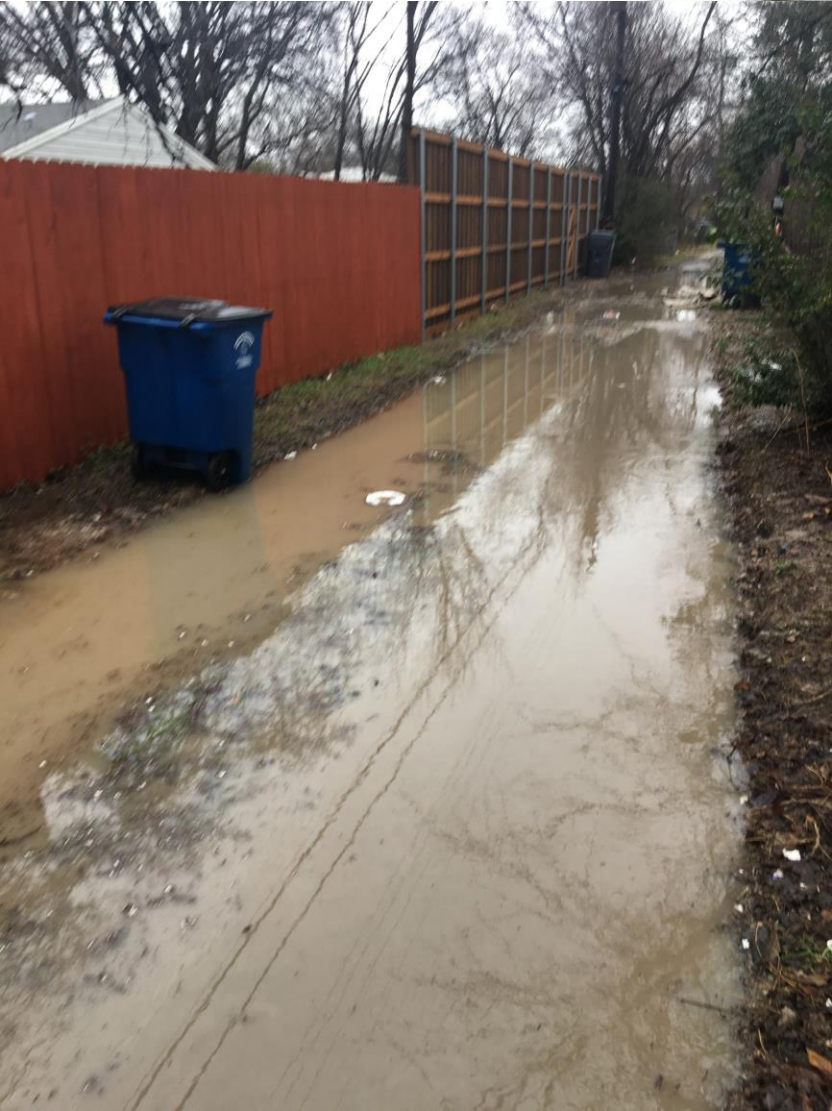
Leak surveys were performed after each explosion, with RMLD and CGI.

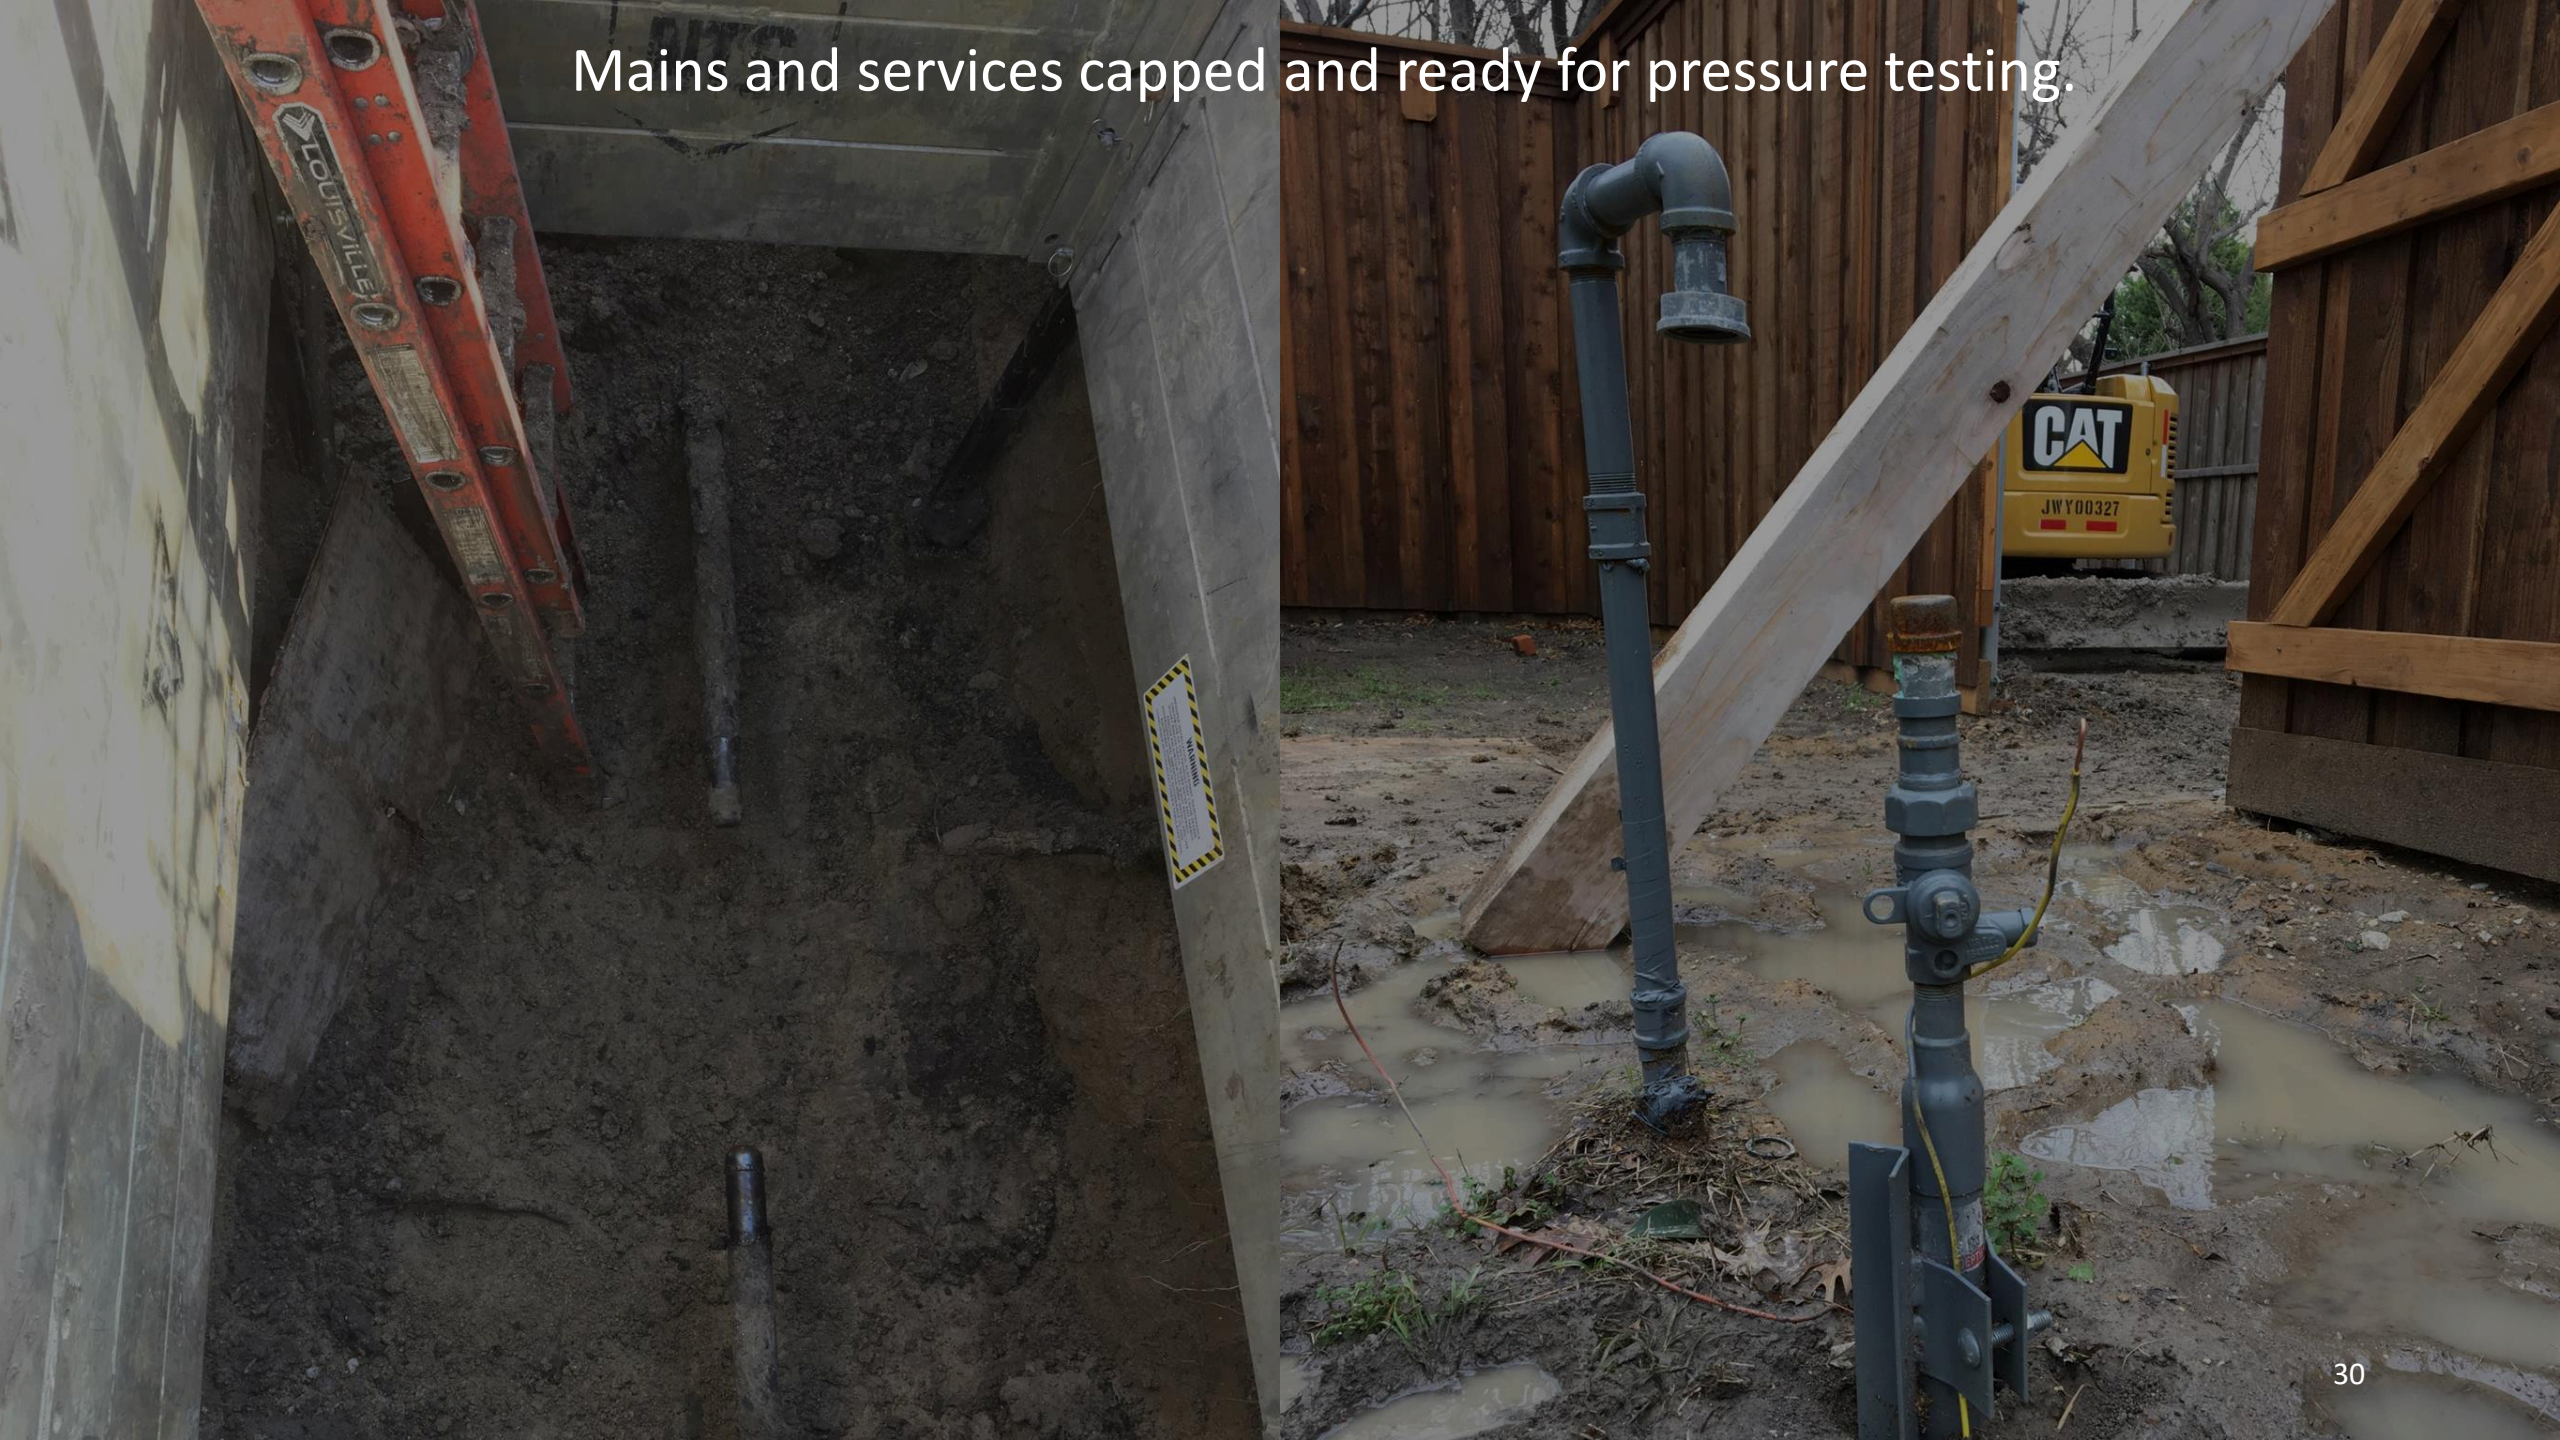
Mains and services capped and ready for pressure testing.

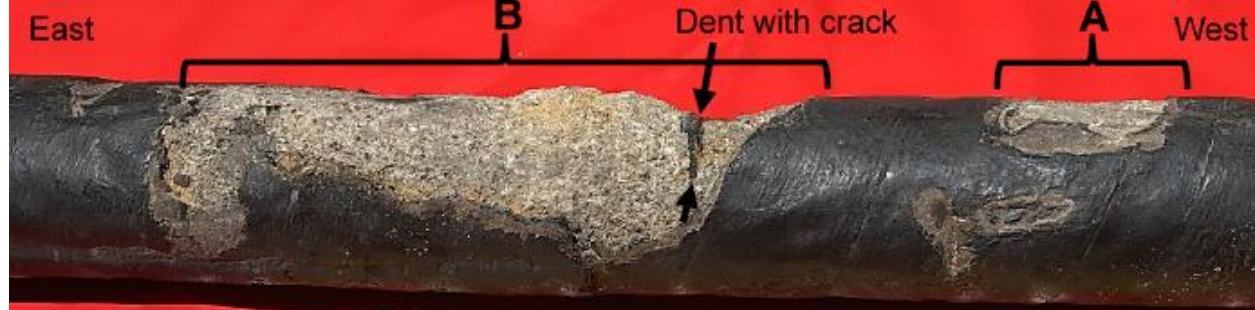
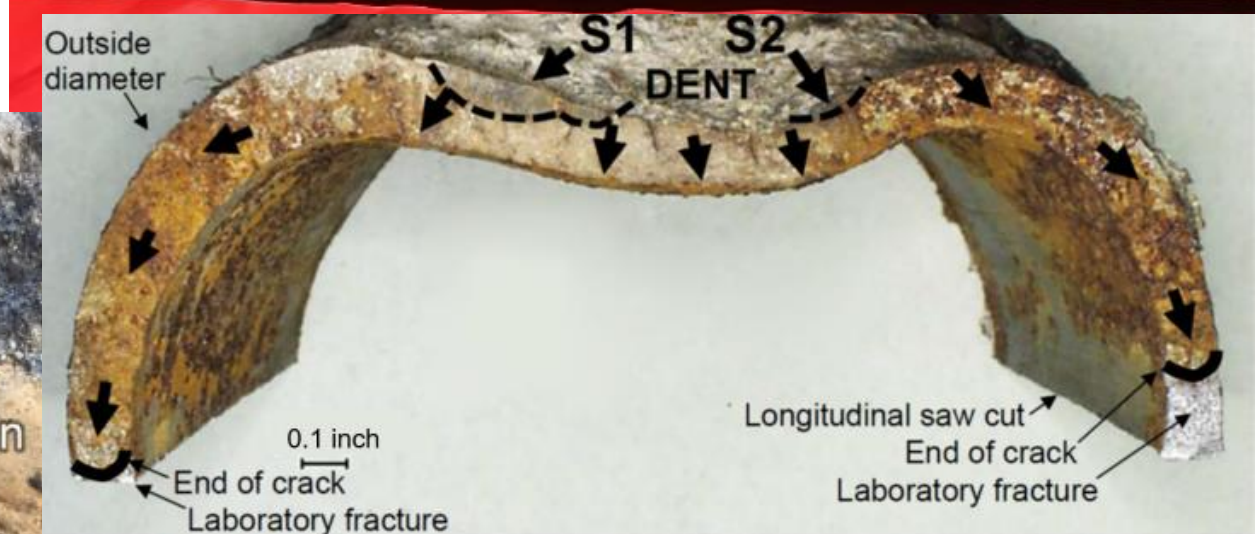
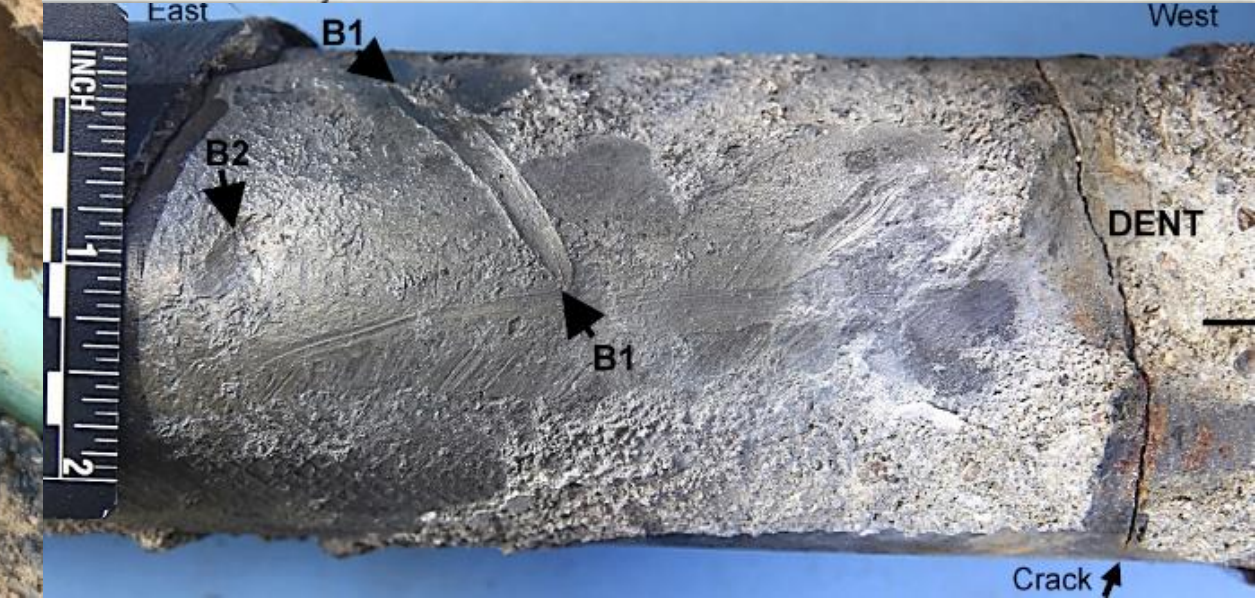
Overview of gas main and service in alley between Espanola and Durango Updated March 7, 2018

Document the details as it paints a picture. 664 feet of pipe tested with multiple leaks identified. Only one was large enough to result in the migration.

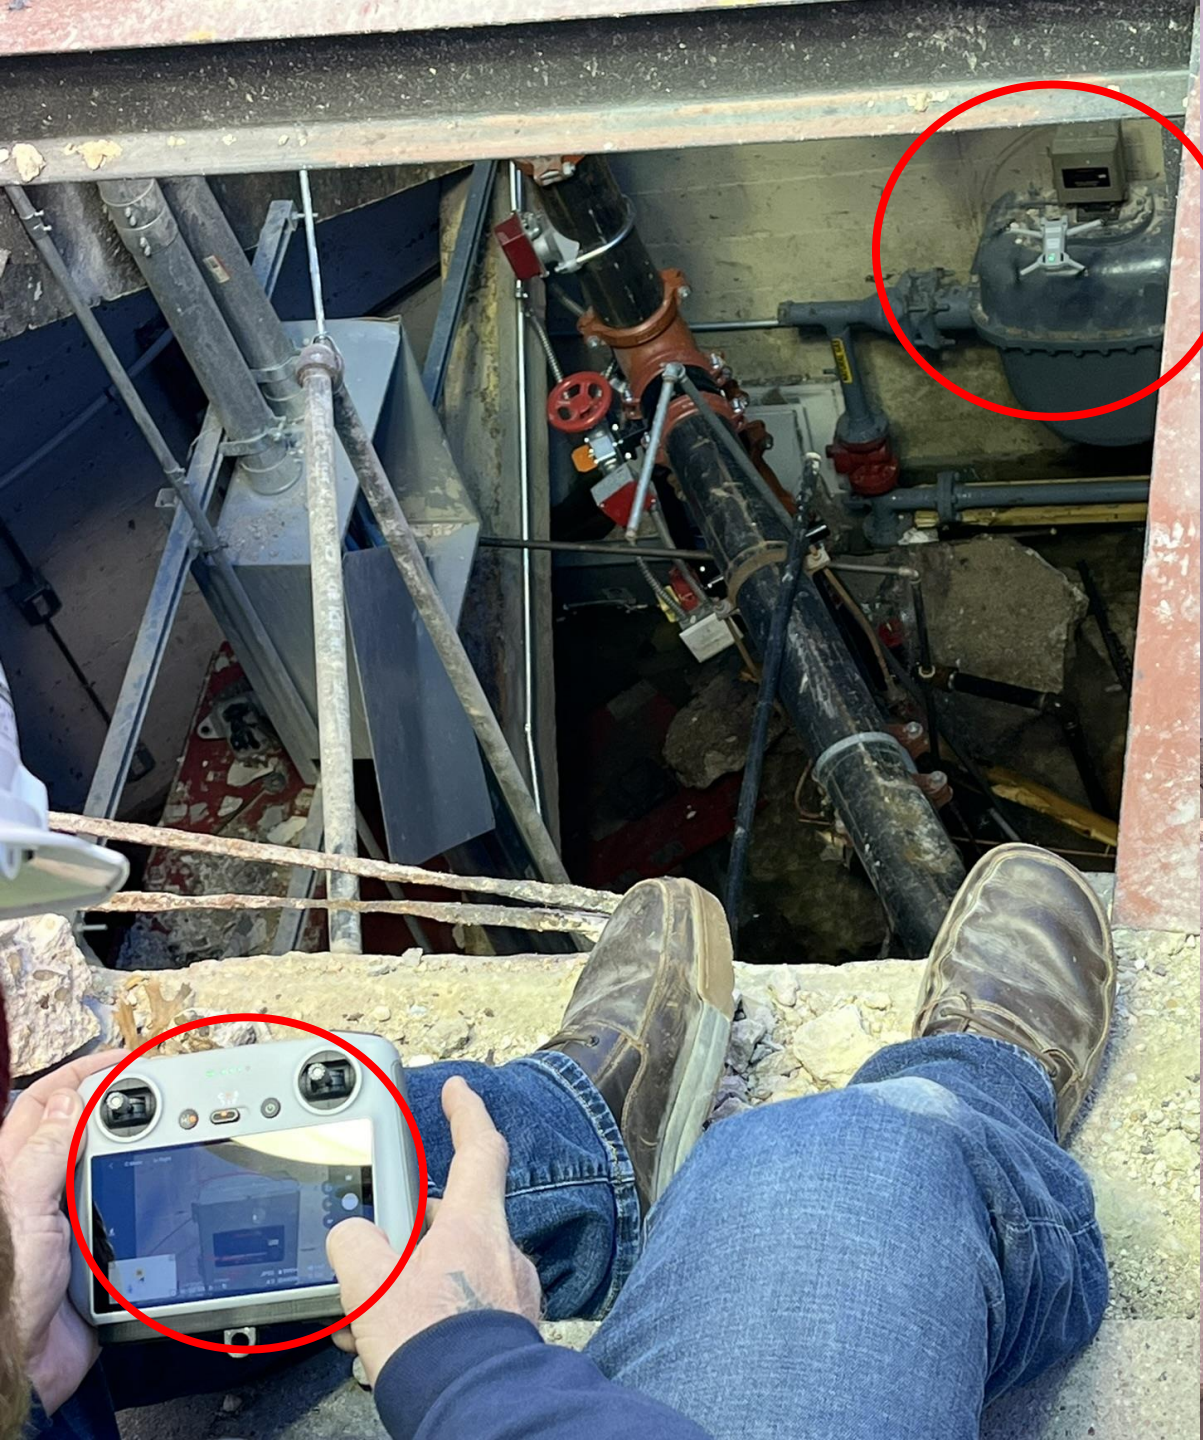
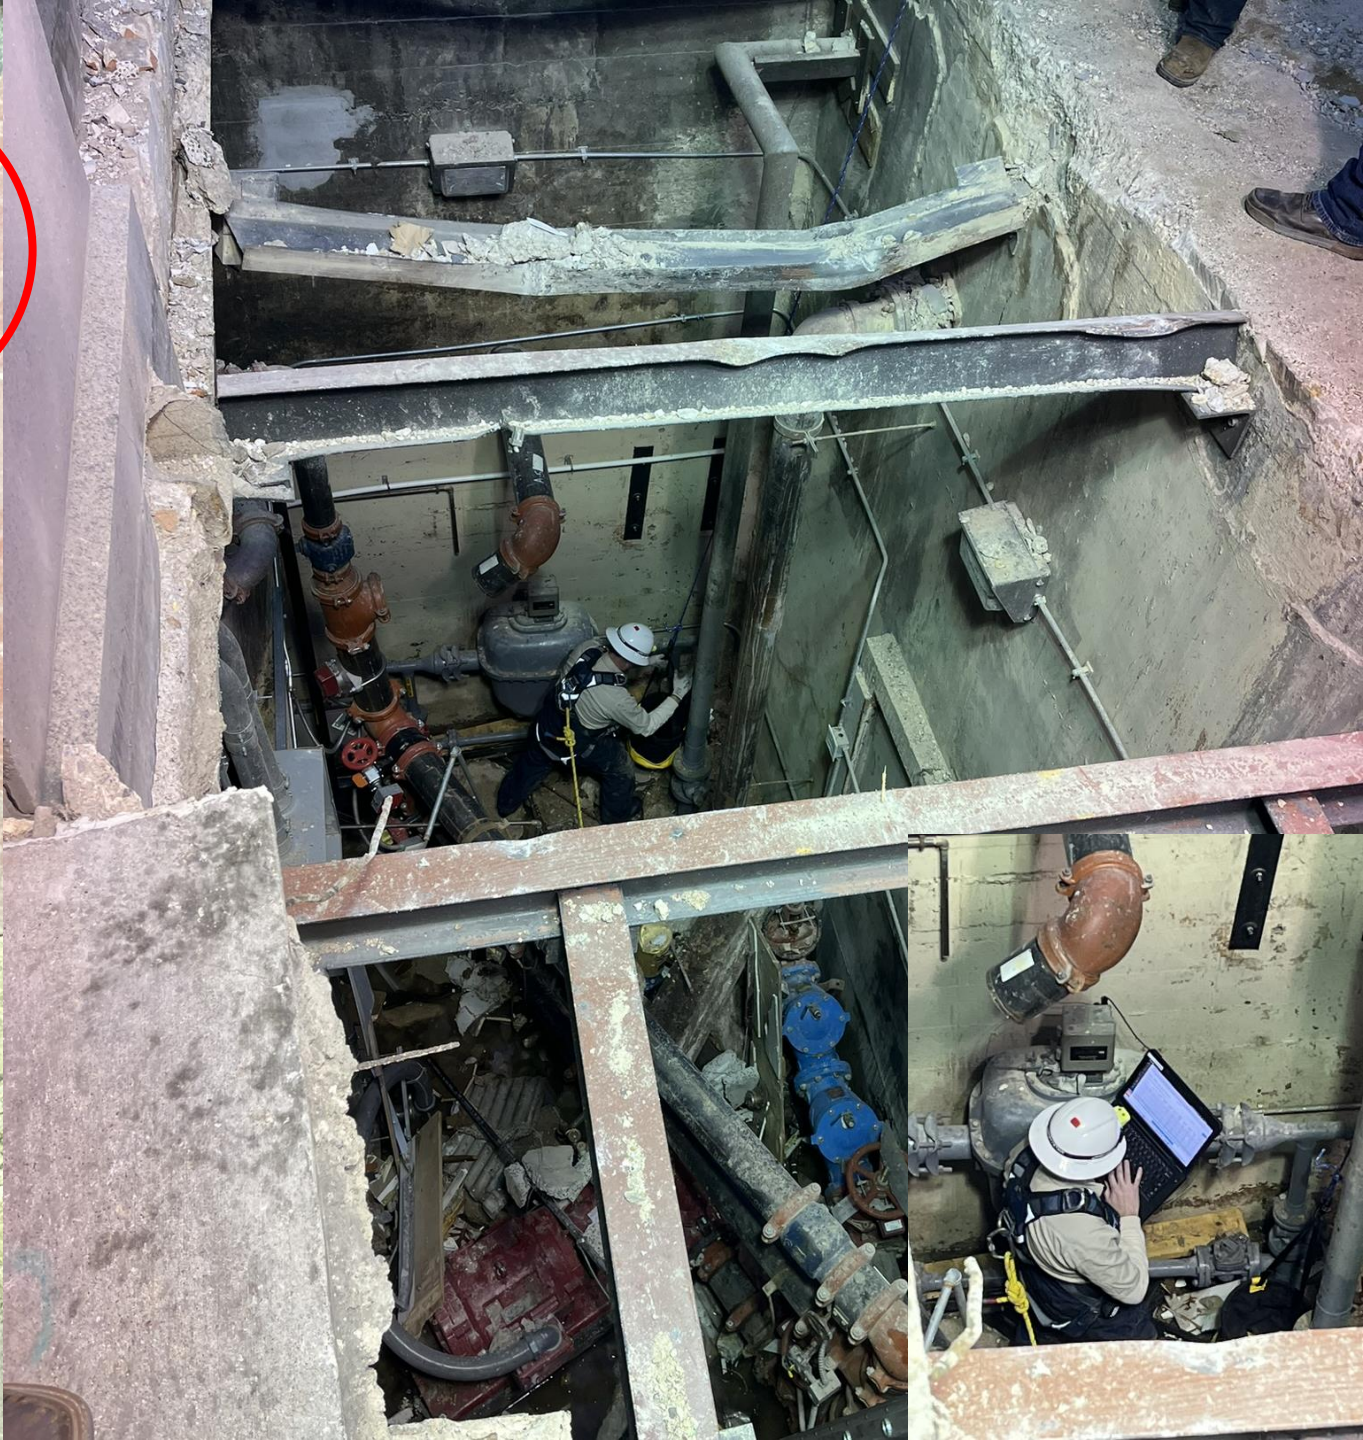
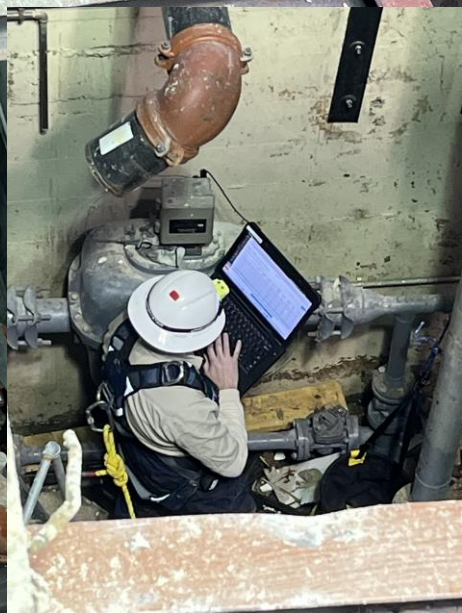
Be safe while working, What is wrong with this picture. A pressure test cap will be welded on for pressure testing in a few minutes. A compression coupling can be seen by support block.
